Ipswich Mills Dam Removal Feasibility Study

Ipswich, Massachusetts

March 2019

Prepared by:
Horsley Witten Group, Inc.

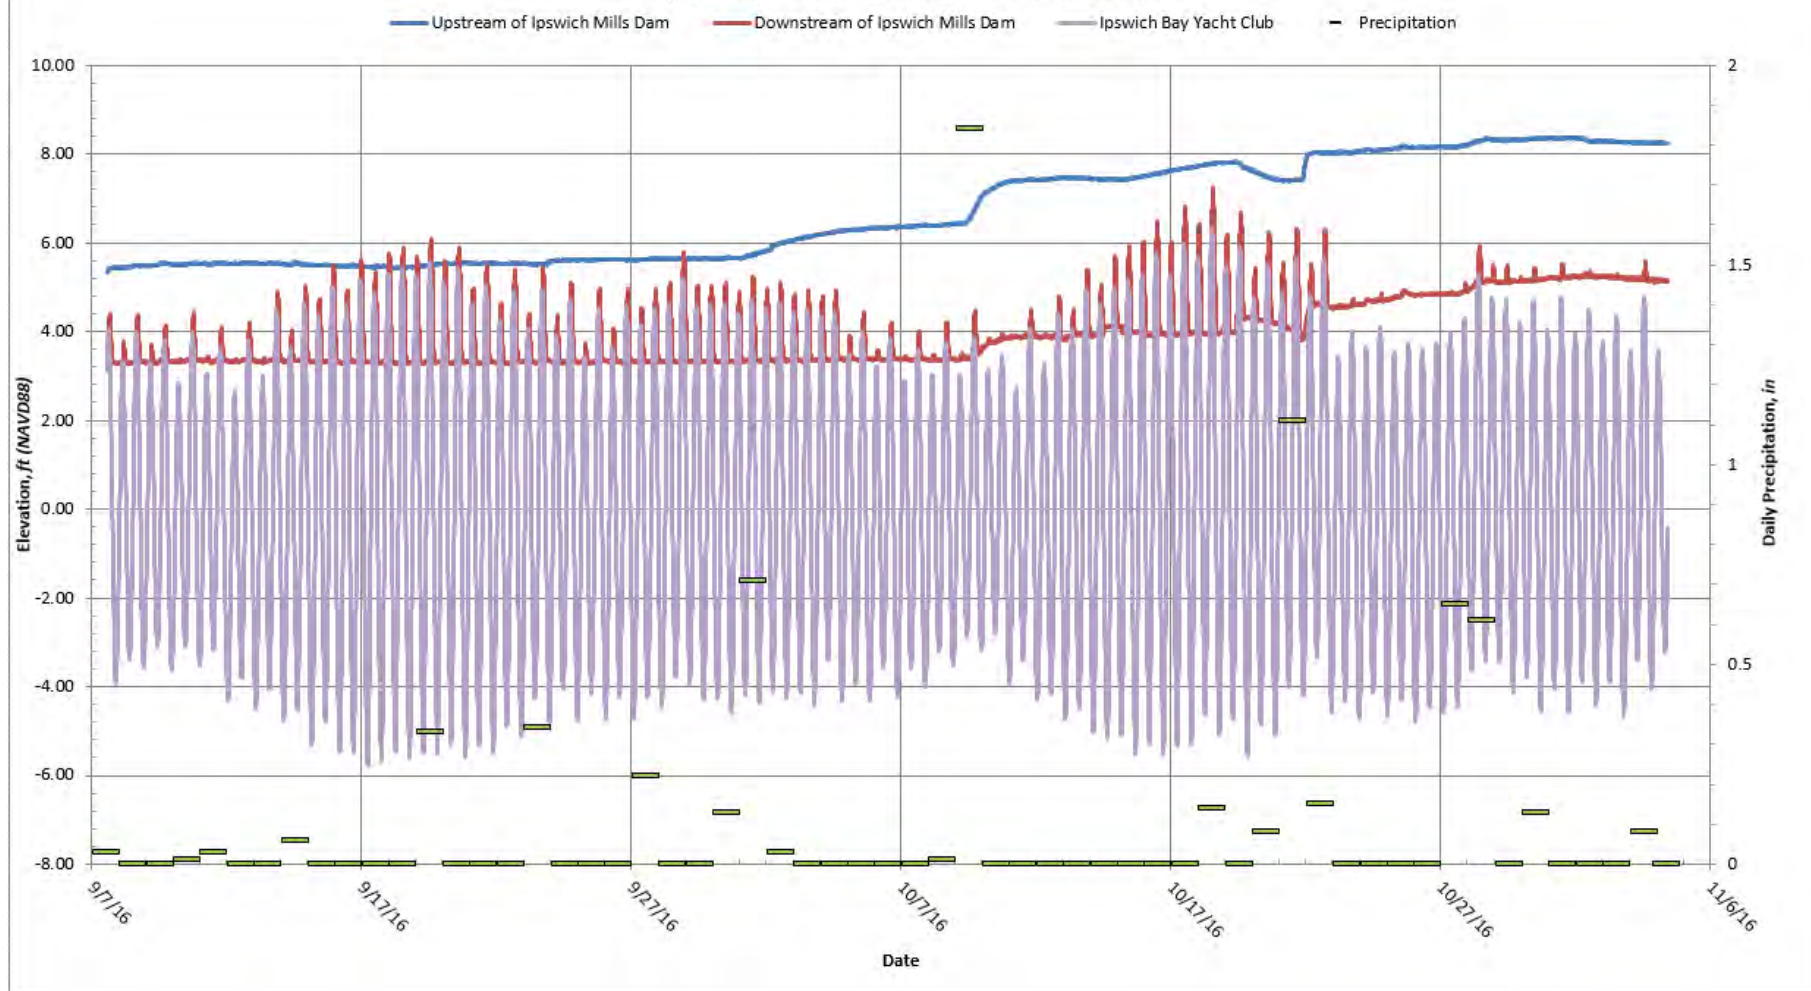
Figure 2-4. Surface Water Elevations
Ipswich River and Ipswich Bay
October 13th to 23^d, 2016

- No tidal response can be observed above the dam as the dam crest is above maximum tidal elevation. There is no observed periodicity of rising and falling water levels above the dam in response to rising and falling tidal levels below the dam.

- When fresh water river flows are high (upstream river stage above 8 feet) and the tidal cycle is in a neap period, river flow overwhelms the tidal influence of those lowest high tides below the dam. The converse is true for periods of low river flow and spring high tides. Due to the drought conditions prevalent for most of the monitoring period, no data are available to inform the relative influence of river flow versus tides below the dam for high flows and spring tides. According to IRWA, hydraulic responses to spring high tides are observed at the toe of the dam even during these higher river flow periods, though not at flood events.

- High tides at the toe of the dam reach to between approximate elevations 4 to 7 feet. These are all above the estimated bedrock controlling elevation in a potential dam-out scenario. Therefore, in a potential dam-out scenario, it appears that high tides would exert hydraulic influence above the current dam location. The available data are not sufficient to predict whether any saline water would reach above the current dam site. According to IRWA, salt water has rarely been detected above the Lower Falls in the dozens of water samples collected by the Division of Marine Fisheries (DMF) over the years, and only reaches to the dam site for spring high tides that occur during periods of low river flow. Given that reported limited presence of saline water at the toe of the dam, and the preference for higher density salt water to remain low and fresh water to sit above it, the likelihood of significant amounts of saline water reaching above the dam appears low but may require further study if warranted.

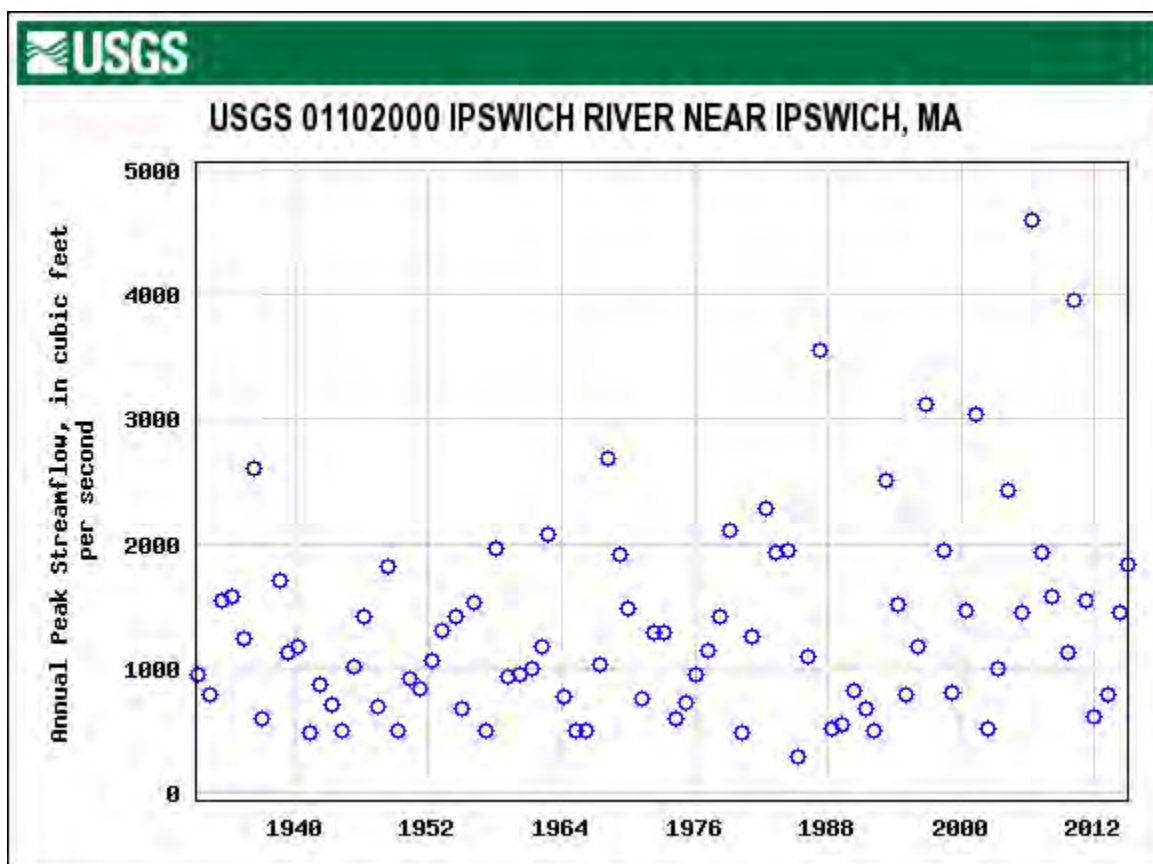
Figure 3-1. Instantaneous annual peak flows at USGS Willowdale Gauge

The nearest USGS flow gage (ID 01102000, Ipswich River near Ipswich, MA) is located approximately 200 feet downstream of the Willowdale Dam and 4.6 miles upstream of the Ipswich Mills Dam (<https://waterdata.usgs.gov>). The drainage area to the gage is 125 square miles. Instantaneous annual peak flows and daily average flows were downloaded for the period of record (1930-present). Annual peak flow rates are plotted in Figure 3-1.

Analysis of the flow data from 1930 to present suggests a trend of increasing magnitude of runoff events since around 1970, with the highest flows on record occurring after 1980. The

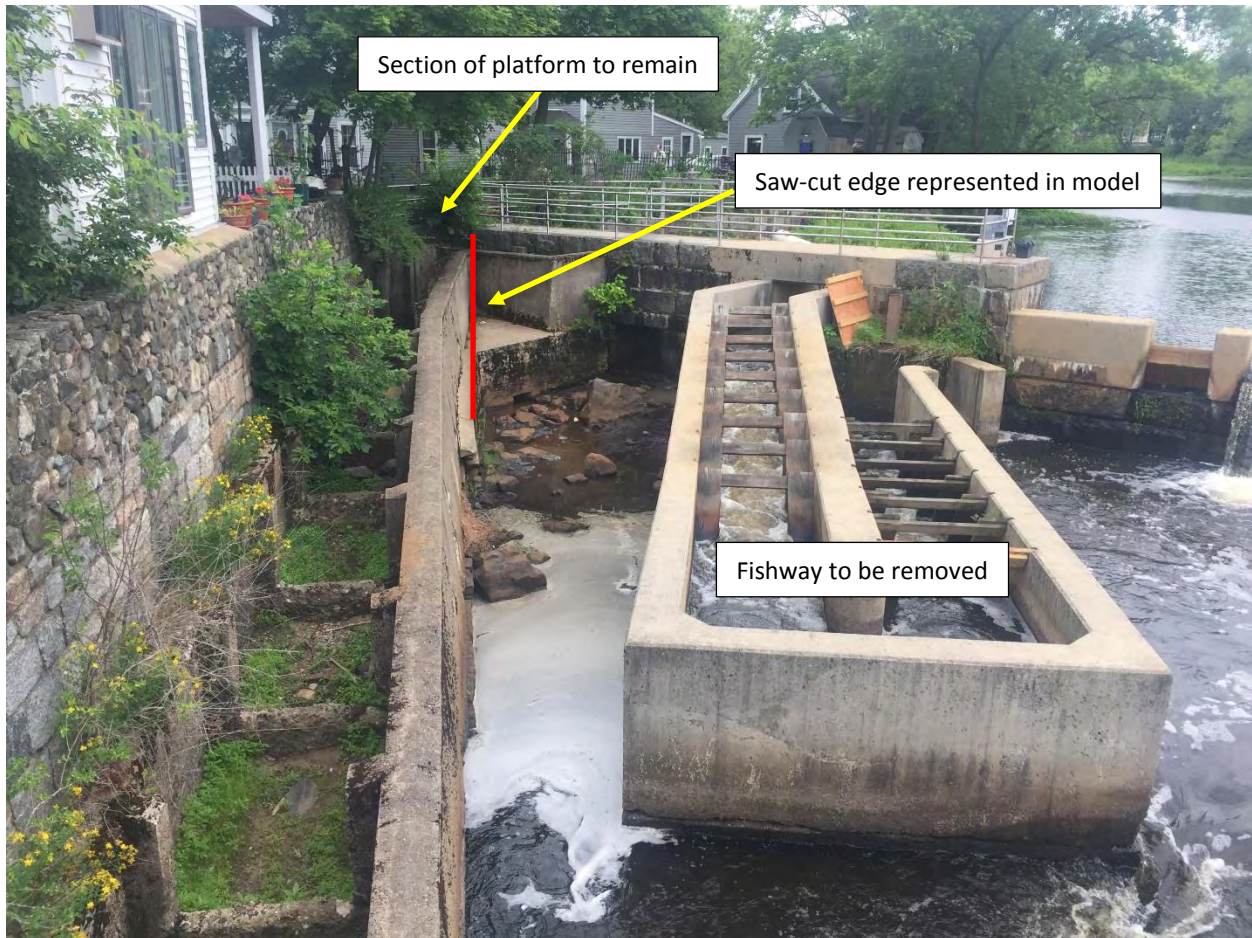
Figure 3-3. Modeled limits of dam removal on river right

This scenario involves leaving the abandoned fishway integral with the existing river in place in order to avoid destabilizing the river right wall (looking downstream) during demolition. An approximate 10-foot section of the existing viewing platform would be retained as a part of this minimum measure to protect the river right wall (Figure 3-3). All other elements of the dam would be removed to the full vertical extent.

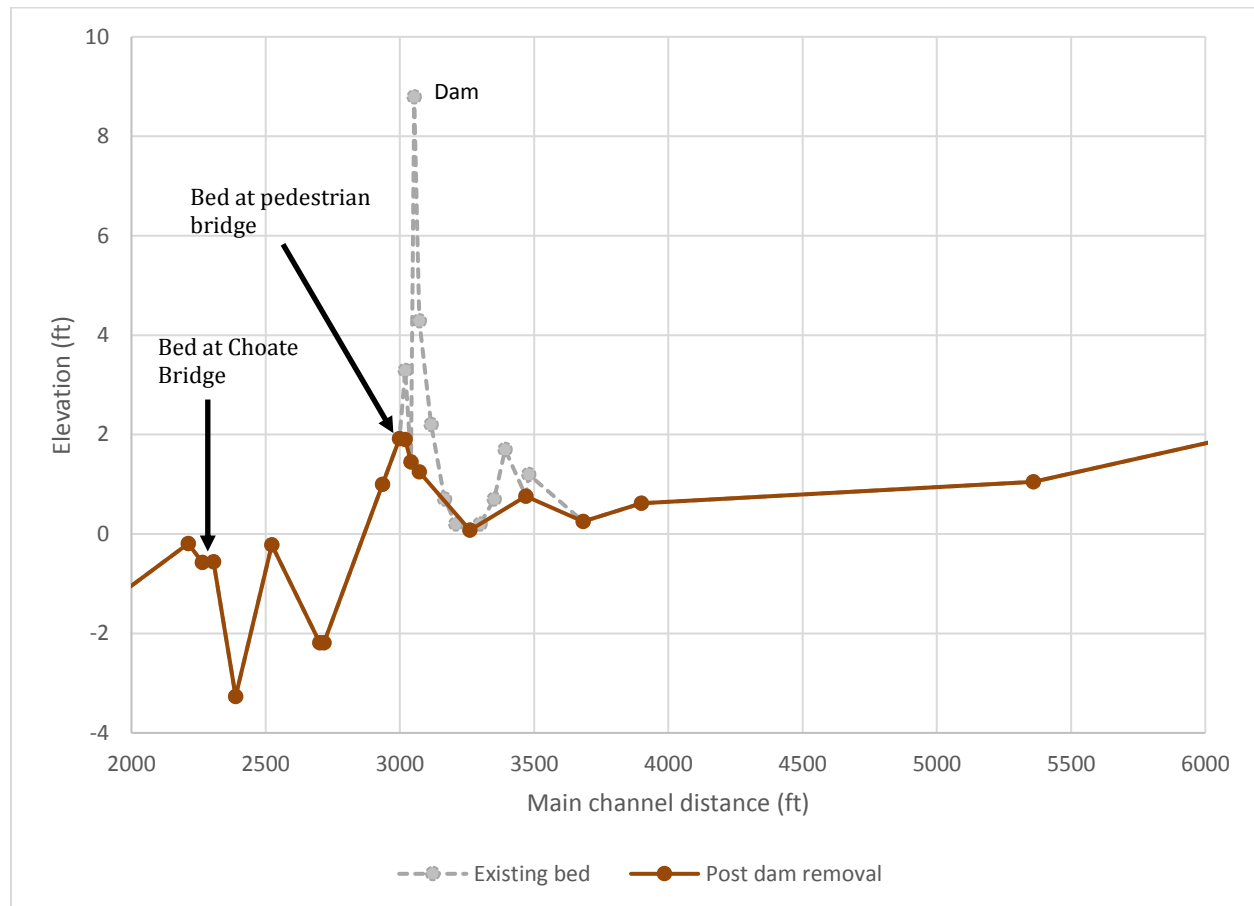
Figure 3-4. Comparison of existing and modeled long-term longitudinal channel bed profiles. Flow is from right to left.

Because of the uncertainty concerning the elevation of bedrock at the dam site, the dam-out model has taken a conservative (i.e., safe) approach from the perspective of infrastructure risk by assuming any bedrock is present at a low enough elevation so that the long-term bed profile will align with the average upstream and downstream bed profiles. This means that the proposed bed profiles are modeled at their likely lowest possible elevation, thus presenting the highest possible “risk” to upstream infrastructure. Further investigation will be required to clarify the presence or absence and elevation of bedrock at the site. Figure 3-4 shows the dam-out condition represented by the model as compared with existing conditions.

The dam-out conditions model geometry includes removal of the dam, filling of the scour pool below the dam, removal of the fishway from the cross sections immediately downstream of the dam, lowering the bed levels at Sta 3072 (21 feet upstream of former dam) by 3.04 feet to reflect mechanical regrading or removal of the accumulated rock immediately behind the dam, and lowering the bed levels at Sta 3020 (between dam and pedestrian bridge) by 1.39 feet to depict mechanical regrading of accumulated bed material downstream of the scour pool at the base of the dam. Bed levels elsewhere were left unchanged.

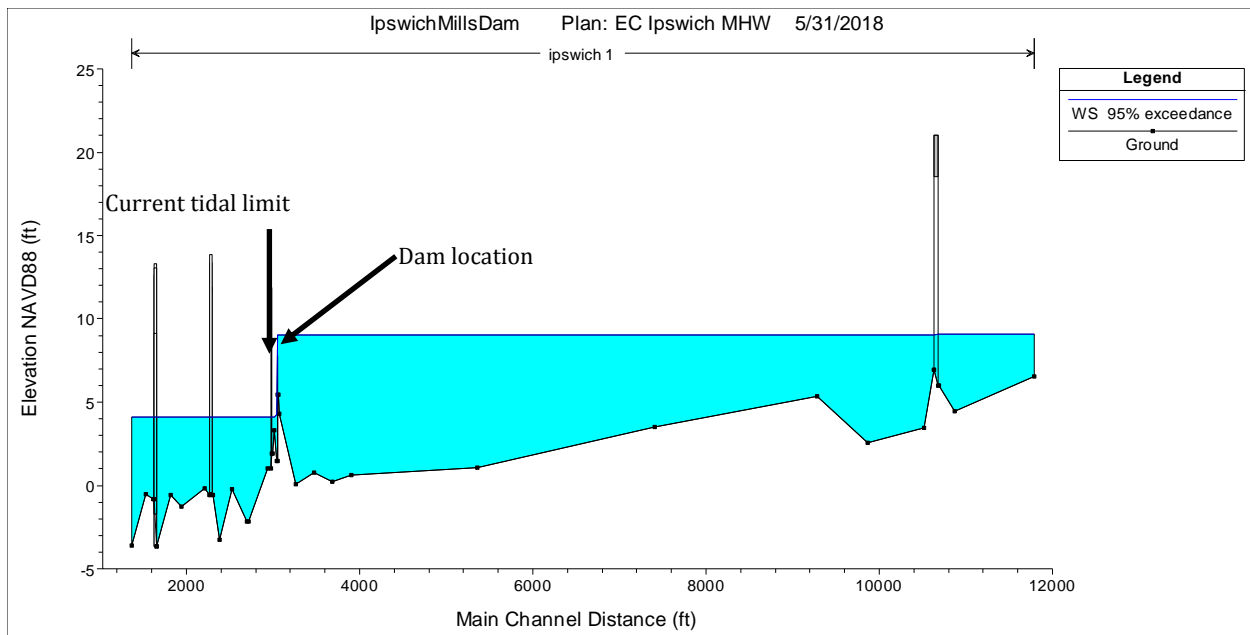
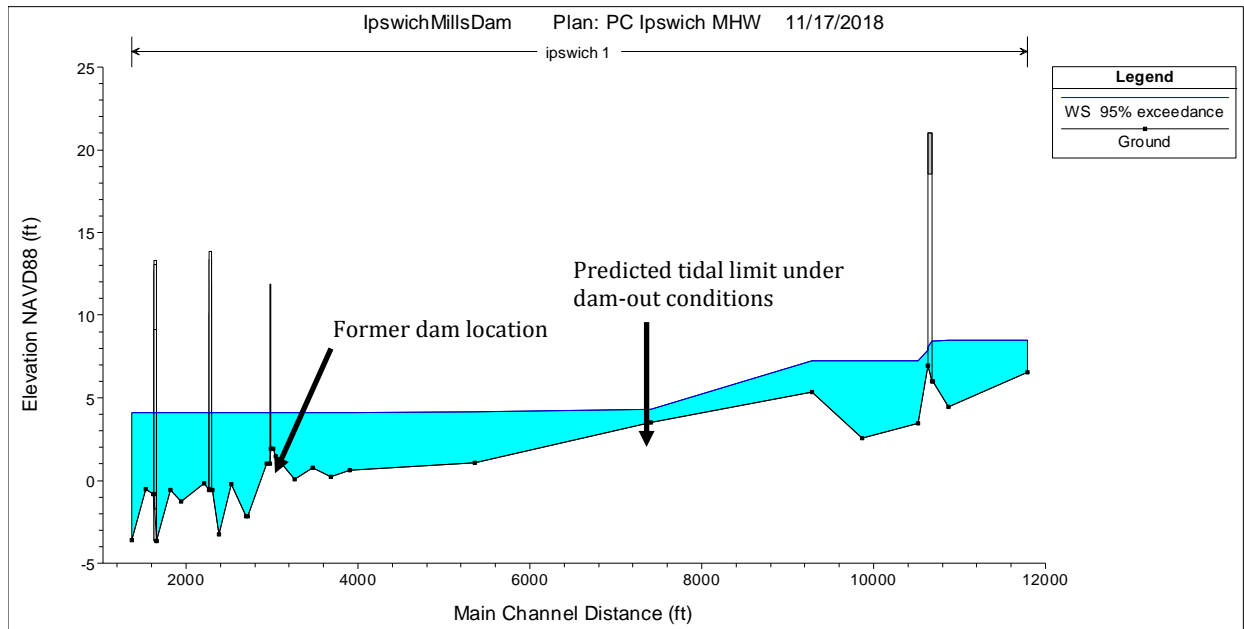
Figure 3-5. Predicted low-flow water surface profiles for existing (top) and dam-out (bottom) conditions during high tide

A combination of high tide (MHW) and low flow (95% exceedance) under existing and dam-out conditions were simulated to examine the impact of dam removal on the extent of hydraulic tidal influence on river conditions. Comparison of the water surface profiles in Figure 3-5 shows that in the absence of the dam, the hydraulic tidal influence is predicted to extend upstream to near Upper River Road, or approximately 4,350 feet upstream of the existing dam and current tidal limit.

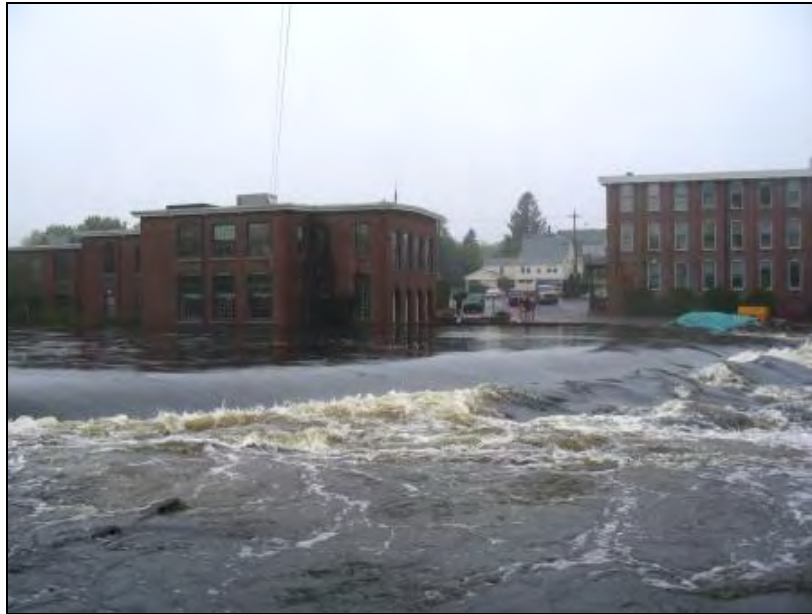
Figure 2a. Ipswich Mills Dam on May 16, 2006, facing southwest (photo provided by IRWA)

In addition, the USGS maintains a gage located 200 feet downstream from the Willowdale Dam, or 25,000 feet upstream of the Ipswich Mills Dam, and has continuously recorded water surface elevation and discharge data as far back as June 1930. Monthly mean flows at the Willowdale Dam between 1930 and 2009 range from 42.0 cubic feet per second in August to 446 cubic feet per second in March. Appendix A presents the monthly gage data according to the USGS analysis of data between June 1930 and 2009. The highest flow on record of 4,600 cfs occurred on May 16, 2006. Two photos of the

Ipswich Mills Dam on May 16, 2006 are provided below (Figures 2a and 2b), showing that the dam is virtually drowned out by the discharge in the river.

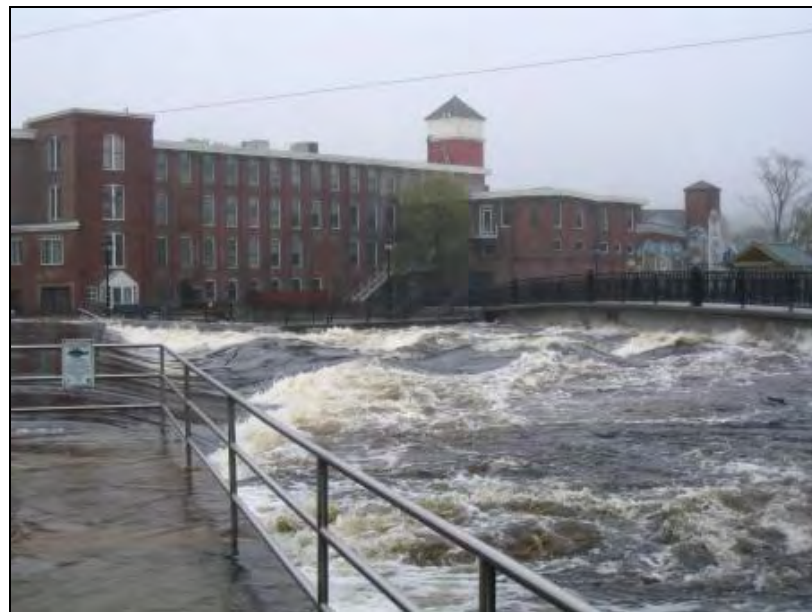
Figure 2b. Ipswich Mills Dam on May 16, 2006, facing northwest (photo provided by IRWA)

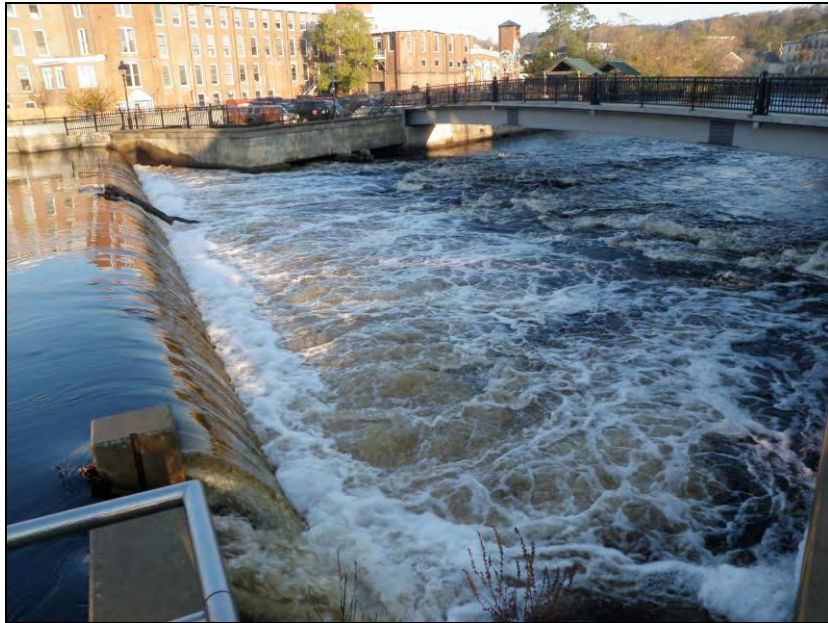
Figure 4a. The Ipswich Mills Dam is a run-of-the-river mill dam formerly used to power the nearby mills. (Horsley Witten Group, November 2011)

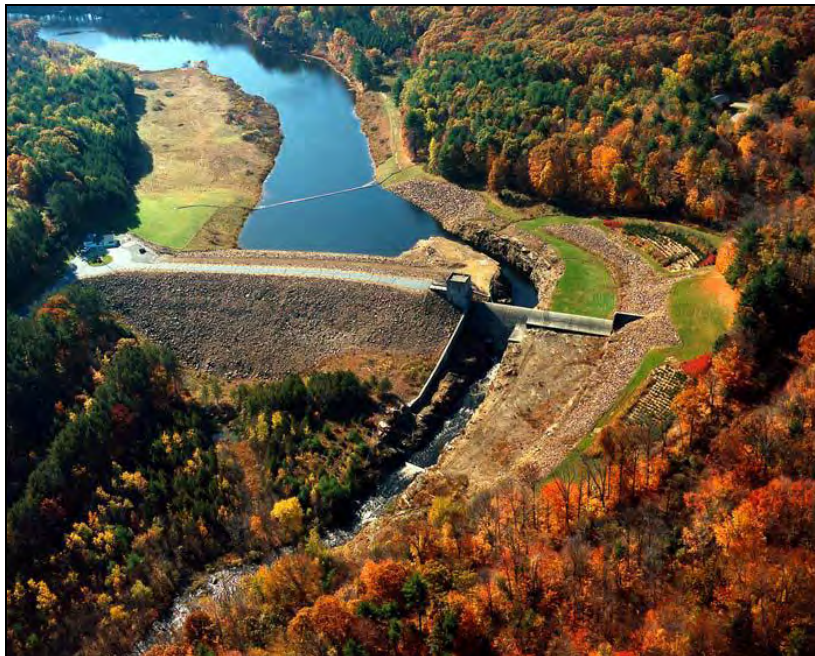
Figure 4b. The Westville Lake Flood Control Dam on the Quinnebaug River in Southbridge, MA serves to control flooding to downstream areas. This dam serves an entirely different purpose than the Ipswich mills Dam. (US Army Corps of Engineers)

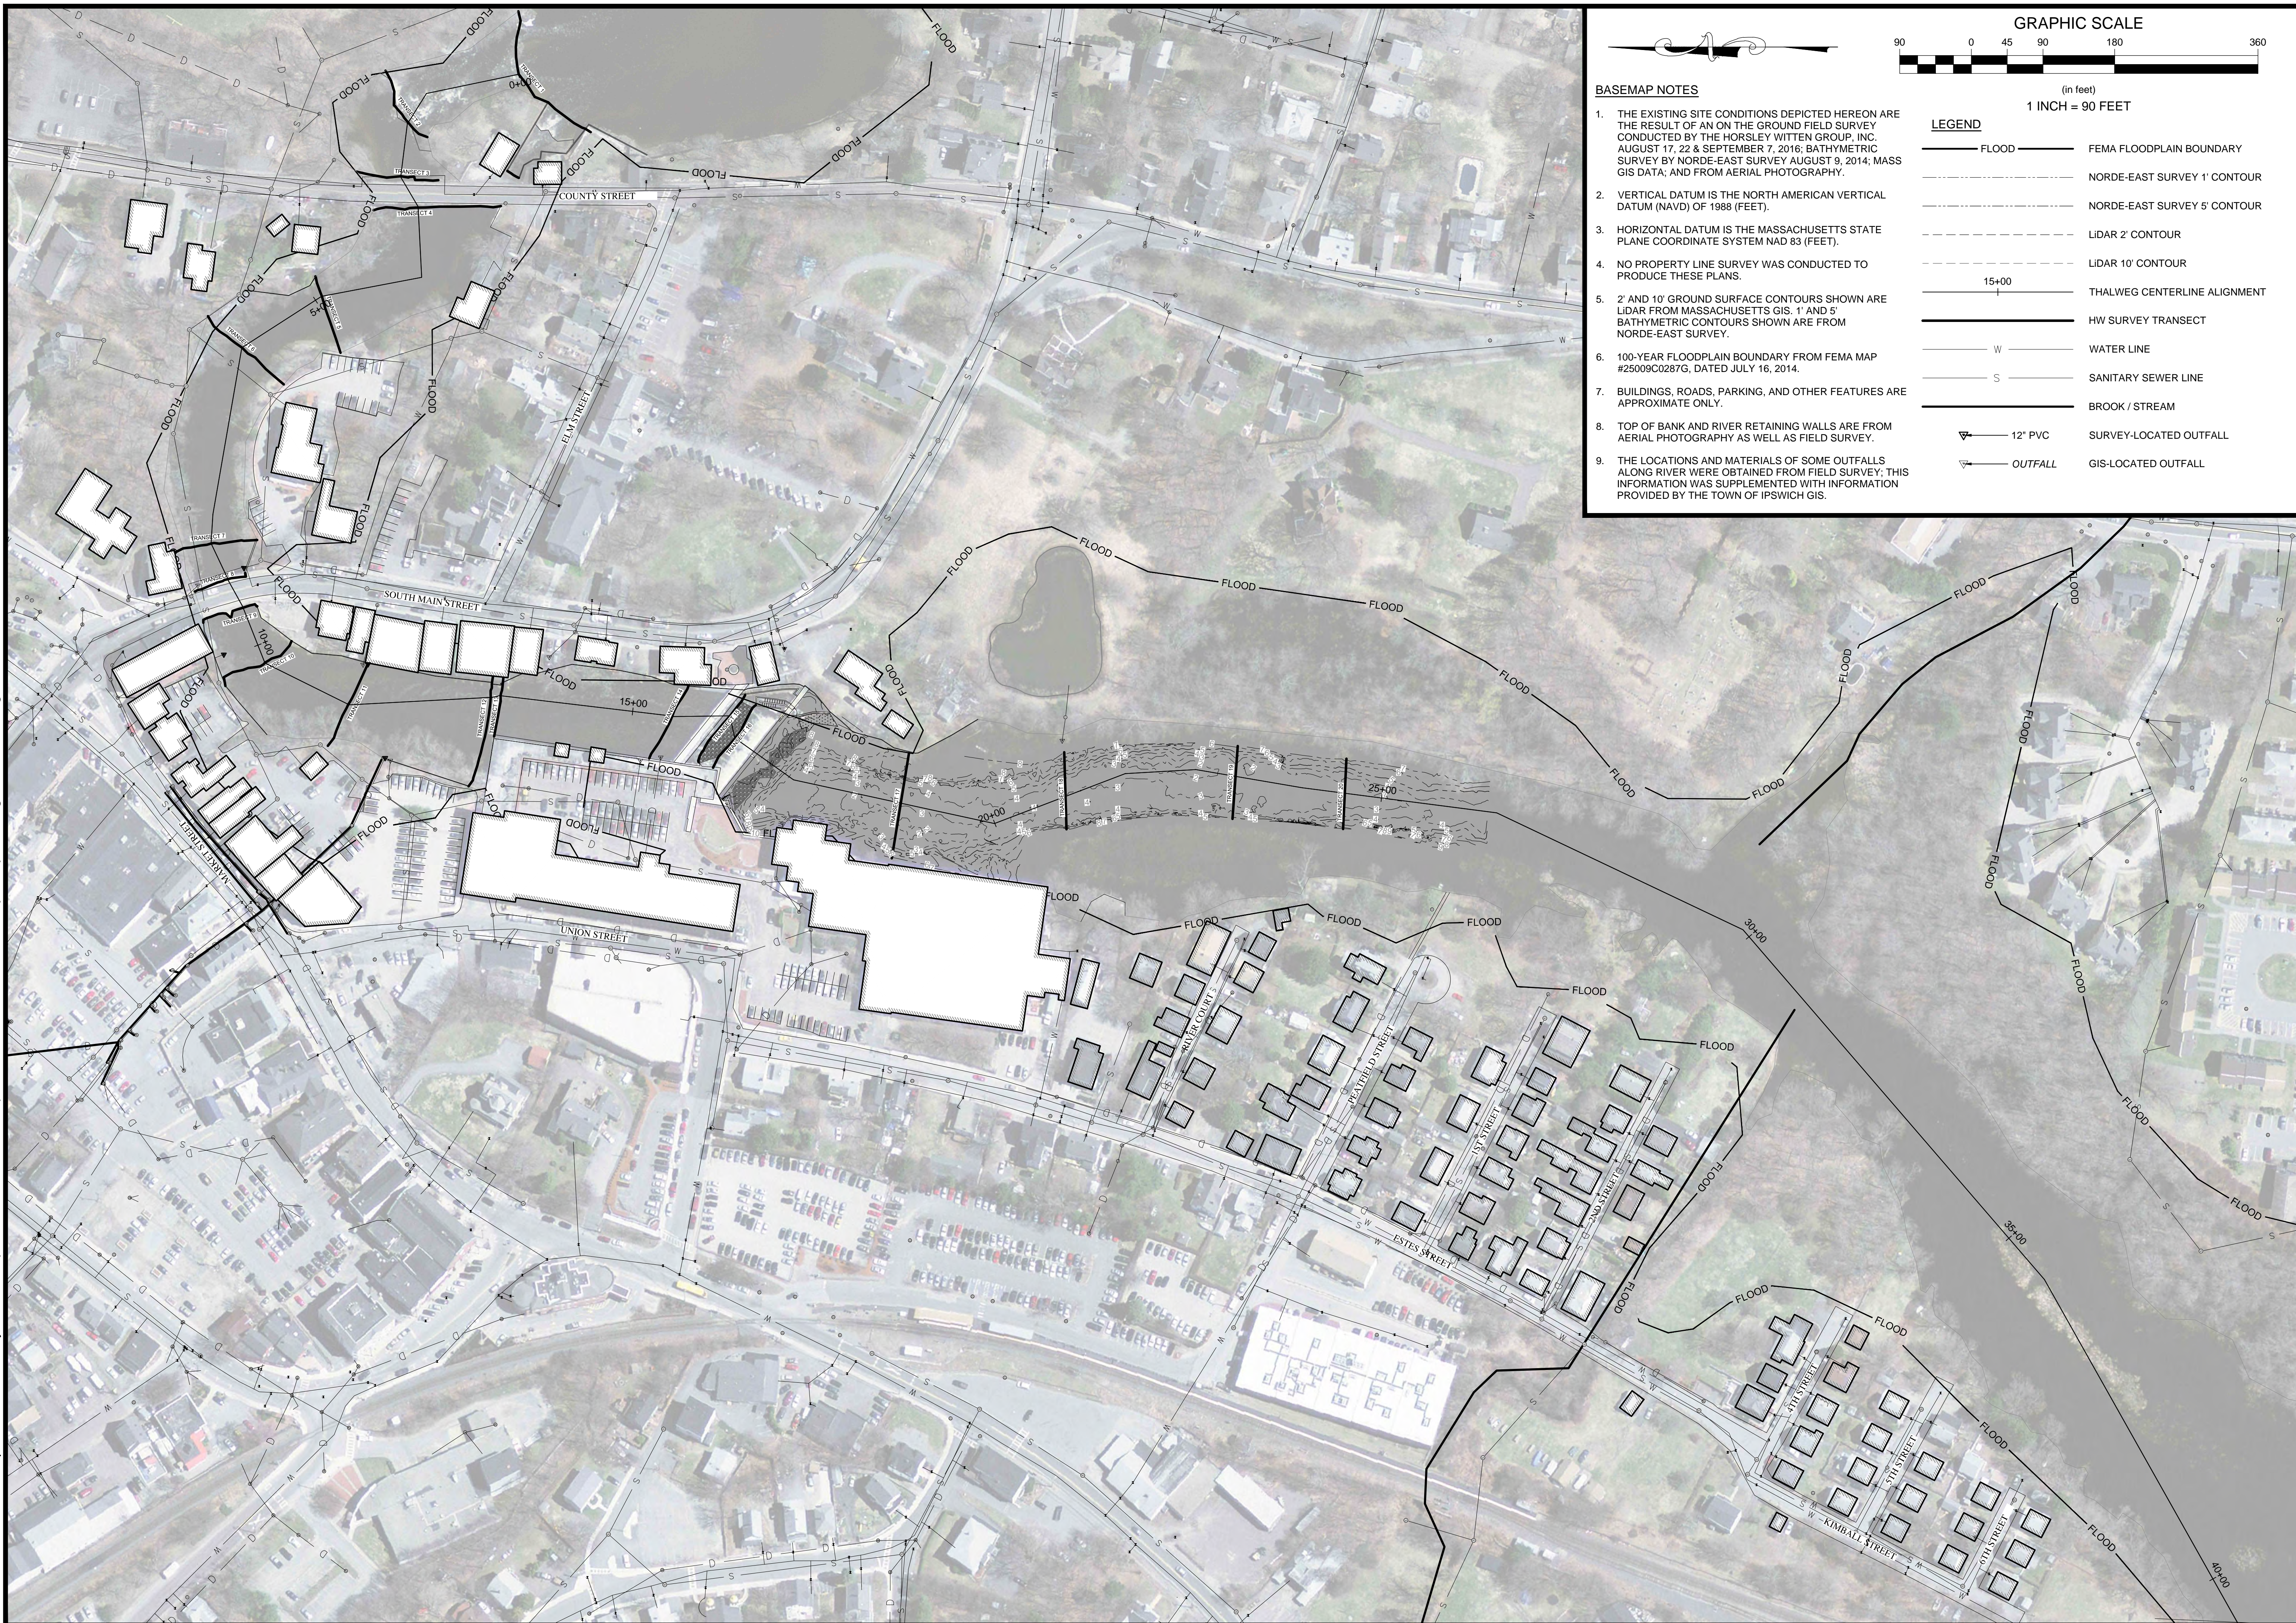
1. THE EXISTING SITE CONDITIONS DEPICTED HEREON ARE THE RESULT OF AN ON THE GROUND FIELD SURVEY CONDUCTED BY THE HORSLEY WITTEN GROUP, INC. AUGUST 17, 22 & SEPTEMBER 7, 2016; BATHYMETRIC SURVEY BY NORDE-EAST SURVEY AUGUST 9, 2014; MASS GIS DATA; AND FROM AERIAL PHOTOGRAPHY.

9. THE LOCATIONS AND MATERIALS OF SOME OUTFALLS ALONG RIVER WERE OBTAINED FROM FIELD SURVEY; THIS INFORMATION WAS SUPPLEMENTED WITH INFORMATION PROVIDED BY THE TOWN OF IPSWICH GIS.

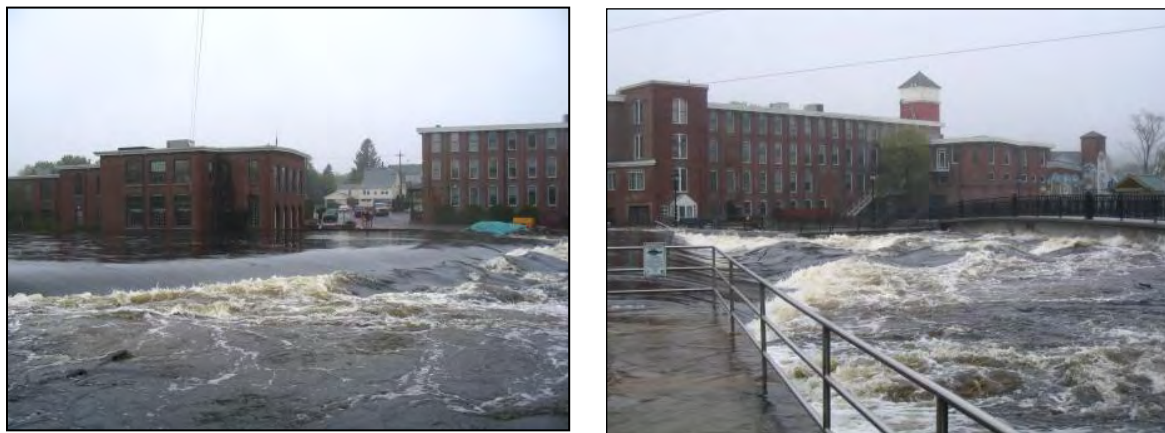
Figure 3. Ipswich Mills Dam on May 16, 2006, facing southwest (left) and northwest (right) (photos by IRWA)

The USGS maintains a gage located 200 feet downstream from the Willowdale Dam, or approximately 4.6 miles upstream of the Ipswich Mills Dam, and has continuously recorded water surface elevation and discharge data as far back as June 1930. Monthly mean flows at the Willowdale Dam between 1930 and 2009 range from 42.0 cubic feet per second in August to 446 cubic feet per second in March. The highest flow on record of 4,600 cfs occurred on May 16, 2006. Two photos of the Ipswich Mills Dam on May 16, 2006 are provided below showing that the dam is virtually drowned out by the discharge in the river (Figure 3).

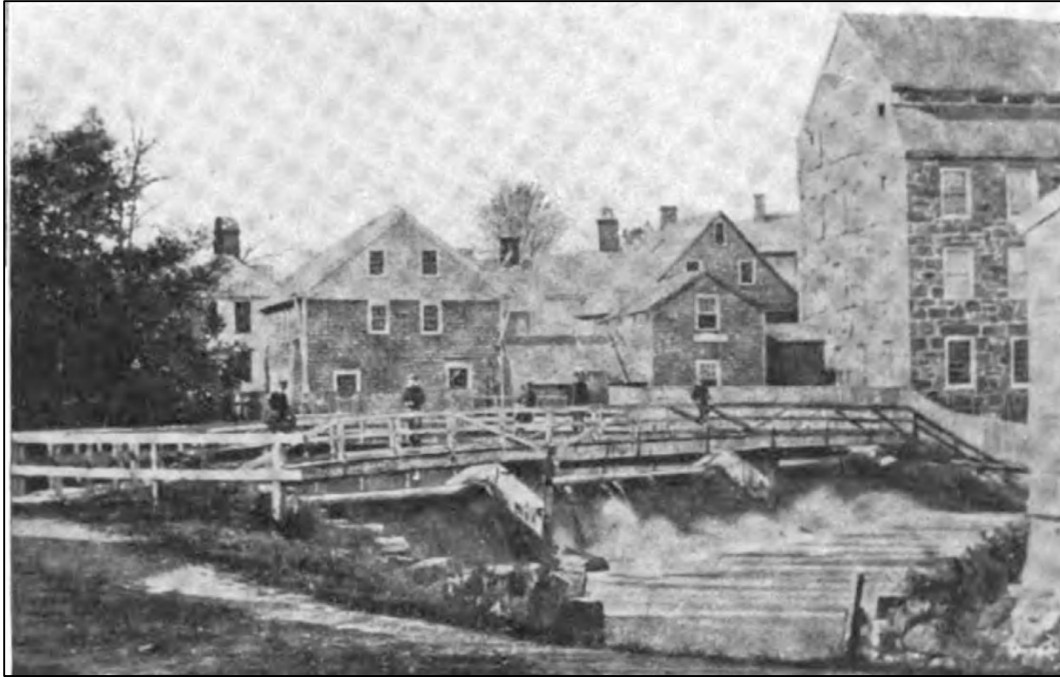
Figure 2. Ca. 1867 photograph of Ipswich Mills Dam, showing “foot-bridge” and “water-way”, view looking southwest (stone mill at right) (source: Waters 1917:678).

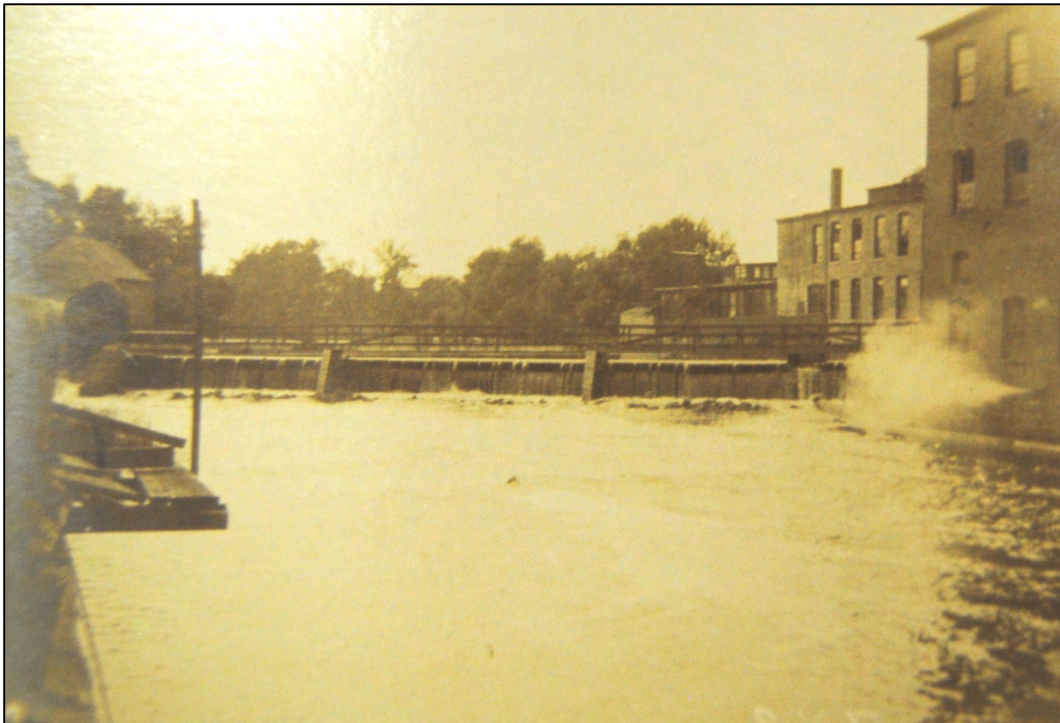
Figure 3. Ca. 1896 photograph of the Ipswich Mills Dam, looking south (upstream) towards dam (source: Courtesy Ipswich Public Library, Ipswich, MA).

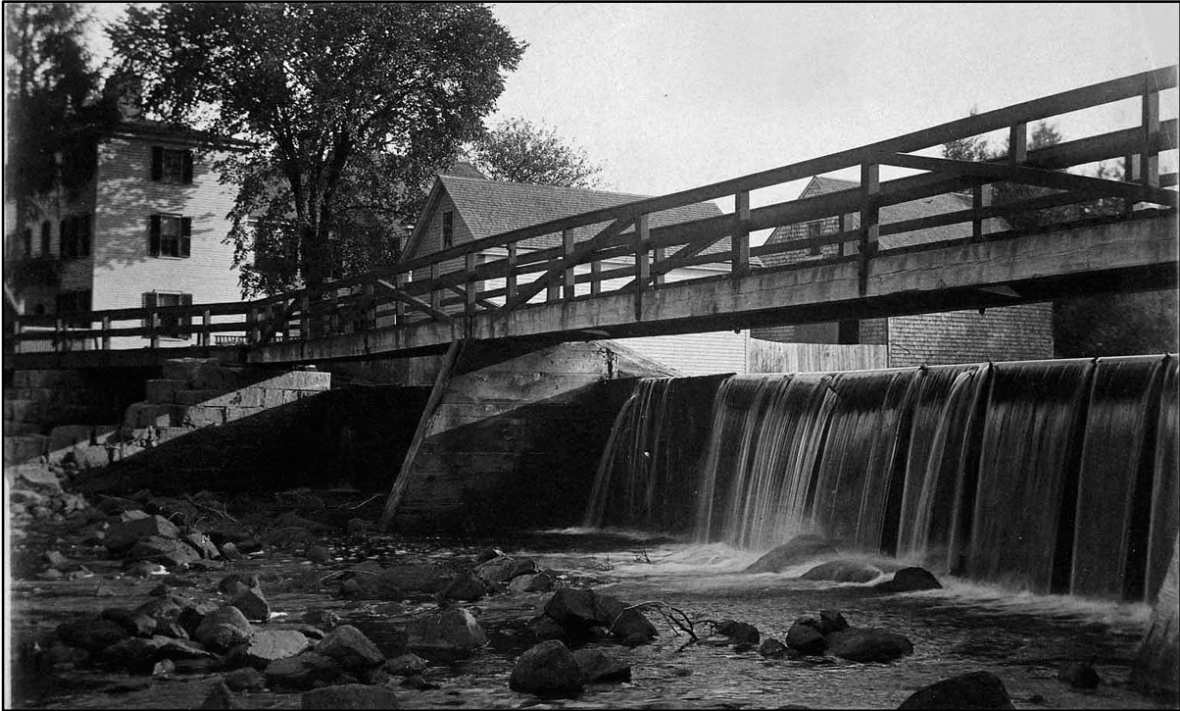
Figure 4. Ca. 1900 photograph by Arthur Wesley Dow showing the northeast end of the Ipswich Mills Dam (source: electronic document: StoriesFromIpswich.org).

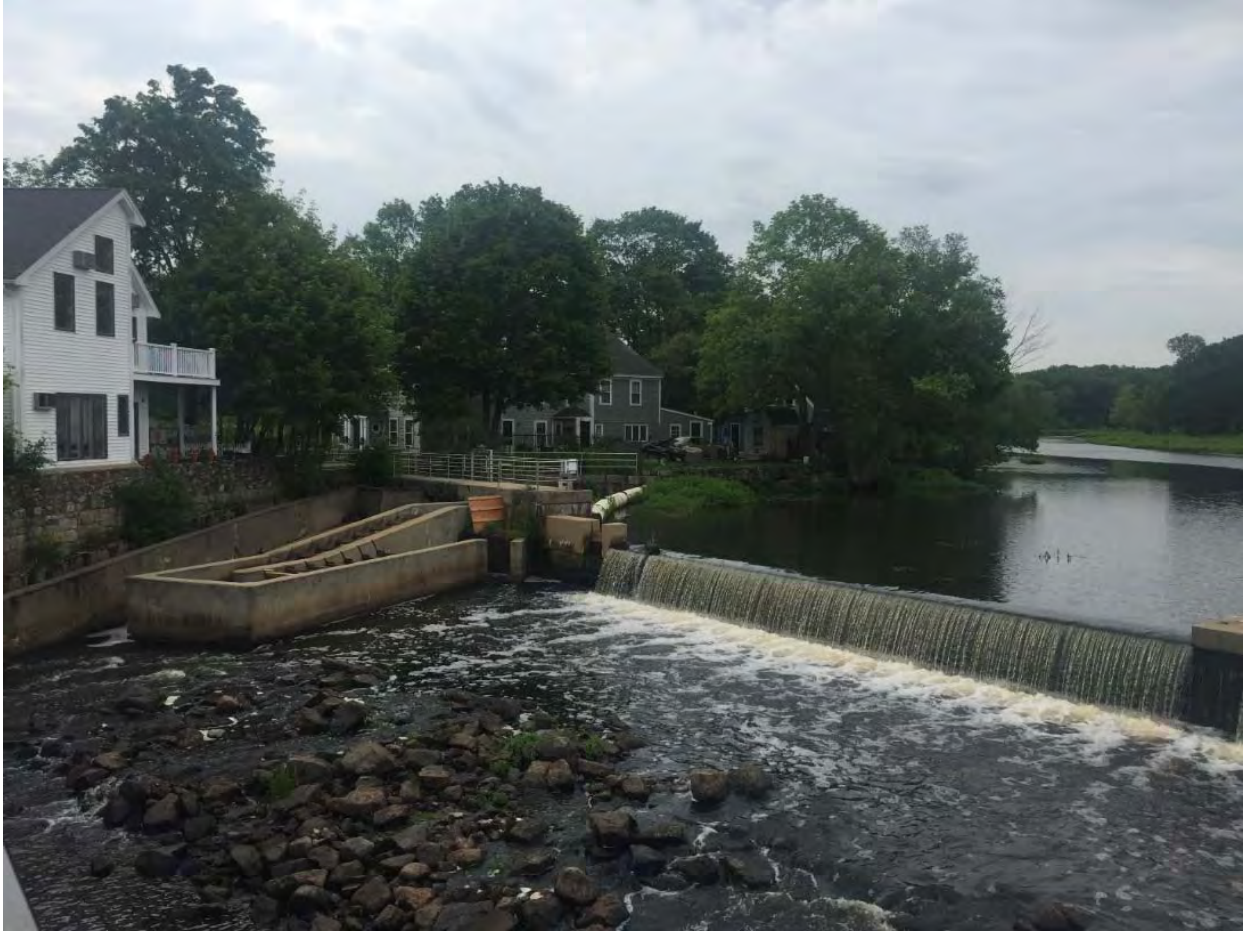
Figure 1. Ipswich Mills Dam

The Ipswich Mills Dam consists of a cut stone spillway that extends across much of the width of the river. On the right side of the dam is a granite pier incorporating low level gates used to control water levels in the river. Most of the outlets have been plugged, although one still controls flow into an active fish ladder. The dam is thought to have been built on or just downstream of a bedrock outcrop forming the river bed (known as the “upper falls”). It is the downstream-most barrier to fish passage on the river and is located at the head of tide, approximately 3.7 miles from the river mouth. Tidal influence and numerous bridges downstream of the dam have an effect on flood flows at the dam location.

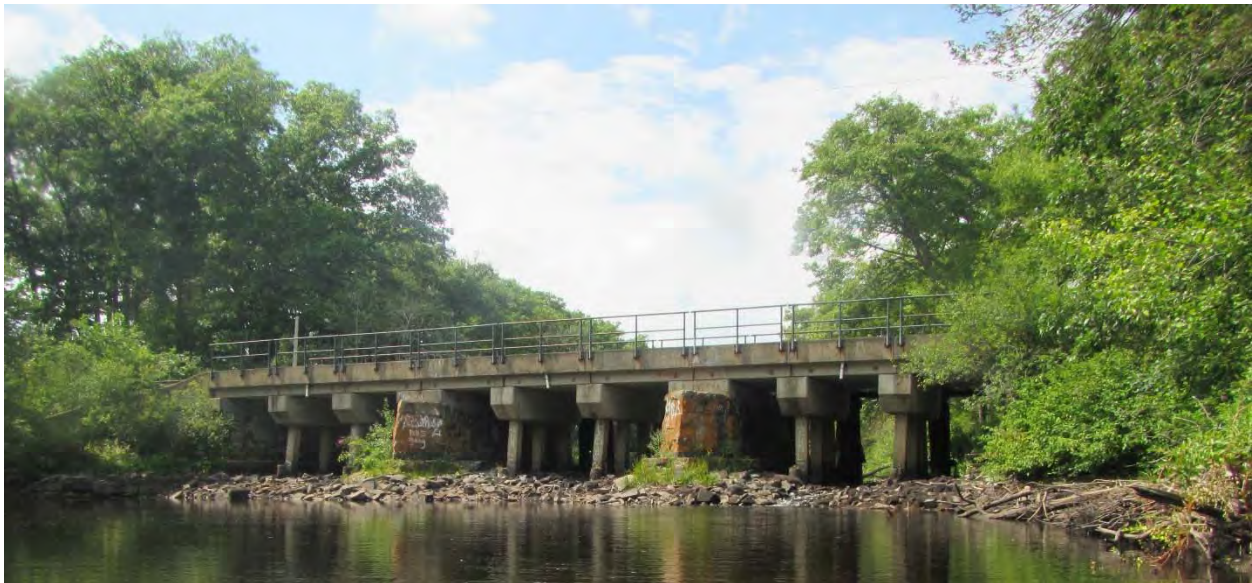
The railroad bridge located near the upstream limit of the study area spans approximately 90 feet and has two primary central piers and six rows of piles in the main channel (Figure 6). The surveyed low chord of the bridge is 12 to 13 feet above the channel thalweg through the bridge section. Bed levels are higher along the downstream side of the bridge where rock has likely been placed to provide scour protection. The high chord of the bridge was estimated from LiDAR data to be 21 feet. The energy (standard step) computation method was used for the low flow bridge modeling approach, and pressure and/or weir was used for the high flow modeling. The upstream water surface elevation was used to check for pressure flow.

Figure 6. Looking upstream at the railroad bridge taken when the impoundment was drawn down showing accumulated rock on the bed (photo credit: Horsley Witten Group)

Predicted water surface elevations are given in Table 5 and show a reduction in flood levels through the impoundment upstream to the railroad bridge. High bed levels along the downstream face of the bridge (see rock exposed on bed in Figure 6 and model profiles in Appendix B) and conveyance capacity through the bridge section appear to control flood levels upstream of the railroad bridge.

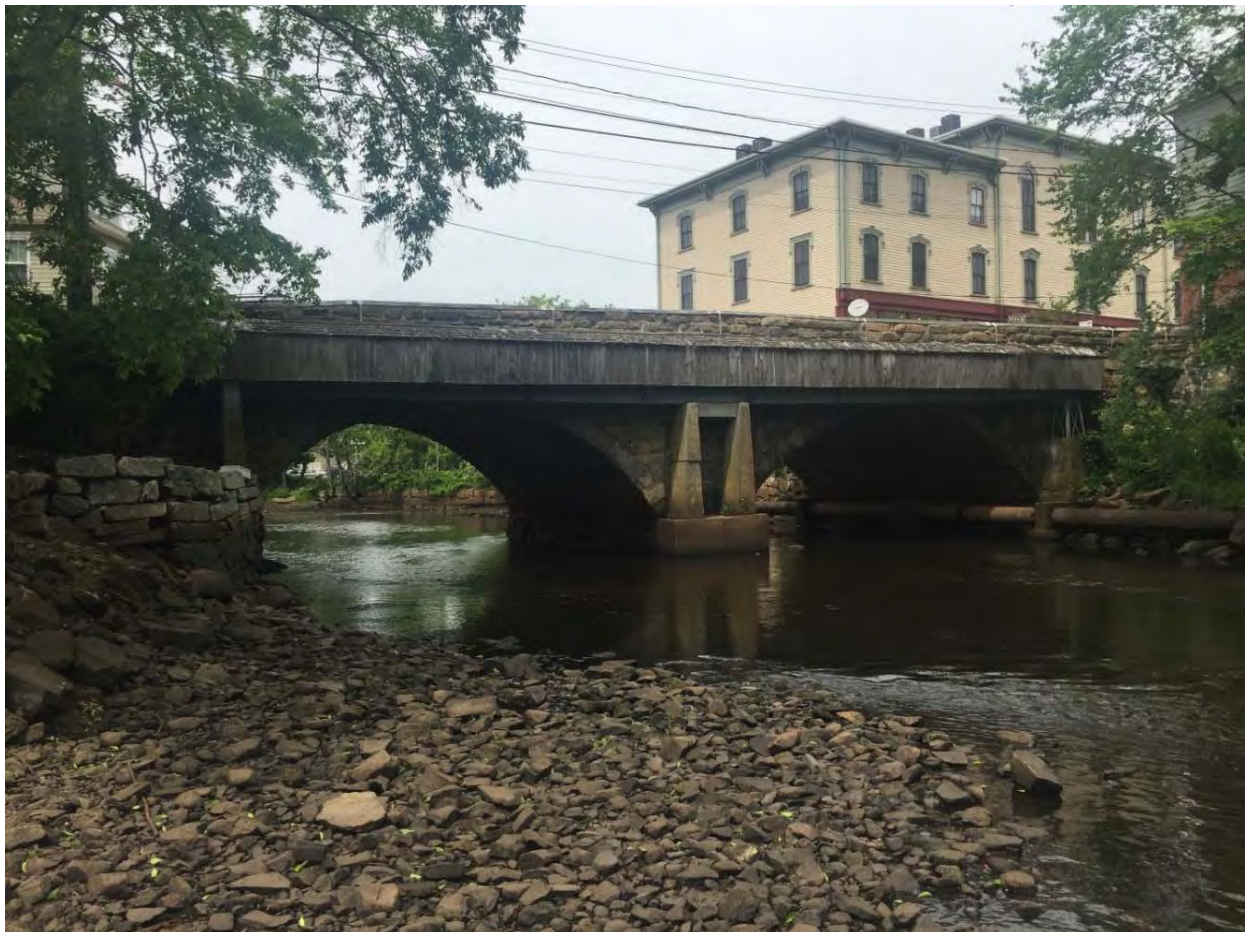
The Choate Bridge is a historic stone bridge built in 1764. It has a total length of approximately 72 feet with two stone arches, each spanning approximately 30 feet and 13 feet in height. Two arch culverts placed in parallel were used to model the Choate Bridge (Figure 7). A Manning's value of 0.015 was used for the top of the structure (brickwork lined with cement mortar) and 0.04 was used for the bottom to replicate the in-channel conditions. At the bridge, a roadway elevation of 16 feet was estimated from the surrounding LiDAR as ground survey of the bridge deck was unavailable at the time of the study. The stone railing was estimated to be three feet tall from photographs; therefore, the upstream high chord was assumed to be 19 feet. The energy (standard step) computation method was used for the low flow bridge modeling approach, and pressure and/or weir was used for the high flow modeling. The upstream water surface elevation was used to check for pressure flow.

Figure 7. Looking upstream at Choate Bridge during low flow and low tide conditions

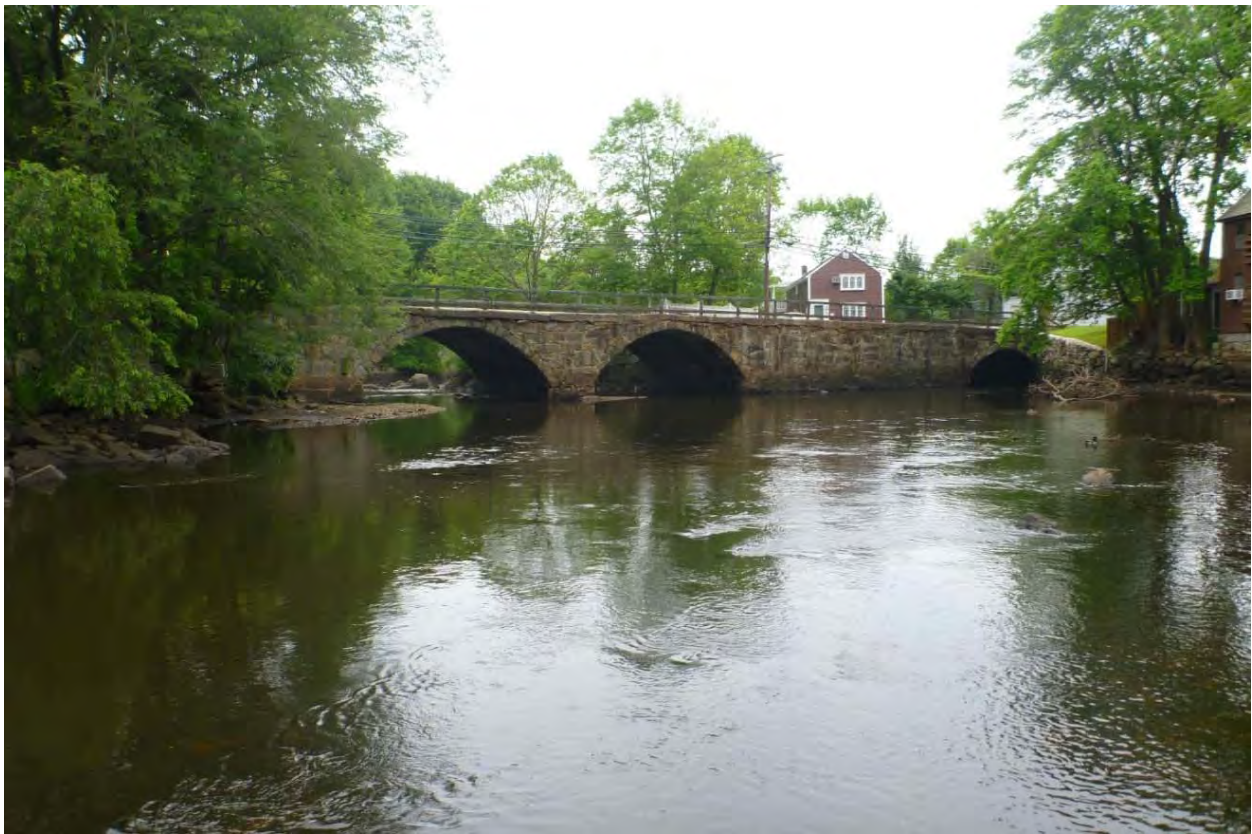
County St. Bridge is composed of three arches, two tandem arches (spanning approximately 30 feet and 13 feet high) along the mainstem of the channel and a third, smaller arch (spanning approximately 15 feet and 9 feet high) on river right that transports water into an abandoned mill raceway (Figure 8). A Manning's value of 0.015 was used for the top of the structure (brickwork lined with cement mortar) and 0.04 was used for the bottom to replicate the in-channel conditions. Cross sections immediately upstream and downstream were manually updated to reflect the in-channel survey data, including sediment deposition that was observed. A high chord of 16 feet was estimated from the surrounding LiDAR as ground survey of the bridge deck was unavailable at the time of the study. The energy (standard step) computation method was used for the low flow bridge modeling approach, and pressure and/or weir was used for the high flow modeling. The upstream water surface elevation was used to check for pressure flow.

Figure 8. Looking downstream at County Street Bridge at low flow and low tide conditions
