Ipswich Mills Dam Removal Feasibility Study

Ipswich, Massachusetts

March 2019

Prepared by:
Horsley Witten Group, Inc.

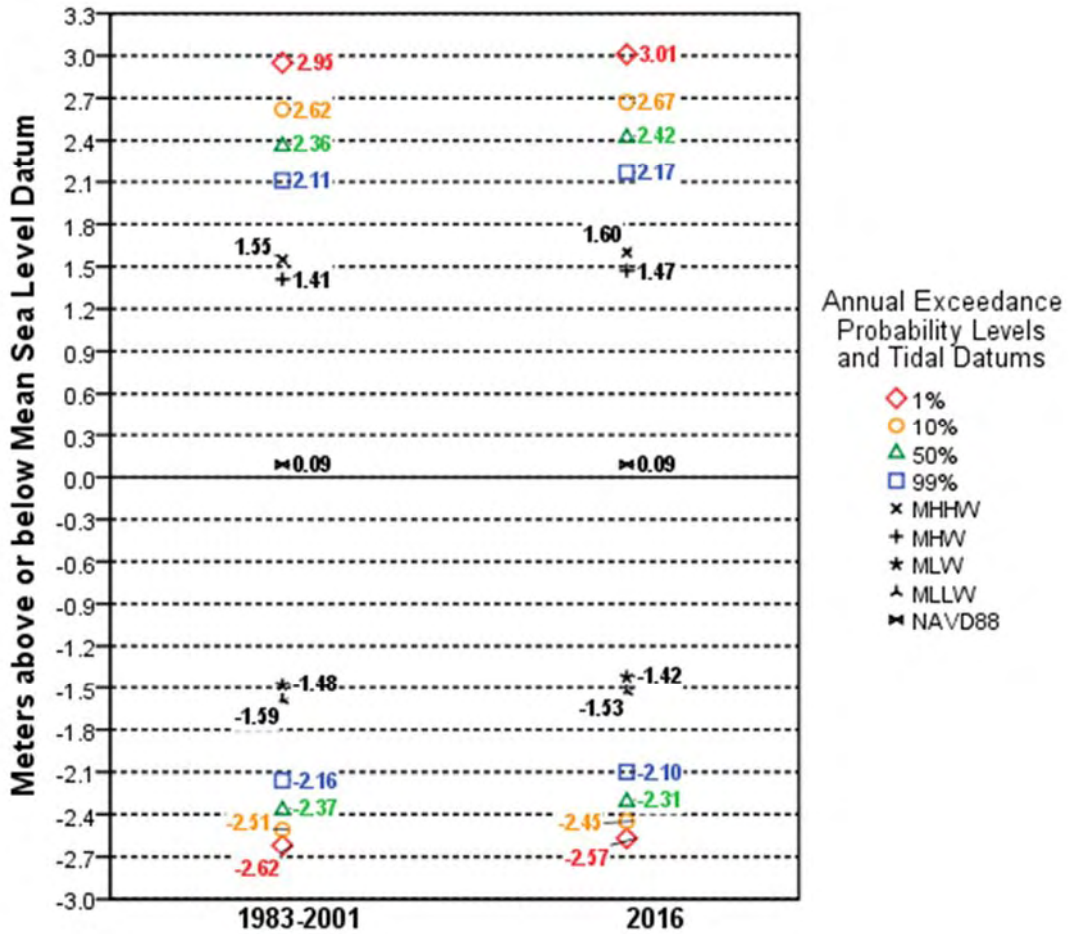
Figure 12. Tidal datums and exceedance probability levels relative to Mean Sea Level. On the left are the exceedance probability levels for the mid-year of the tidal epoch currently in effect for the station. On the right are projected exceedance probability levels and tidal datums assuming continuation of the linear historic trend. (Source: <https://tidesandcurrents.noaa.gov/est/stickdiagram.shtml?Staid=8443970>)

NOAA estimates tidal datums and extreme tide levels for the current year based on linear historic trends over the most recent tidal epoch. For current (2016) predictions, that epoch is 1983-2001. Figure 12 gives 2016 predictions for various datums and exceedance probability levels in meters relative to the Mean Sea Level datum at the Boston gage (-0.3 feet NAVD88). These predictions are likely underestimates given that the rate of sea level rise has been increasing in recent decades (Church and White, 2011).

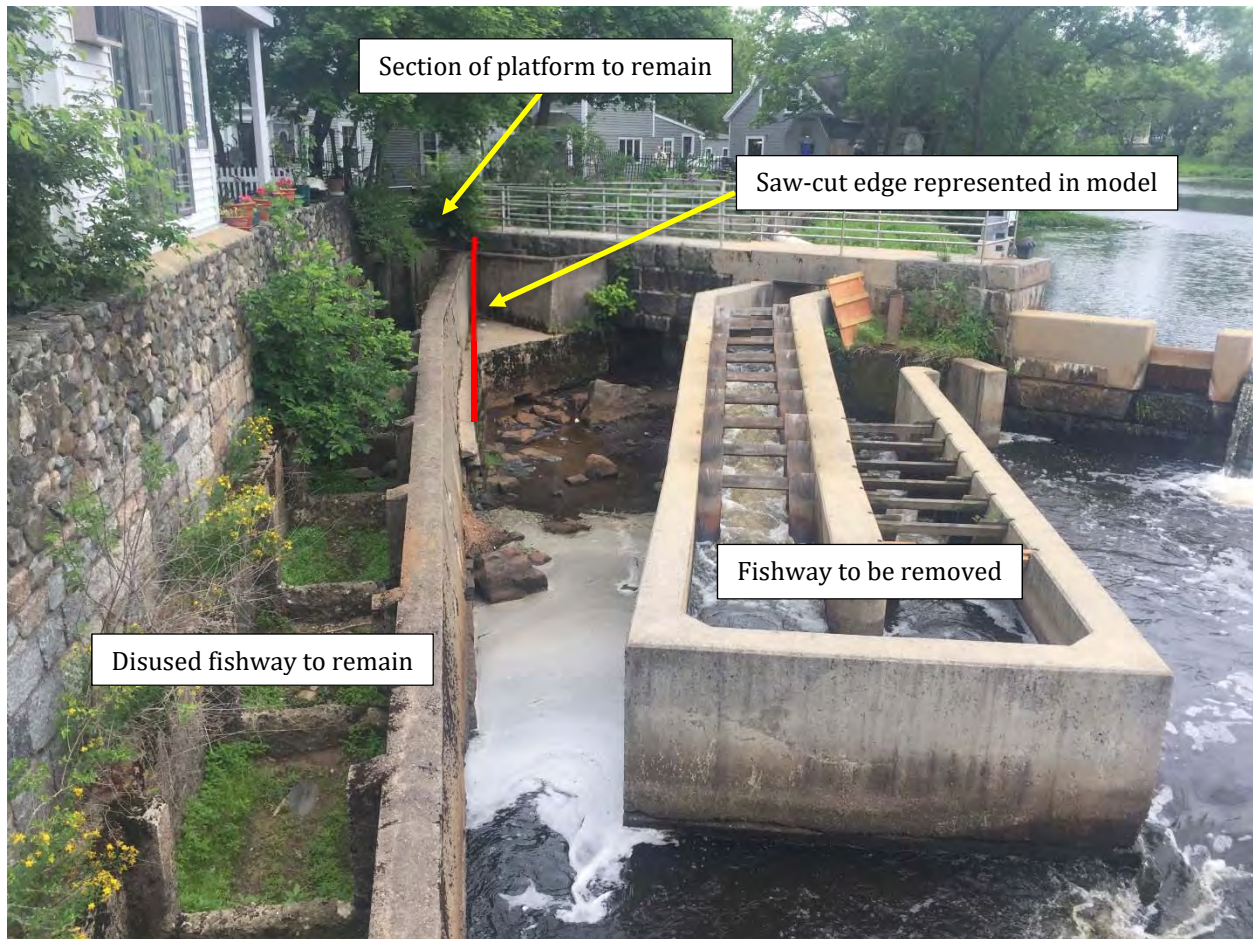
Figure 15. Modeled limits of dam removal on river right

This scenario involves leaving the disused fishway integral with the existing river in place in order to avoid destabilizing the river right (looking downstream) wall during demolition. An approximate 10-foot section of the existing viewing platform would be retained as a part of this minimum measure to protect the wall (Figure 15). All other elements of the dam would be removed down the full vertical extent.

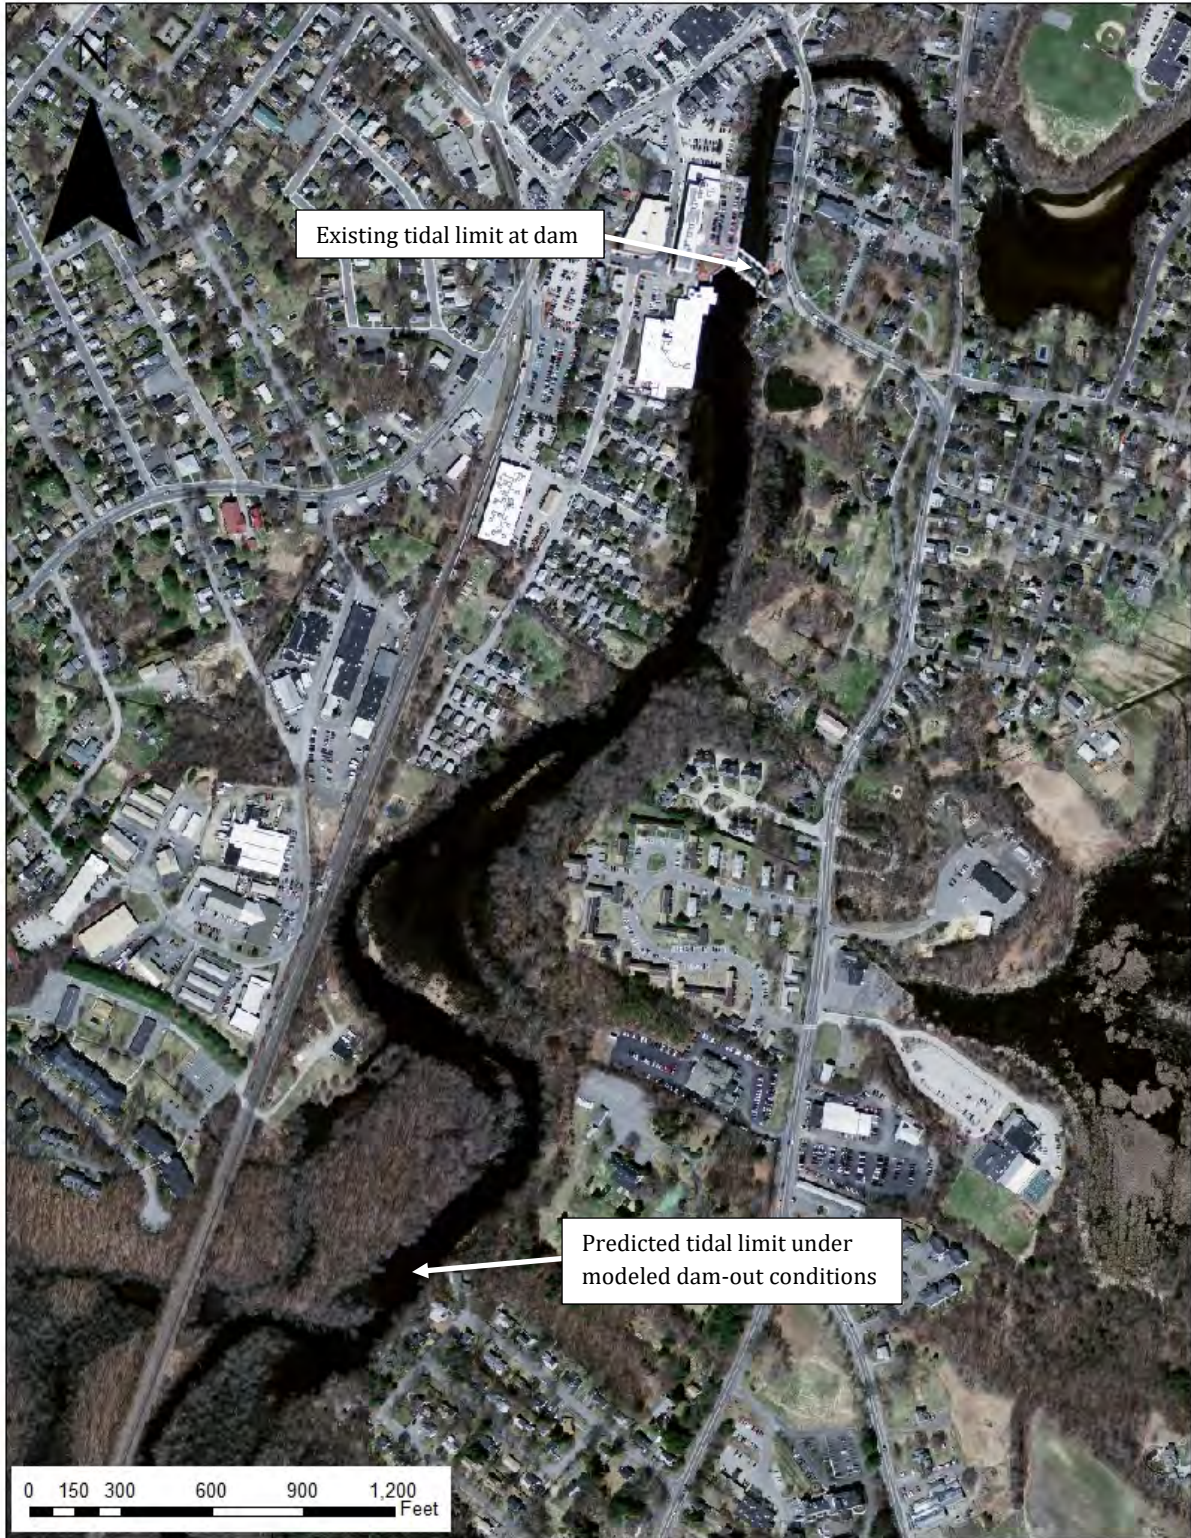
Figure 20. Comparison of the existing tidal limit at the dam and the predicted tidal limit under modeled dam-out conditions

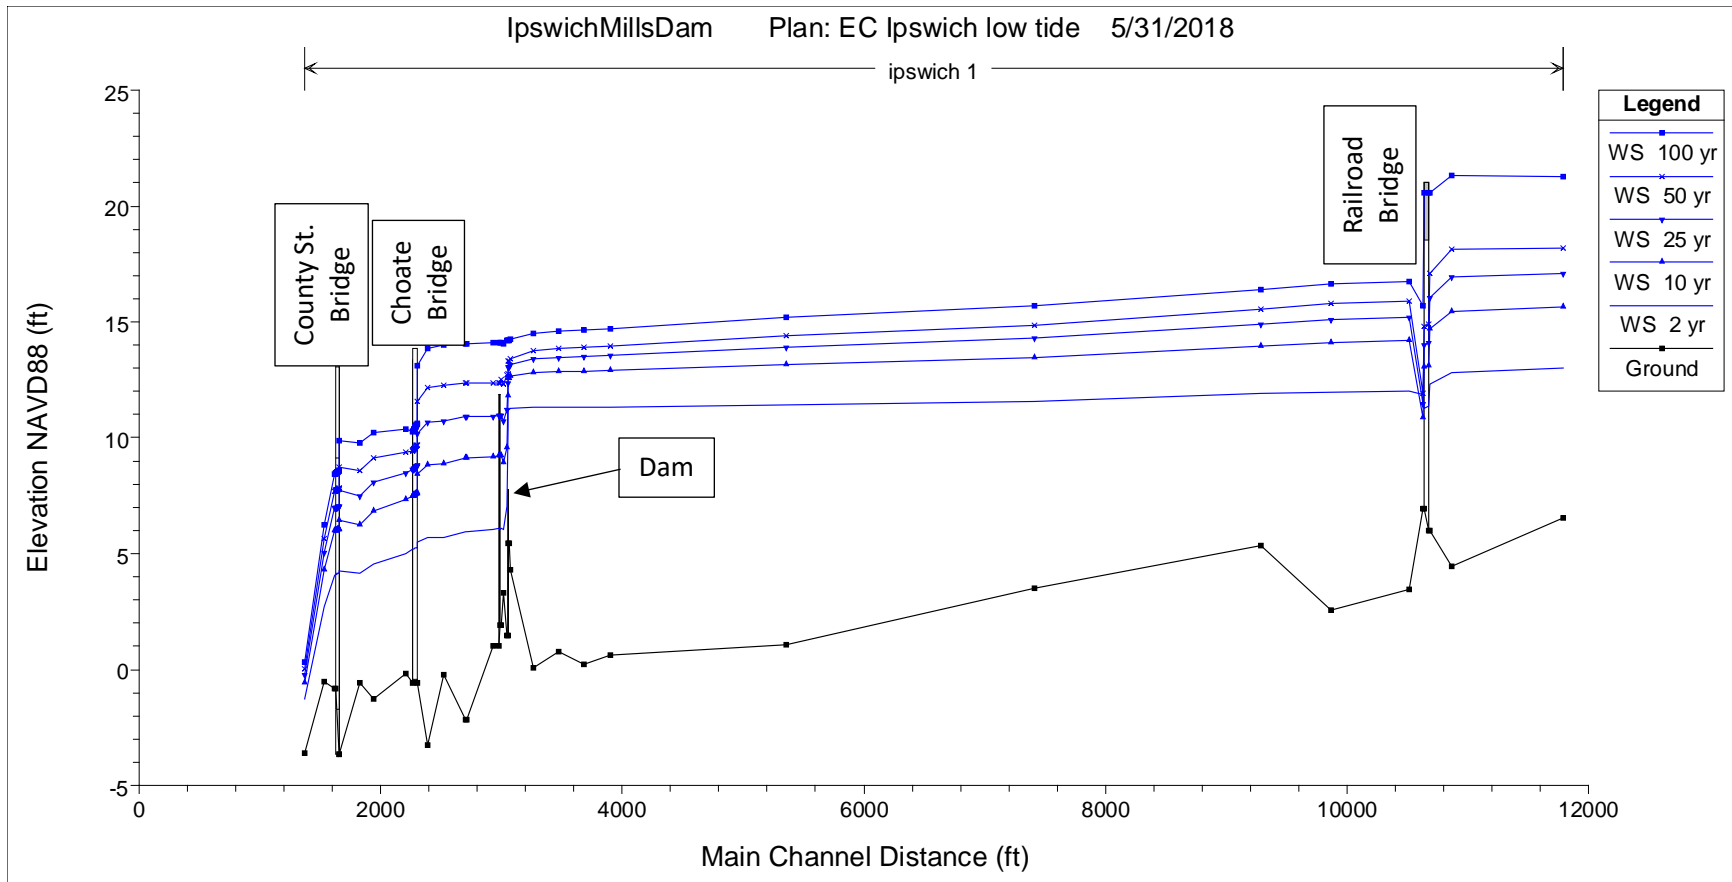
B.3. Existing conditions – Normal depth downstream boundary condition

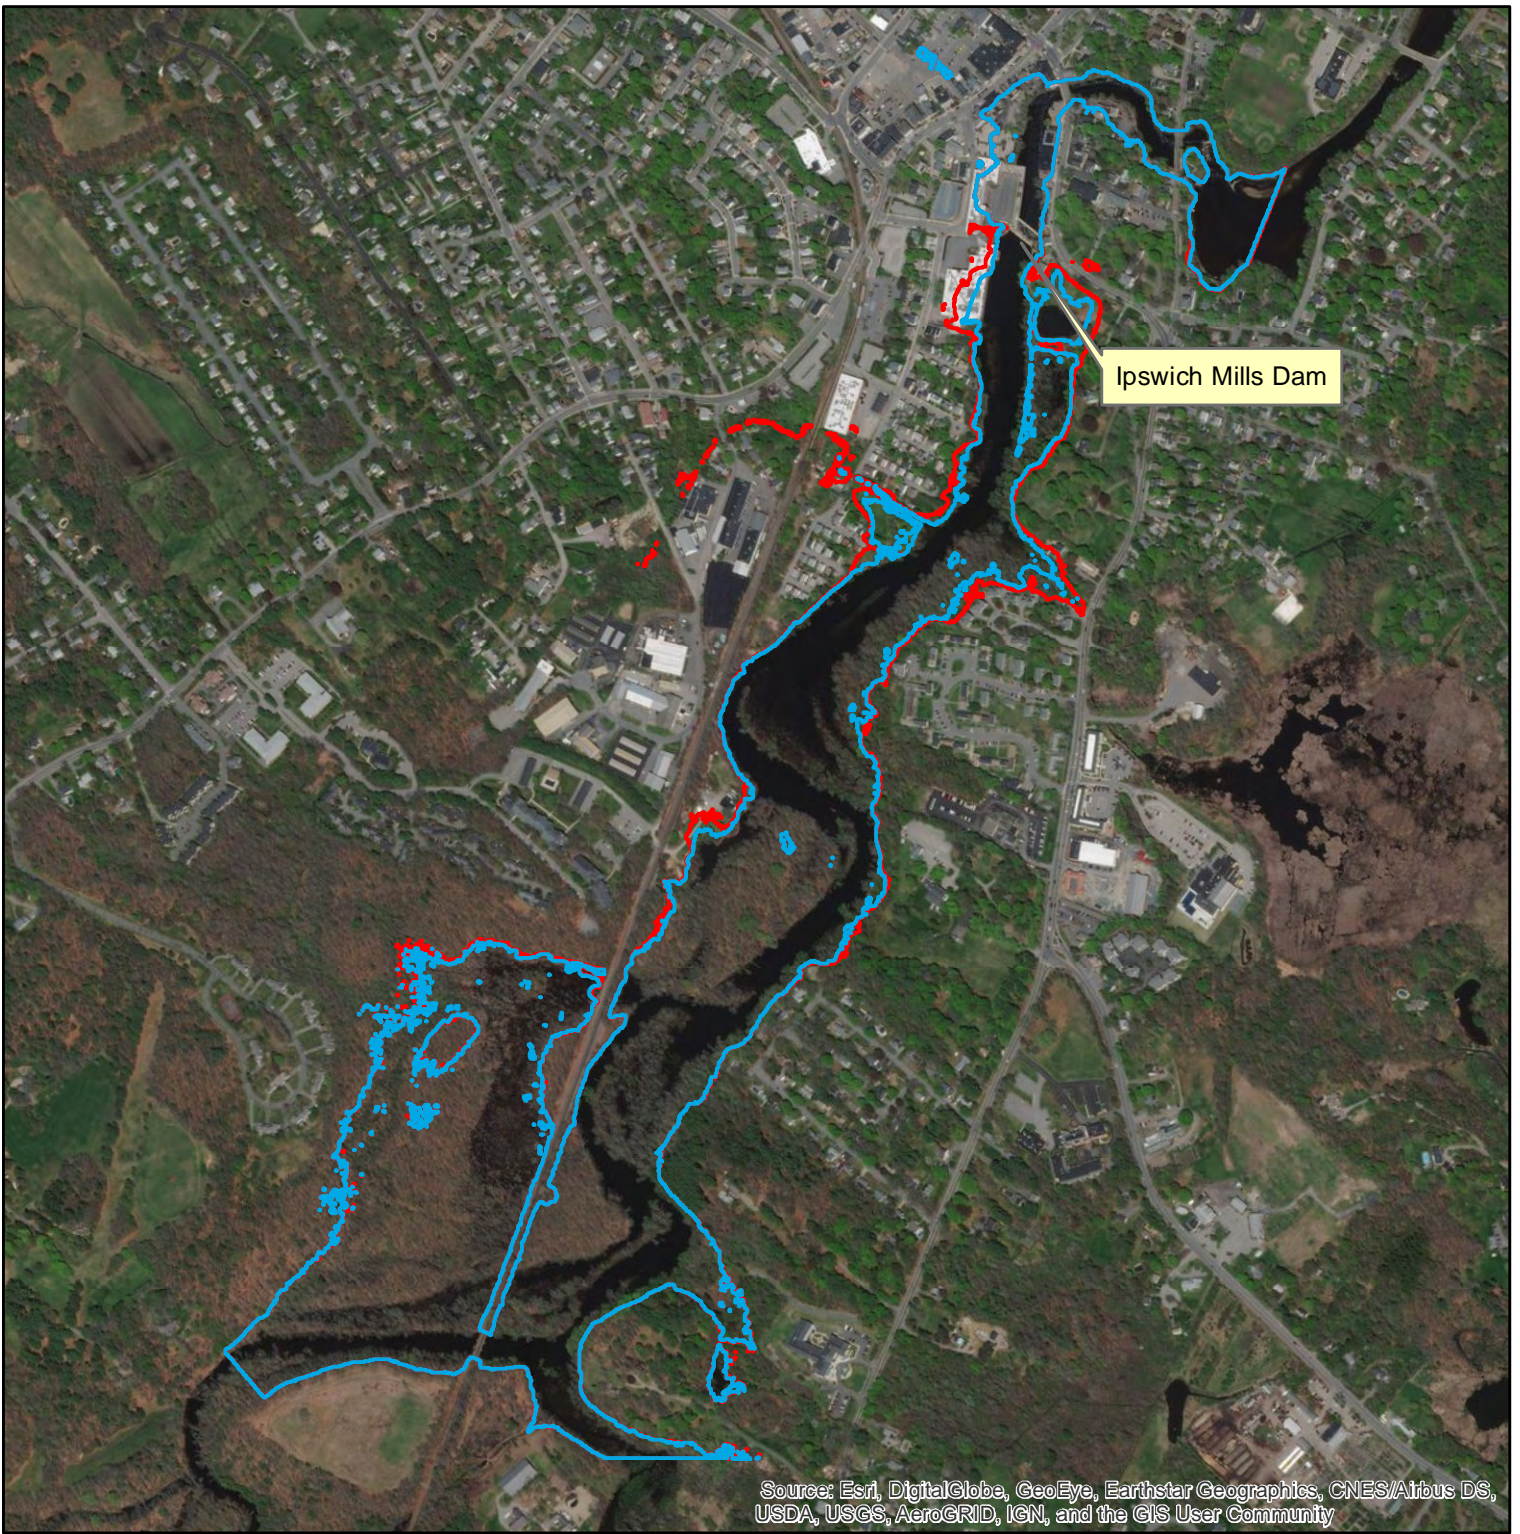
25-Year Flood Inundation Map

Normal Depth (low tide) Downstream Boundary Condition

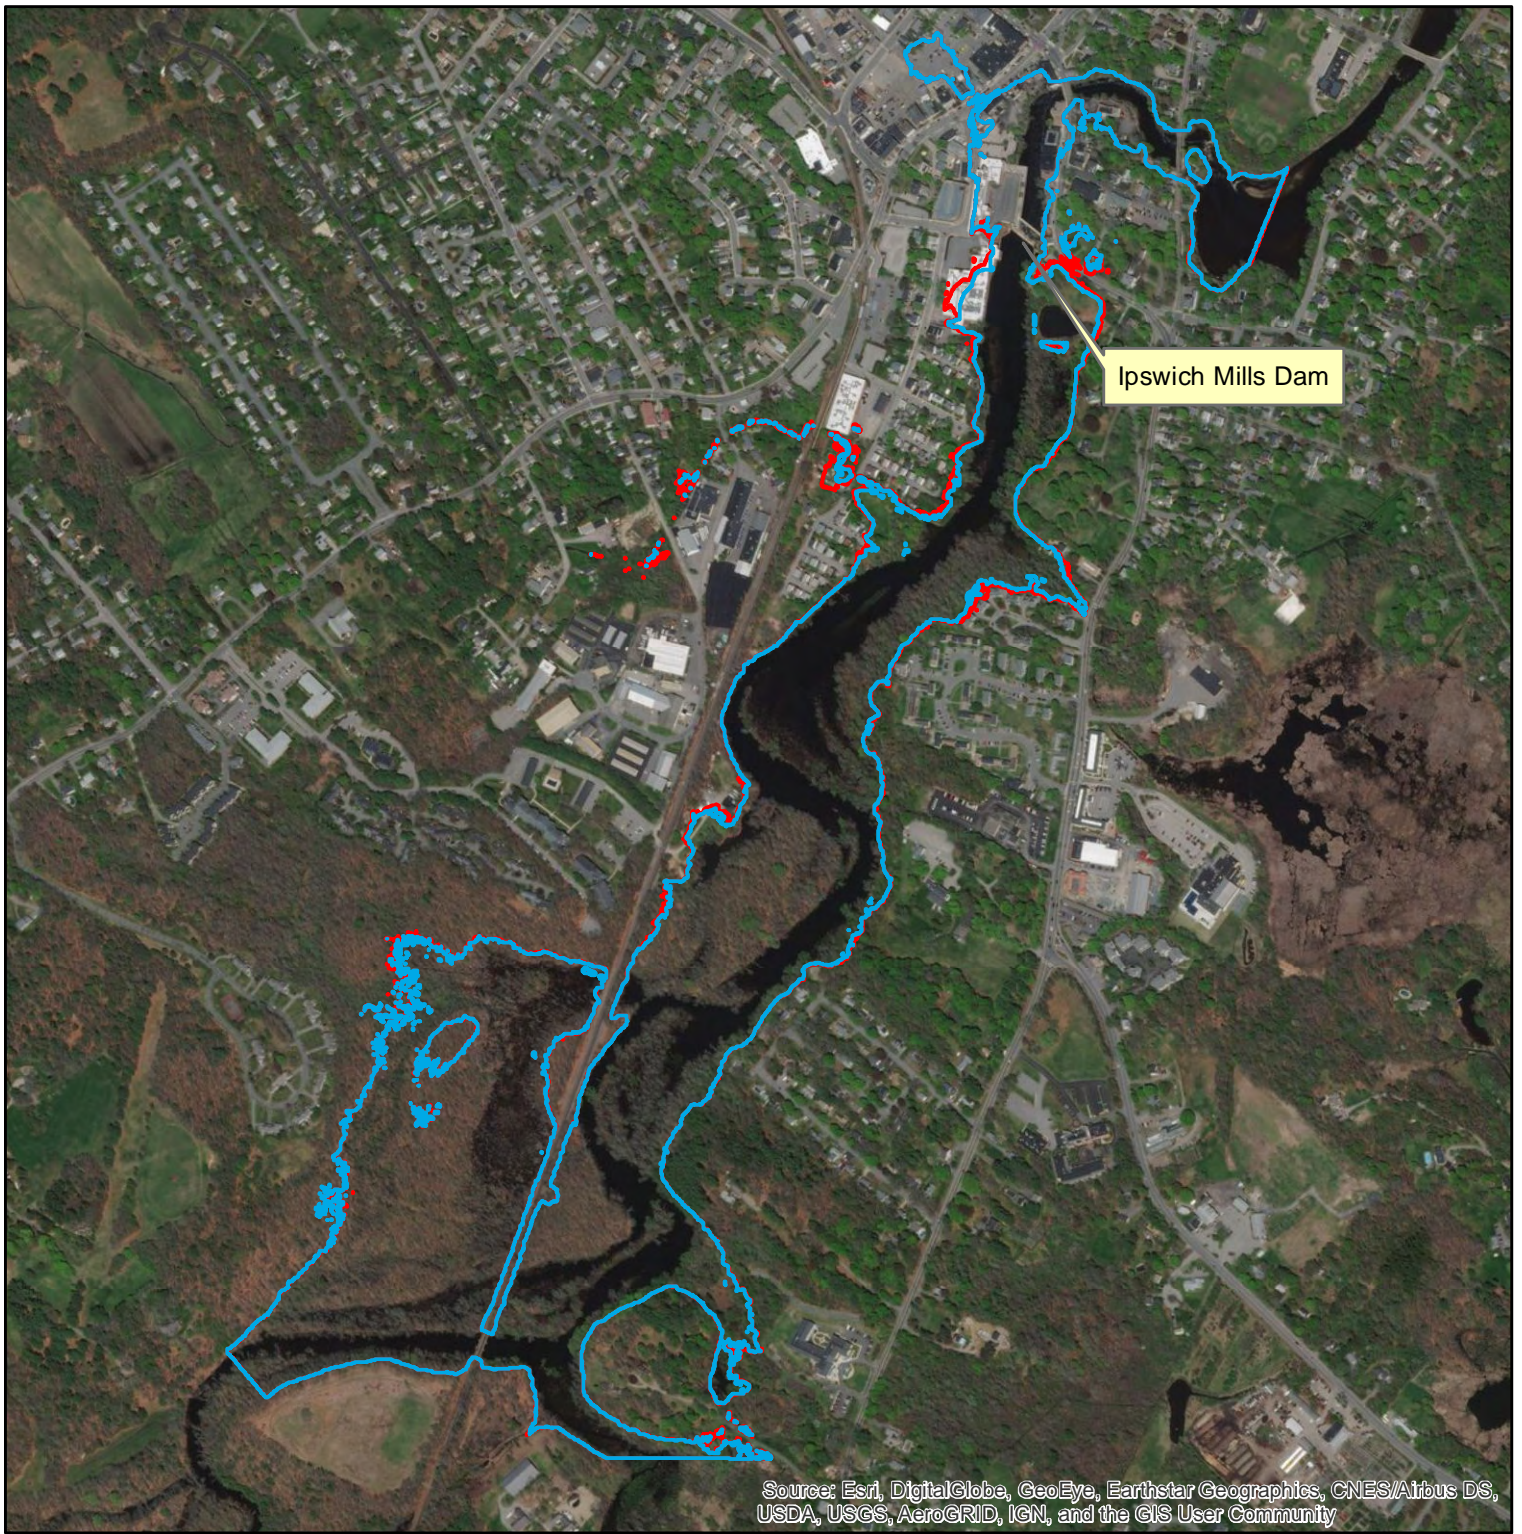
50-Year Flood Inundation Map

Normal Depth (low tide) Downstream Boundary Condition

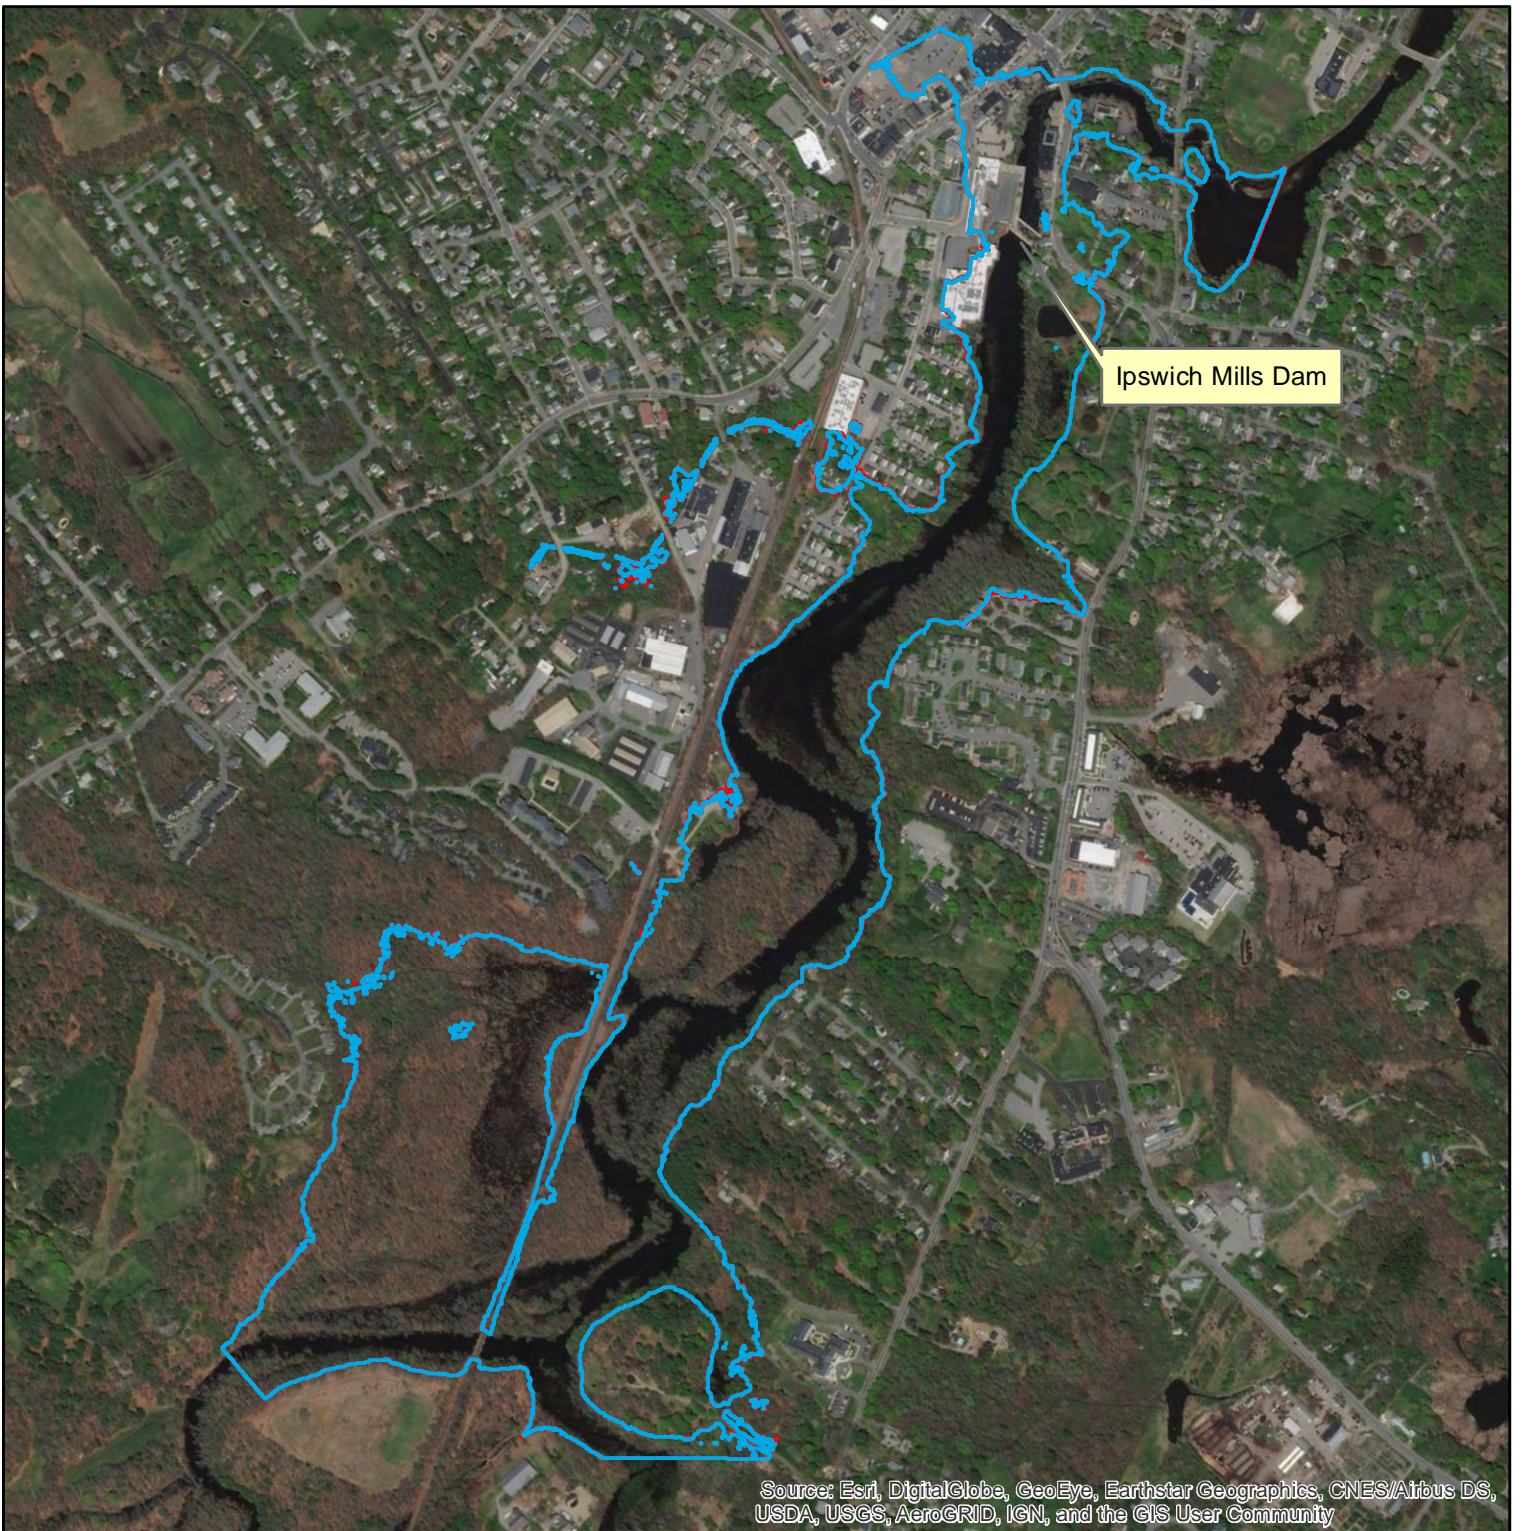
100-Year Flood Inundation Map

Normal Depth (low tide) Downstream Boundary Condition

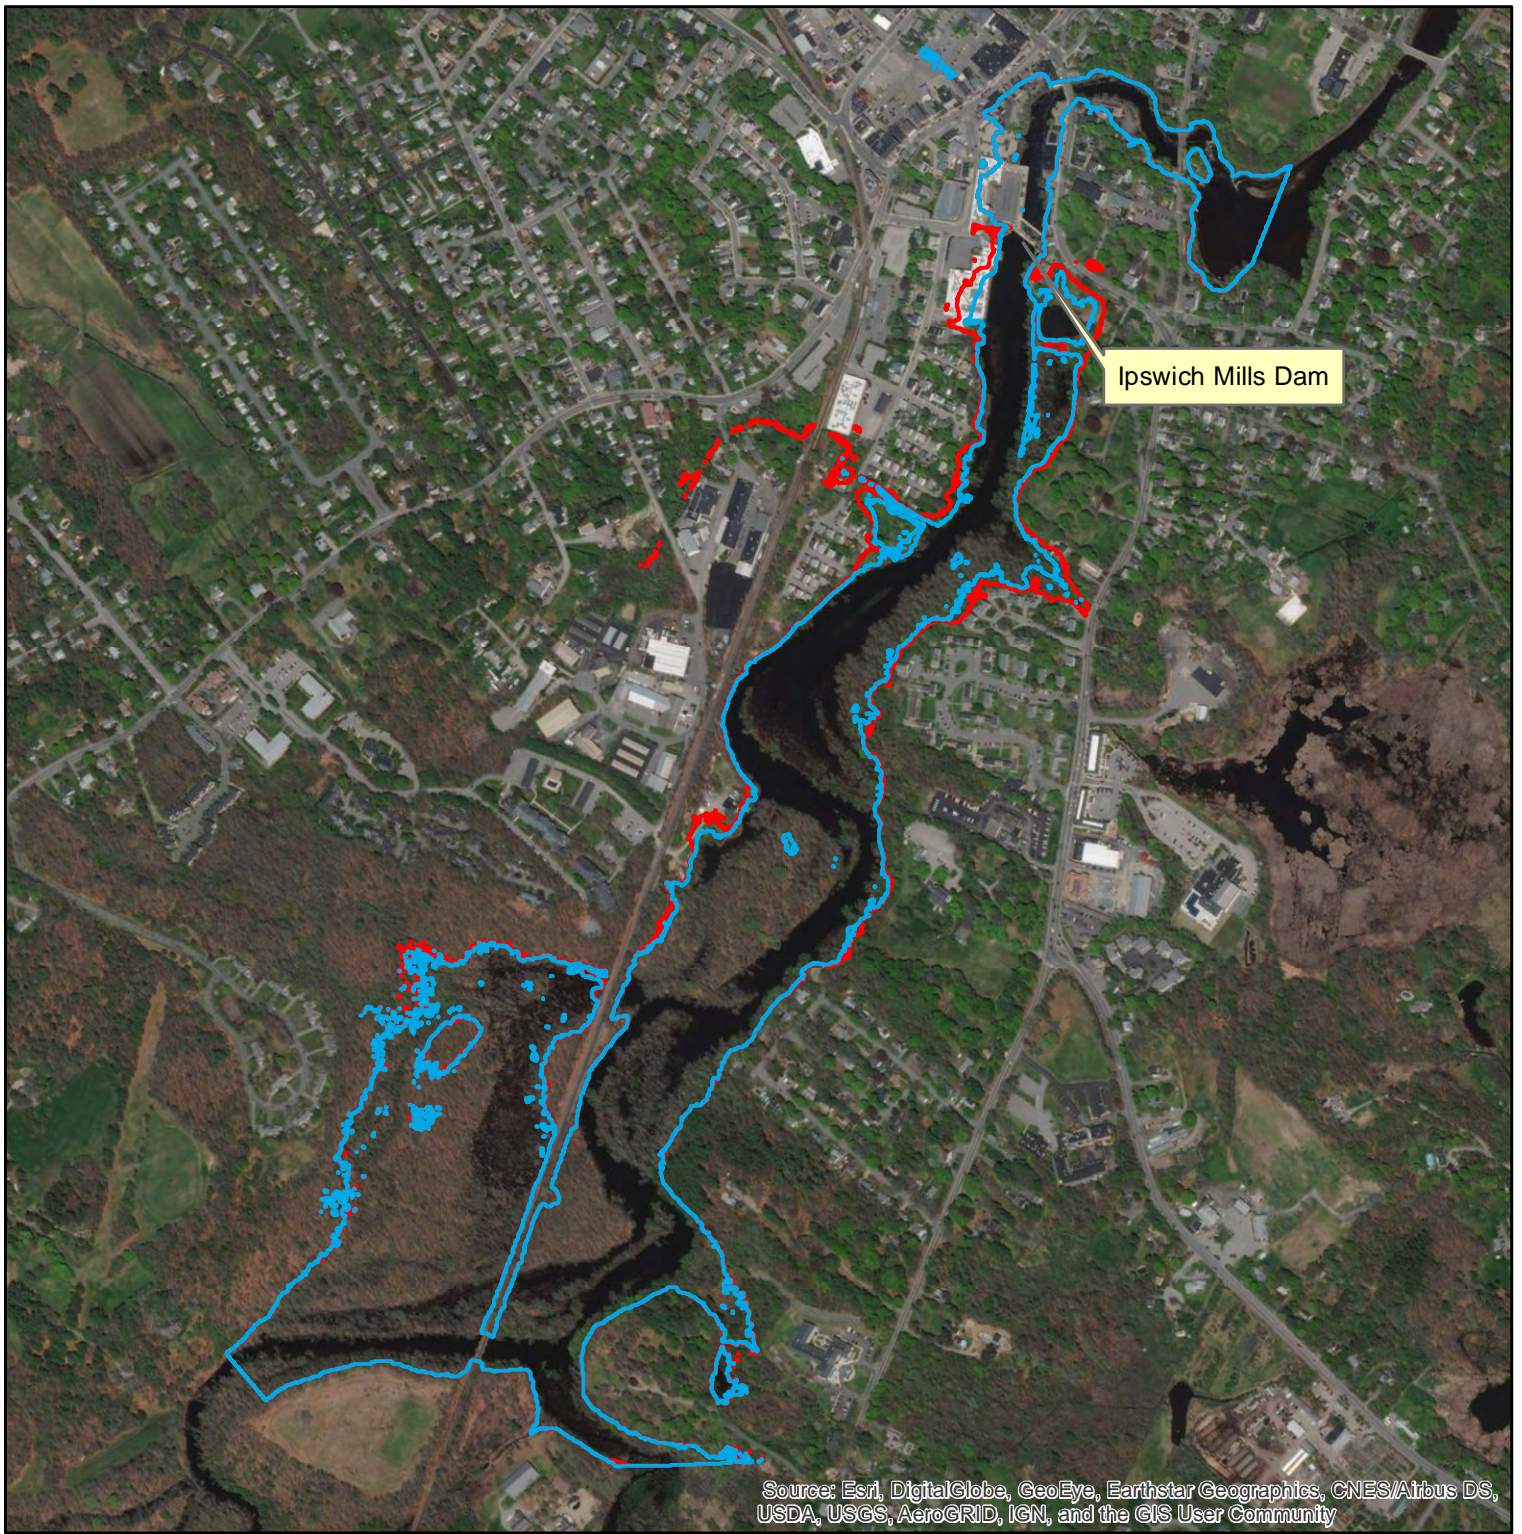
25-Year Flood Inundation Map

MHW Tide Downstream Boundary Condition (4.1 feet NAVD88)

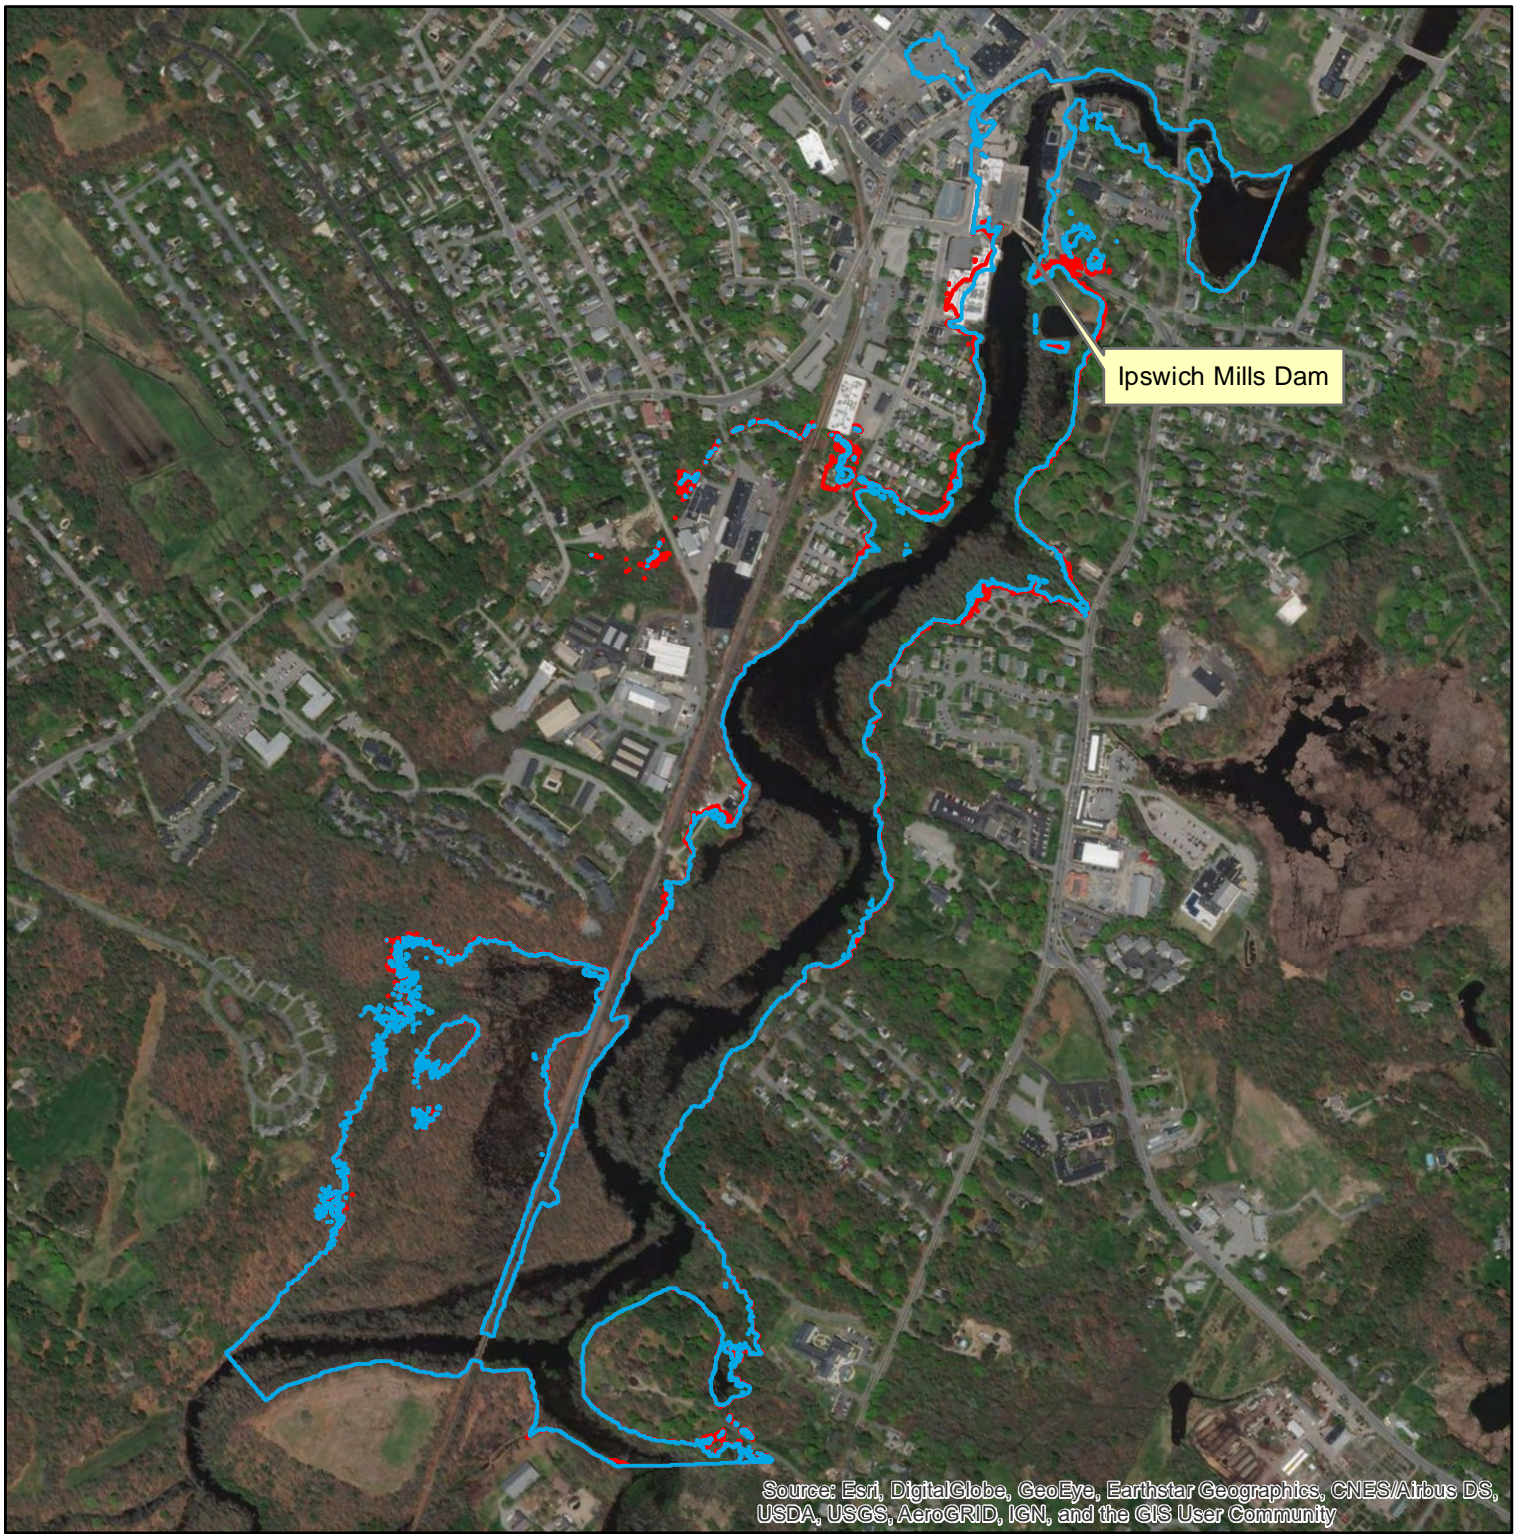
MHW Tide Downstream Boundary Condition (4.1 feet NAVD88)

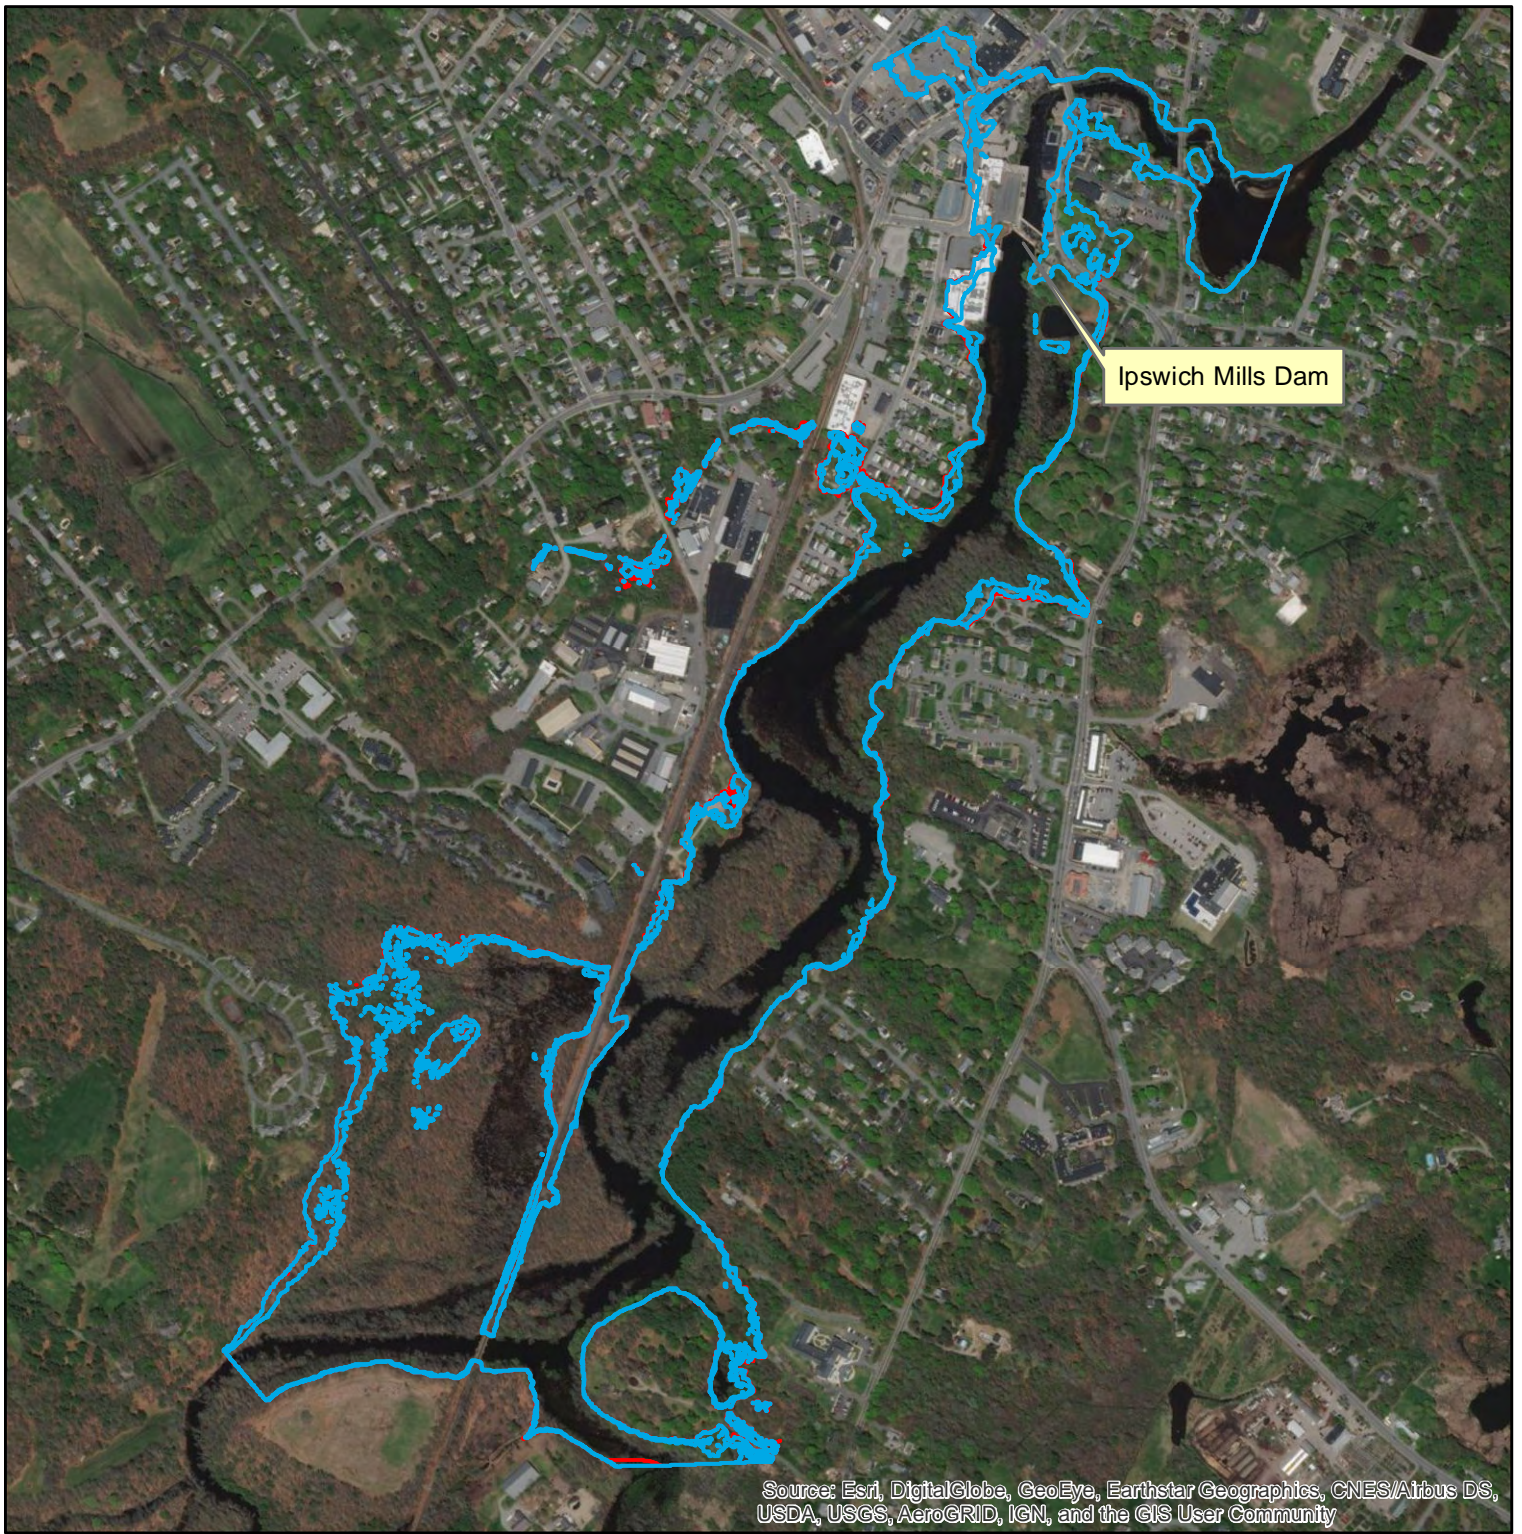
100-Year Flood Inundation Map

MHW Tide Downstream Boundary Condition (4.1 feet NAVD88)

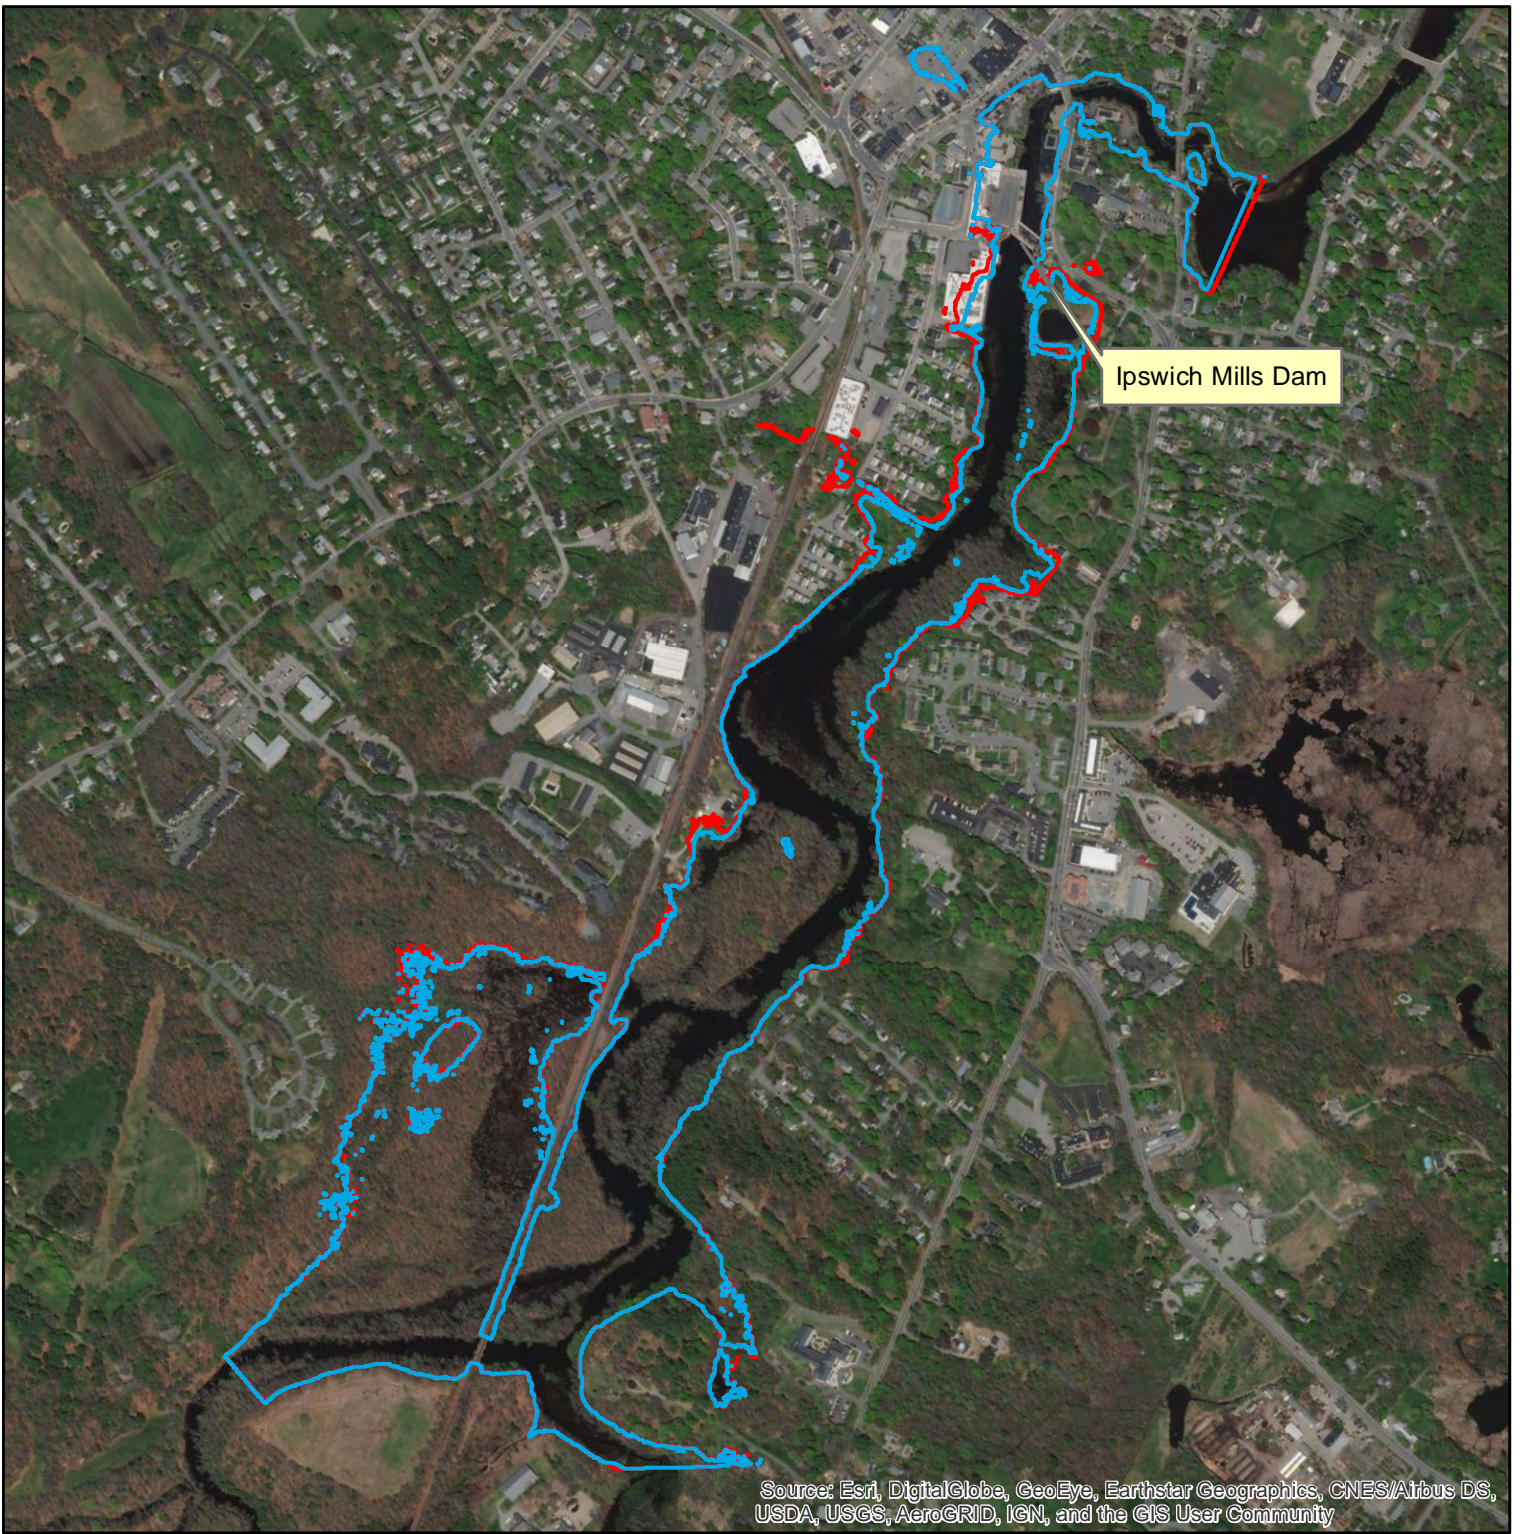
25-Year Flood Inundation Map

Stillwater Tide Downstream Boundary Condition (8.7 feet NAVD88)
