Ipswich Mills Dam Removal Feasibility Study

Ipswich, Massachusetts

March 2019

Prepared by:
Horsley Witten Group, Inc.

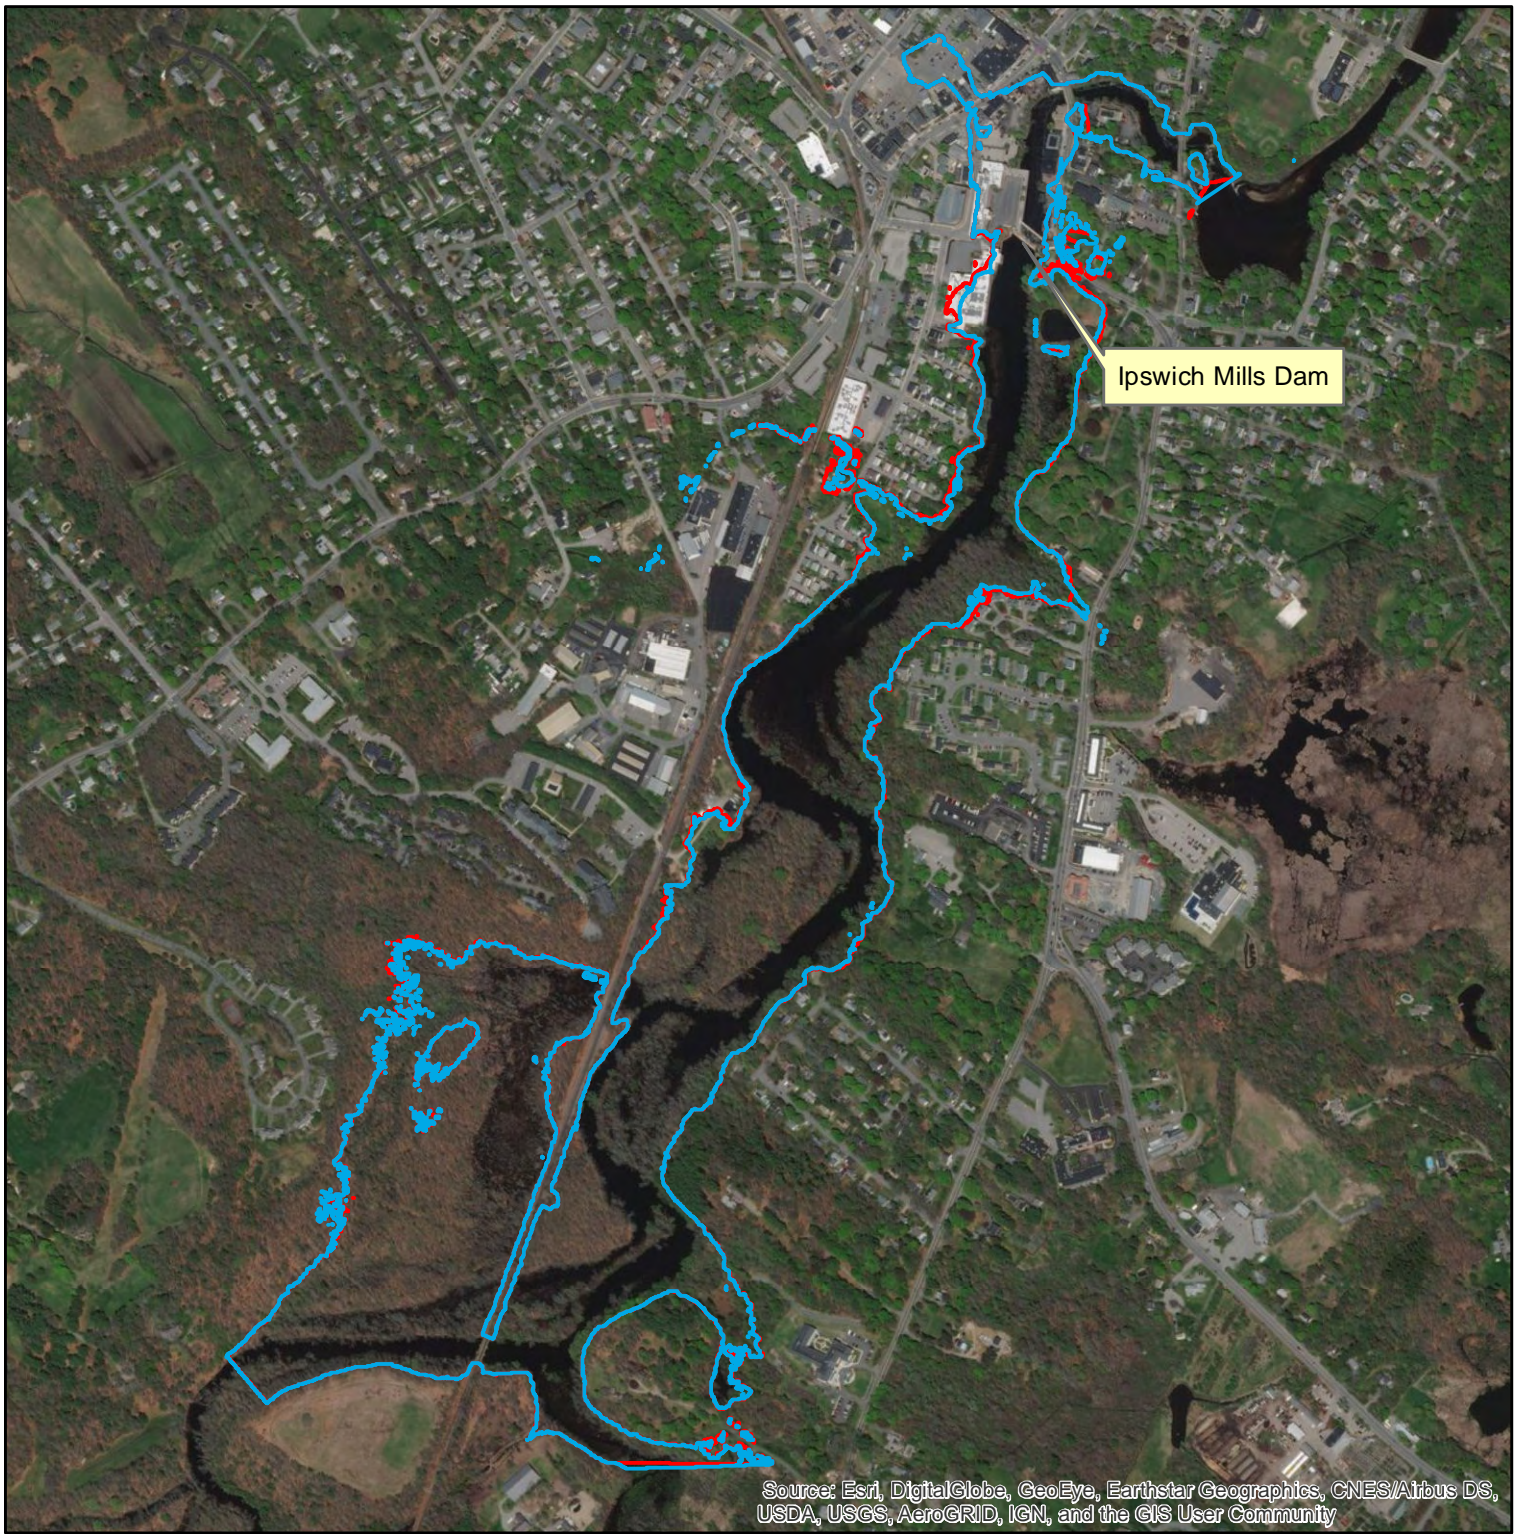
50-Year Flood Inundation Map

Stillwater Tide Downstream Boundary Condition (8.7 feet NAVD88)

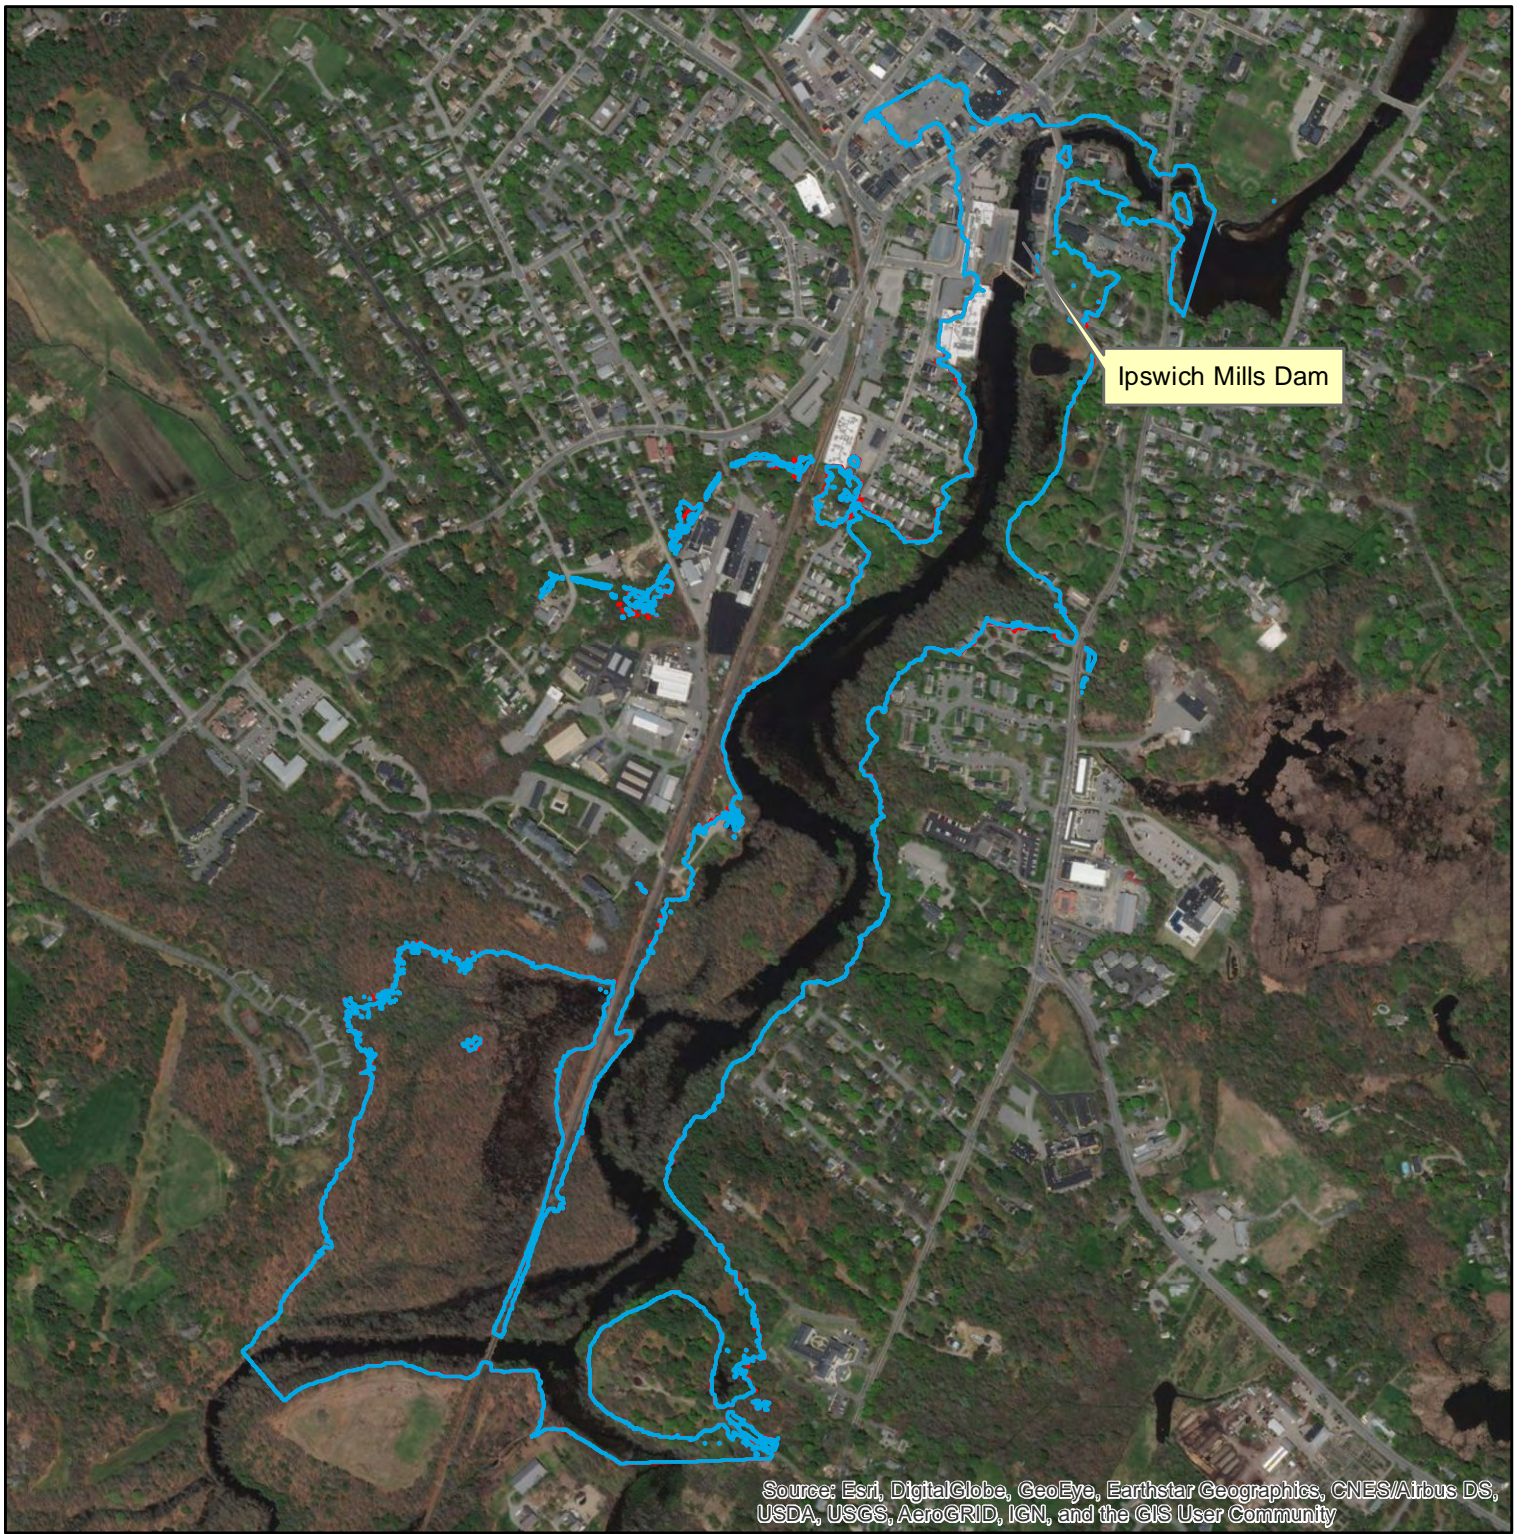
100-Year Flood Inundation Map

Stillwater Tide Downstream Boundary Condition (8.7 feet NAVD88)

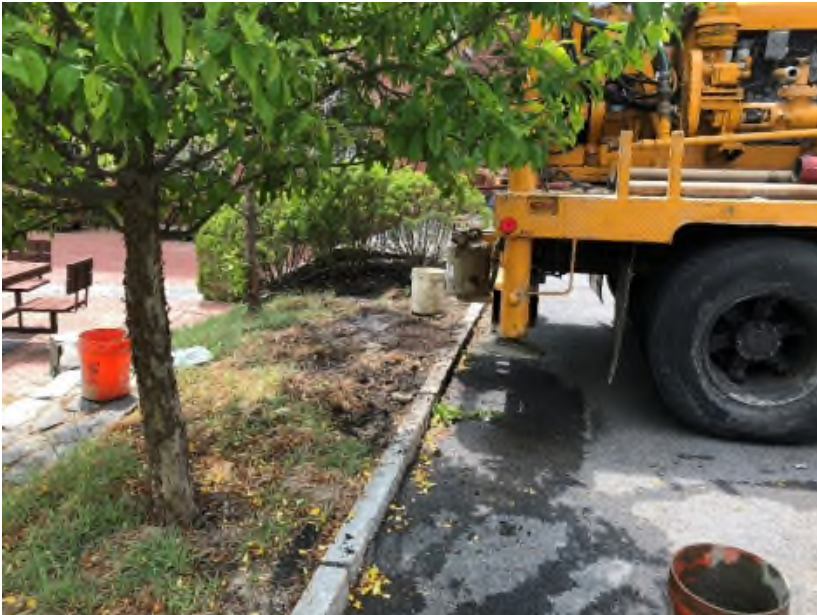
Photo 1

Location of Soil Test Boring SGH-2018-7 on the north elevation of the site adjacent to the patio area at the EBSCO Facility

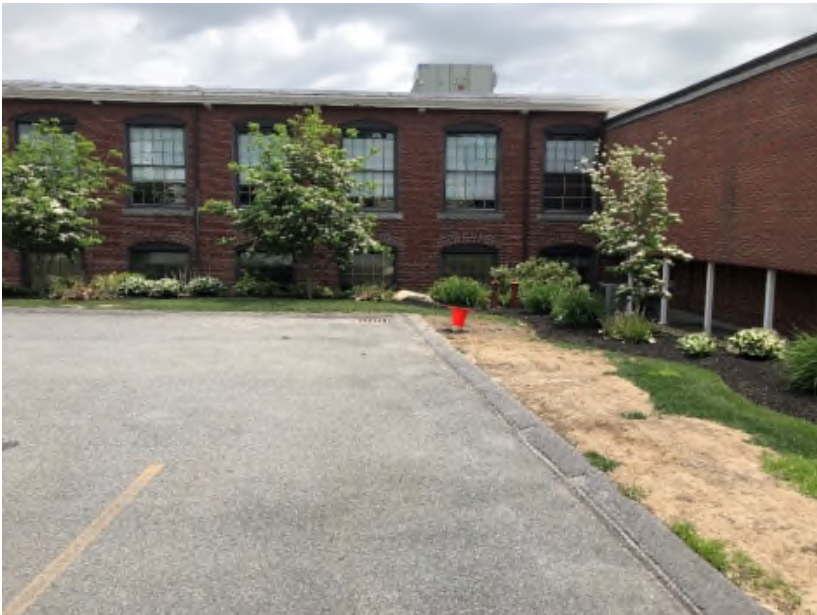
Photo 2

West elevation of Building No. 10 and north elevation of Building Nos. 10-B and 11. The construction cone indicates the location of Soil Test Boring SGH-2018-4.

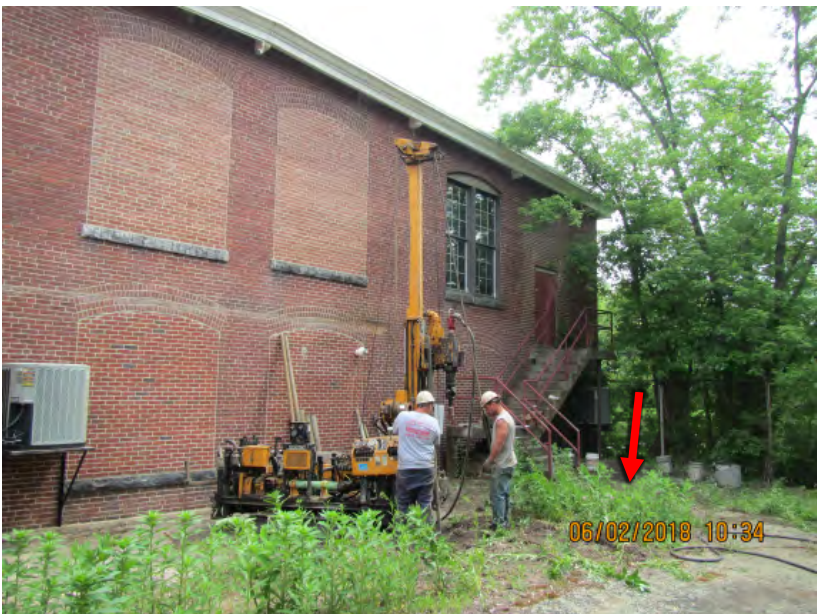
Photo 3

Drill rig set up at SGH-2018-3 on the south elevation of Building No. 10-A, adjacent to the Ipswich River. Arrow indicates the general location of Soil Test Borings SGH-2018-2 and SGH-2018-2A.

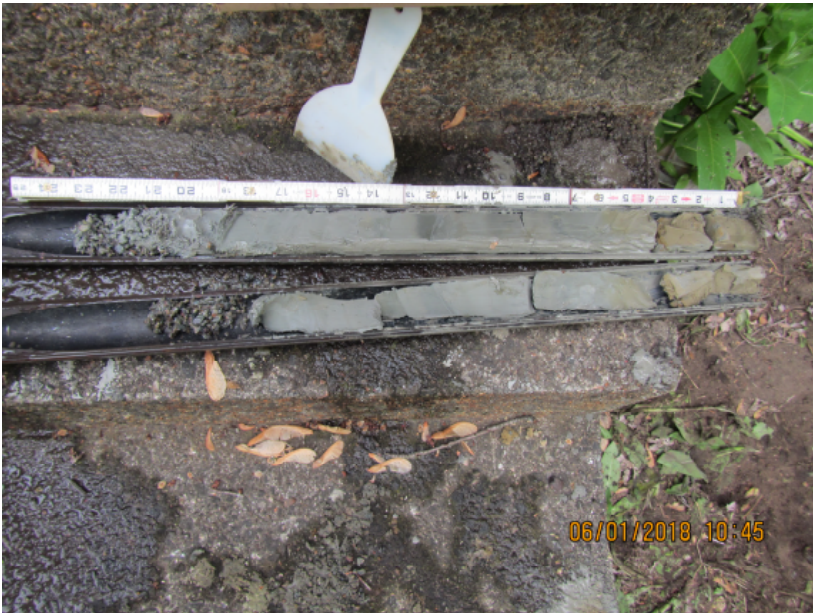
Photo 4

Split spoon sample collected in the Lower Silty Clay stratum at Soil Test Boring SGH-2018-2.

- **Stratum 5 – Lower Silty Clay:** This stratum consists of 2 to 6 ft of firm to very stiff, gray to olive gray, moist to wet silty clay. SPT blow counts ranged from 5 to 20 bpf. This stratum was encountered in Soil Test Borings SGH-2018-2 (Photo 4), SGH-2018-2A, and SGH-2018-3 underlying the Organic Silt stratum. Fine- to coarse-grained silty sand seams were observed within this stratum at Soil Test Boring SGH-2018-2A.¹ We encountered wood debris in the wash water while drilling at Soil Test Boring SGH-2018-2.

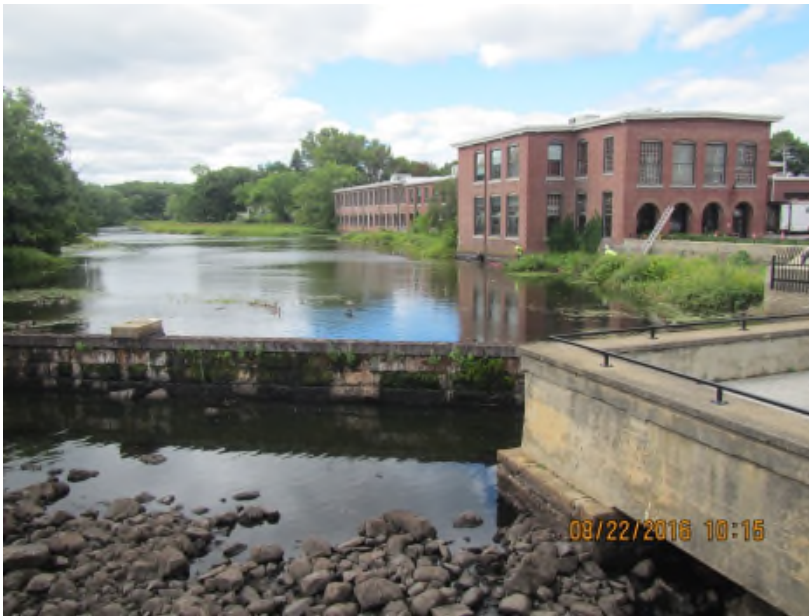
Photo 1

View of EBSCO building on 22 August prior to the temporary impoundment drawdown.

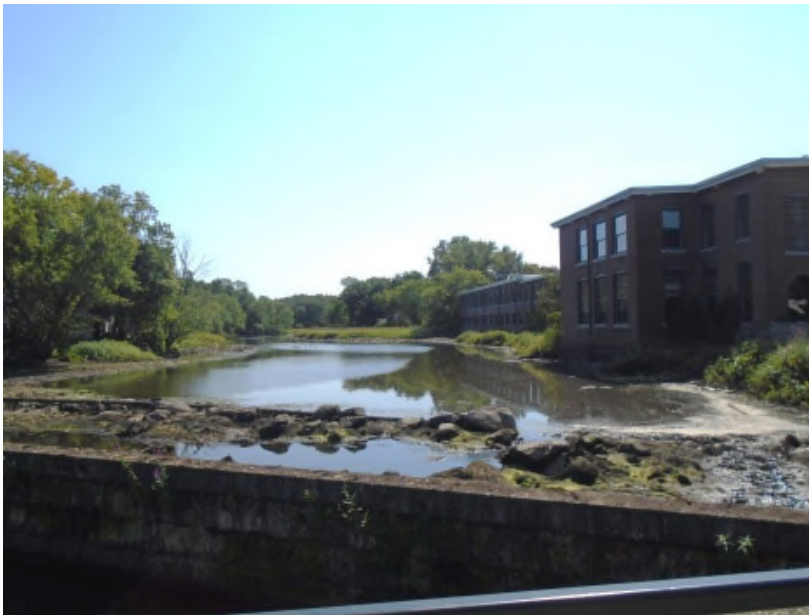
Photo 2

View of EBSCO building on 24 August after the temporary impoundment drawdown.

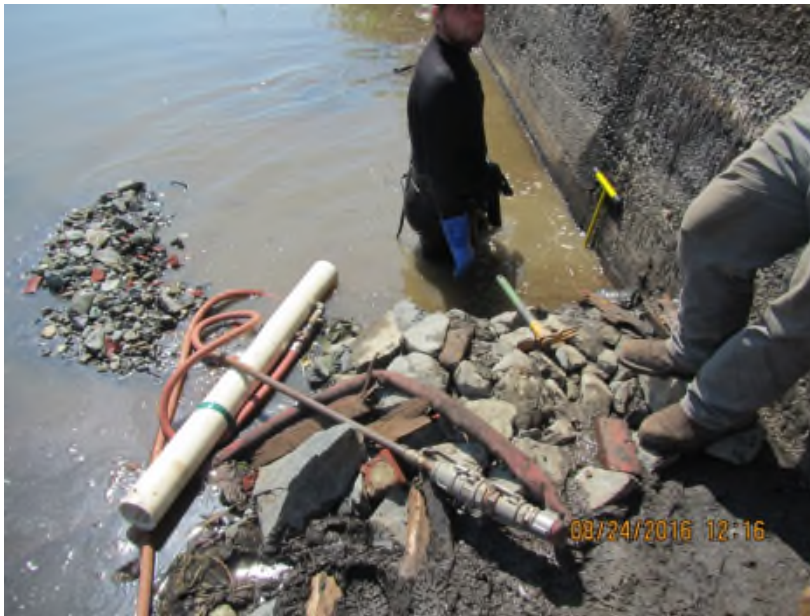
Photo 4

Typical rip rap and debris removed from TP-1.

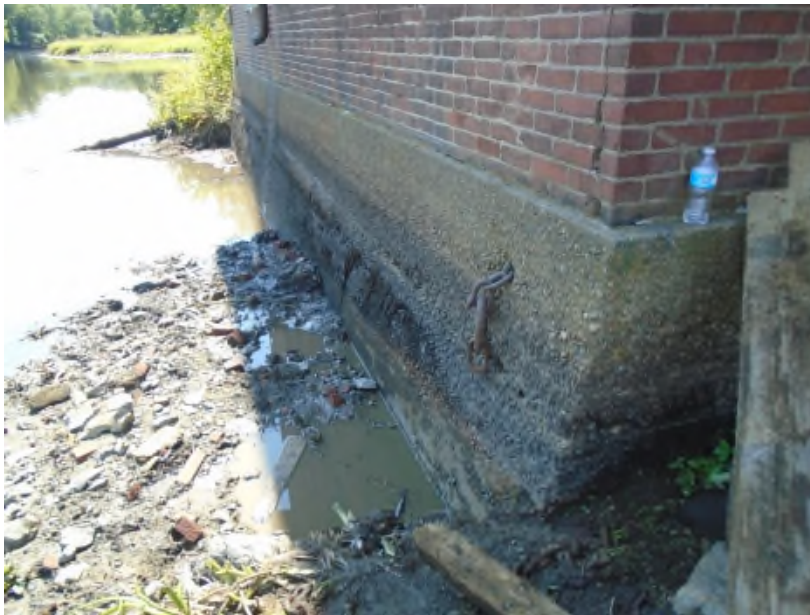
Photo 5

View of riverfront foundation wall at TP-1 (Building No. 9) on 24 August, looking south. Staining and concrete erosion is apparent below-normal water level.

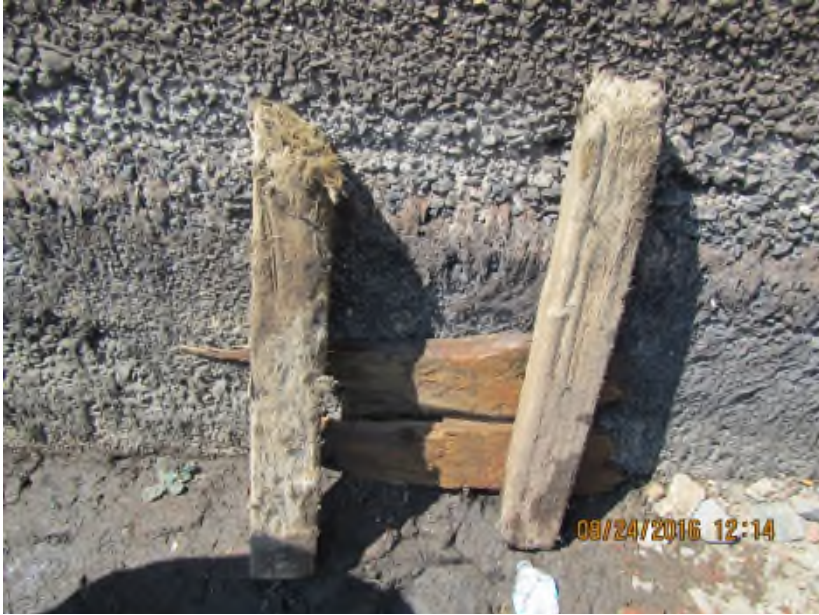
Photo 7

Abandoned timber formwork removed from TP-1.

- At both test pits, we observed a buried timber structure that appears to be the remnants of abandoned concrete formwork (Photo 7). The timber formwork consists of stacked horizontal planks supported by 3 in. by 3 in. vertical posts spaced at 2 ft o.c. At TP-1, the top of the remnant formwork was located at approximately El. 5.7 ft and it extended down to the bottom of the test pit (El. 3.2 ft). At Test Pit No. 2, the top of the remnant

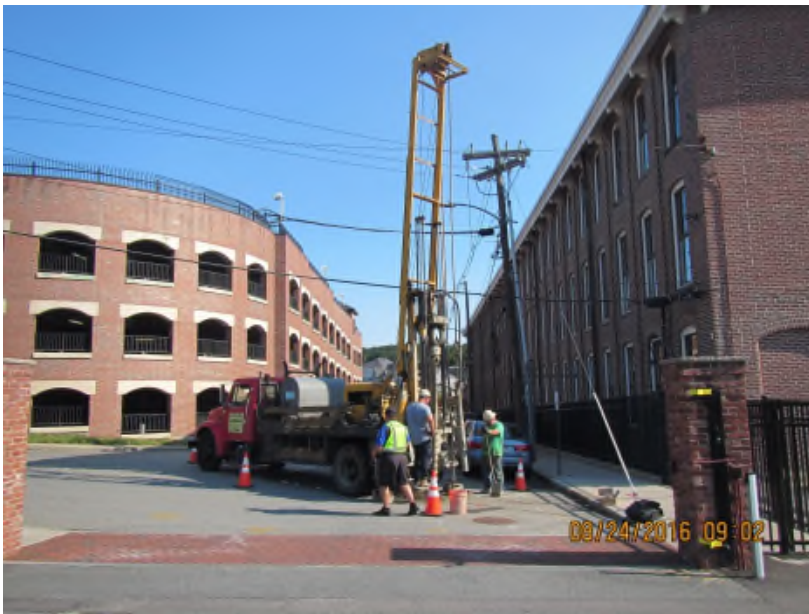
Photo 8

Drill rig set up at Soil Test Boring SGH-2016-1, located approximately 100 ft from EBSCO Building No. 9. EBSCO Building No. 3 on the right hand side.

Soil test boring locations are shown in Fig. 1. Two soil test borings were drilled on Saltonstall Street (Photo 8) and Estes Street, adjacent to the EBSCO campus; and one soil test boring was drilled in the gravel driveway located on the town right of way access to the dam adjacent to the private residence located at 69 South Main Street. A representative from SGH was present throughout the field work to observe drilling, assist in obtaining samples, and prepare a descriptive log of each test boring. The sampling intervals, soil descriptions, Standard Penetration Test (SPT) blowcounts, and other pertinent field data are summarized in the individual soil boring logs included in Appendix D.

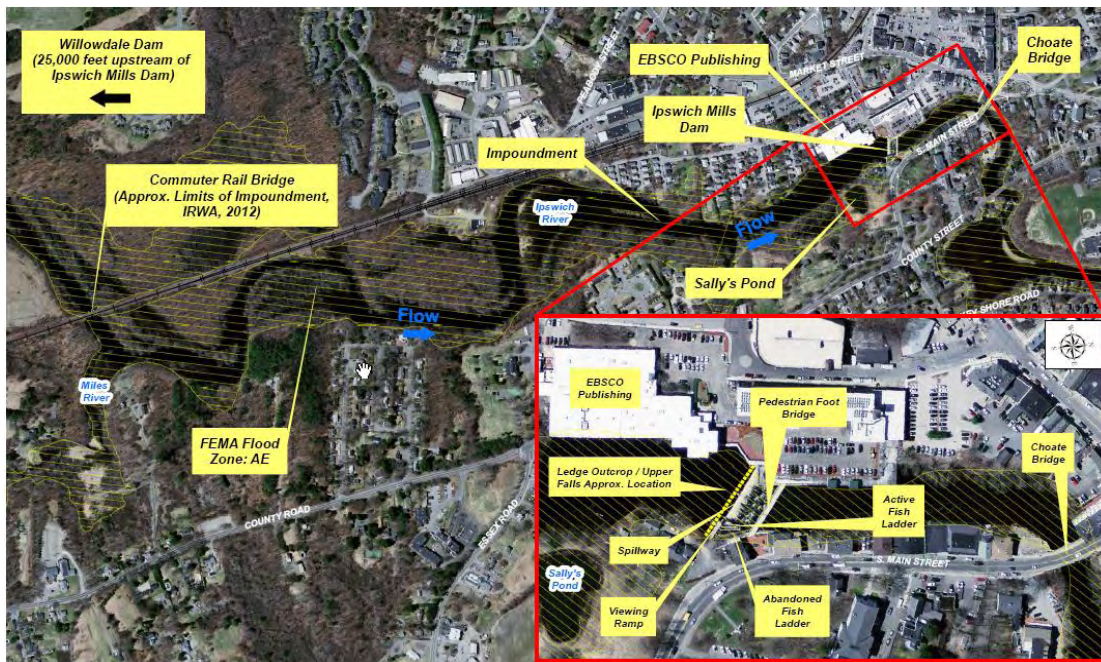
Figure 1. Key Project Area Features

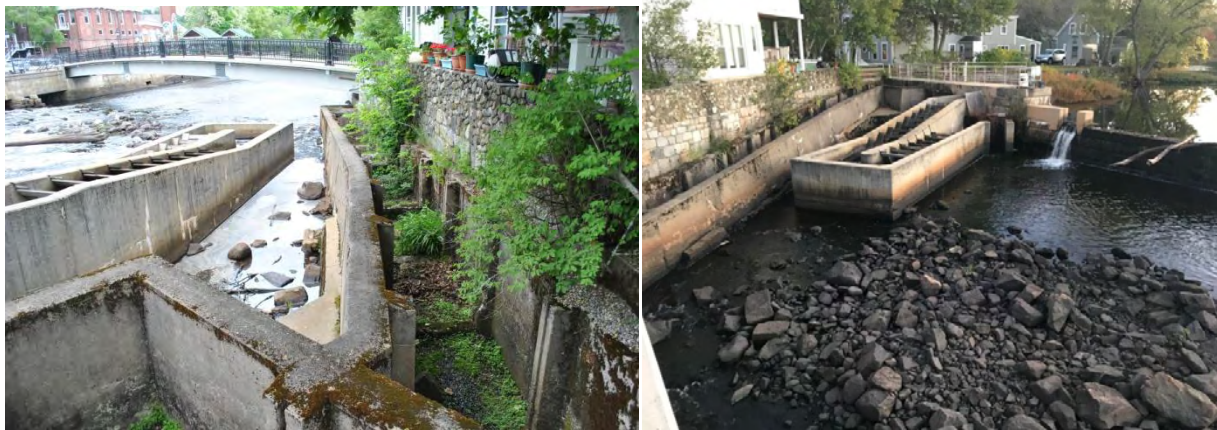
2.1 Old Fishway and Wall River Right (DS-1):

In-use and Abandoned Fishways Views Downstream (left) and Upstream (right)

Two Fishladders currently exist shortly downstream from the dam on river right. The one located closer to the river channel center is newer and still in use. The one flush with the retaining wall at the river's right edge has been abandoned since the newer one was built in 1996 (Haley and Aldrich, 2009). Under the proposed draft Task 2 Conceptual Design for dam removal the newer fish ladder will be removed. The outside edge of the older fish ladder is integral with the retaining wall on the river right edge of the river and so cannot be fully removed.

H&H modeling indicates that water levels in the vicinity of the fish ladder will stay largely similar for the larger flow scenarios and drop by as much as 1.5 feet for the 95% exceedance/ low tide flow scenario. River flow velocities are simulated to either drop, or marginally increase by approximately 0.2 feet per second (fps), depending upon the flow scenario. Given that both water levels and river flow velocities along this stretch of river are generally anticipated to stay similar or drop under modeled dam-out conditions, no significant impact to the old fish ladder and its adjacent wall is anticipated as a result of dam-removal. Nevertheless, because the exact alignment of the river channel in this area under a dam removal scenario for all flow conditions is uncertain, because of the importance of the retaining wall adjacent to the old fish ladder, and because of the fact that the fish ladder will be in the heart of the construction zone if the dam is removed so that mitigation work can be accomplished relatively easily, the draft design proposes to fill the void space in the old fish ladder with large rocks salvaged from the dam removal area to protect the adjacent retaining wall. Concrete filling may also be considered for the old fish ladder in subsequent design phases. The filled and reinforced older fish ladder will serve as mitigative protection for the adjacent retaining wall in the event more erosive river flows are ultimately experienced at this location following potential dam removal, despite current modeling indications to the contrary.

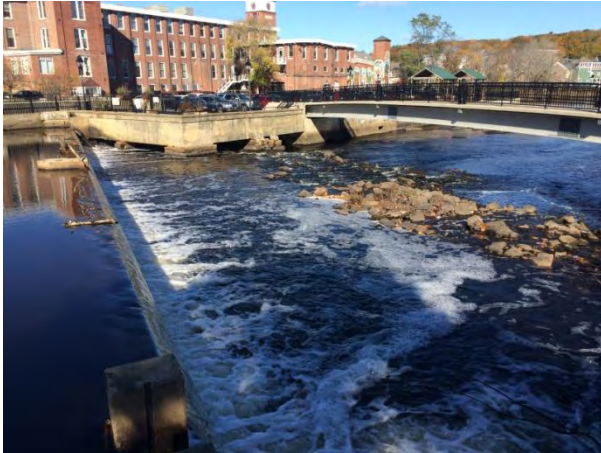
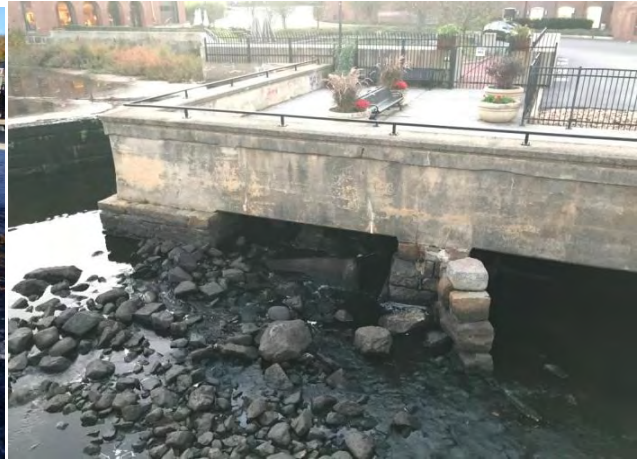
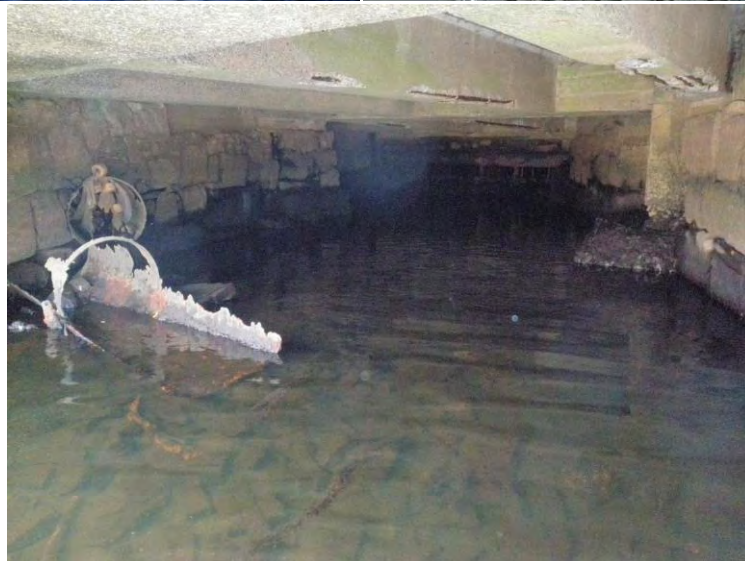
2.2 Pedestrian Platform Piers River Left (DS-2):

Pedestrian Platform Support Piers Far-field (left), Close-up (right), and Underneath (bottom)

A concrete pedestrian platform supported on stone block piers is located immediately downstream of the dam on river left. The platform forms the left end of the pedestrian bridge that spans the river shortly downstream from the dam and provides a means for pedestrians to access either the EBSCO facility or a parking lot further downstream on the left river bank as part of the Town's Riverwalk.

H&H modeling indicates that water levels in the vicinity of the pedestrian platform will remain similar to current conditions under dam-out conditions. River flow velocities are simulated to either drop, or increase slightly by approximately 0.2 fps, depending upon the flow scenario. Given that both water levels and river flow velocities along this stretch of river are generally anticipated to drop under modeled dam-out conditions, no significant impact to the pedestrian platform is anticipated as a result of dam-removal.

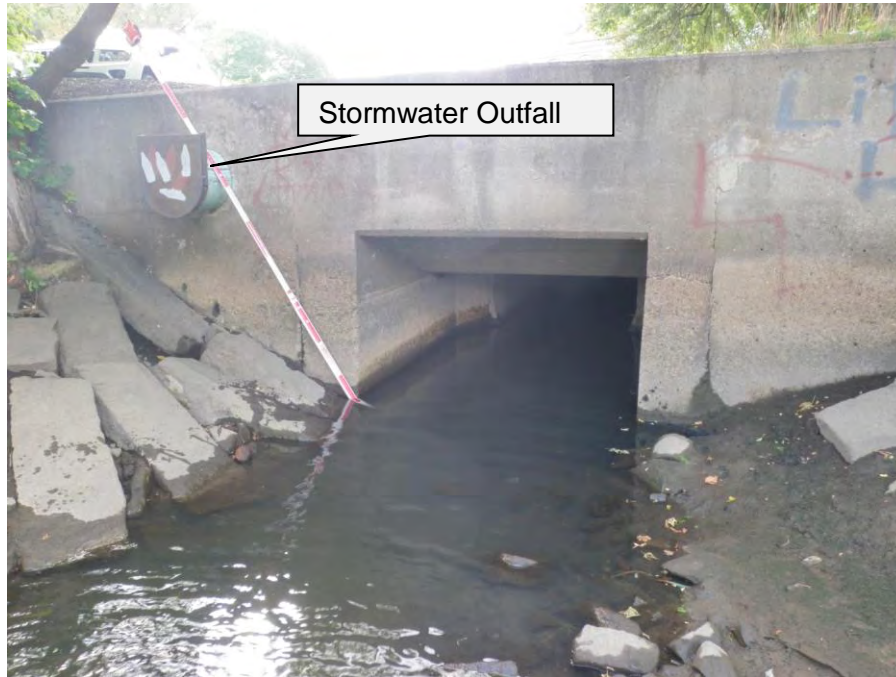
2.5 Farley Brook Outfall River Left (DS-5):

Farley Brook and Stormwater Outfall Entering River Beneath Parking Lot River Left

Farley Brook (culverted along most of its length) joins the Ipswich River via a culvert under the public parking lot river left approximately 440 feet downstream from the dam. A separate stormwater pipe also enters the river at this location at a higher elevation (see photograph above). The stormwater pipe is above all but the highest river stages under either existing or dam-out conditions and will, therefore, not be impacted by dam removal. The Farley Brook culvert is within the range of normal river stage fluctuations under current conditions. Hydraulic modeling indicates no significant changes to river stage or flow velocity at this location under dam-out conditions and, therefore, it too is unlikely to be impacted by dam removal.

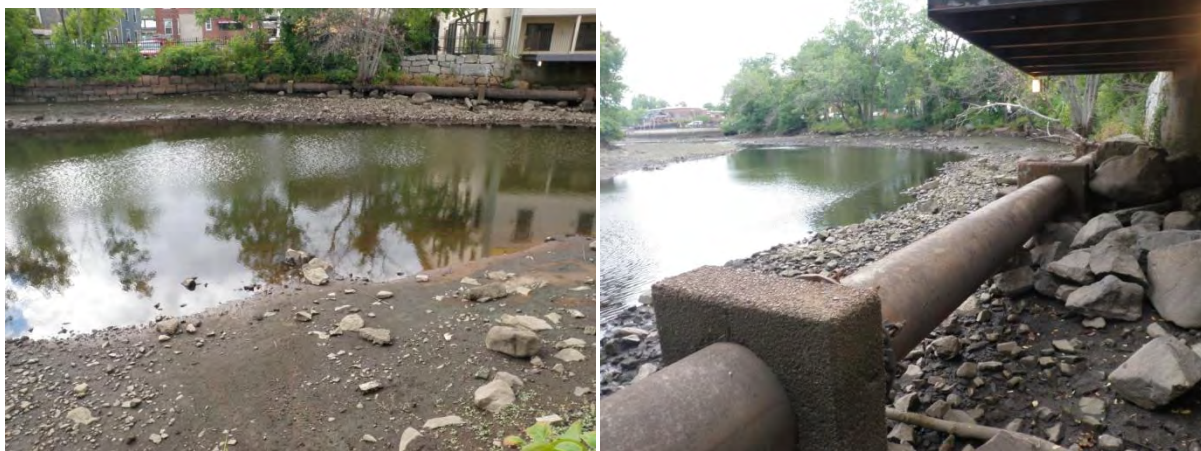
2.6 Sewer Interceptor and Siphon (DS-6):

Exposed Sewer Force Main Crossing Beneath Choate Bridge River Left

An exposed sewer Interceptor runs in the river channel along the left bank from the area of the public parking lot, under the Choate Bridge, and then further downstream (approximately 400 – 1,000 feet downstream of the dam total run length). There is also a gravity sewer line “siphon” extending under the river roughly half way in between Choate and County Street Bridges (approximately 1,000 feet downstream of the dam). The interceptor line is supported by concrete piers that rest on the river bed. Both the line and the piers are partially exposed and subject to scour. Due to its importance to the Town, contamination risk to the environment, and exposed condition within the river channel, these sewer lines are vulnerable pieces of infrastructure under existing conditions. We understand that the town has initiated resiliency-related work on the sewer interceptor and siphon and has budgeted to implement its recommendations. Reportedly, the siphon is due to be replaced and then protected with rip rap in 2019, and the currently exposed interceptor is due to be protected with rip rap in 2020. Thus, the potential issues identified in this report relative to the interceptor and siphon should be addressed prior to any potential dam removal timeframe.

With regards to the potential impacts from dam removal, hydraulic modeling indicates no significant changes to river stage or flow velocity at this location under dam-out conditions and, therefore, it is unlikely to be impacted by dam removal. The currently exposed condition of the main interceptor, and to a lesser degree, the siphon, does place them at risk for damage from river debris such as large trees or logs. The existing dam currently catches a percentage of this debris, at least temporarily, that might otherwise continue downstream and risk damaging the exposed pipes. However, according to IRWA, nearly all floating debris currently caught by the dam eventually work free and continues downstream and the Town on occasion removes debris from the dam of particular concern. The Town’s proposed mitigation plan for the sewer lines should protect the pipes from this impact risk so long as dam removal occurs following the completion of that mitigation project.

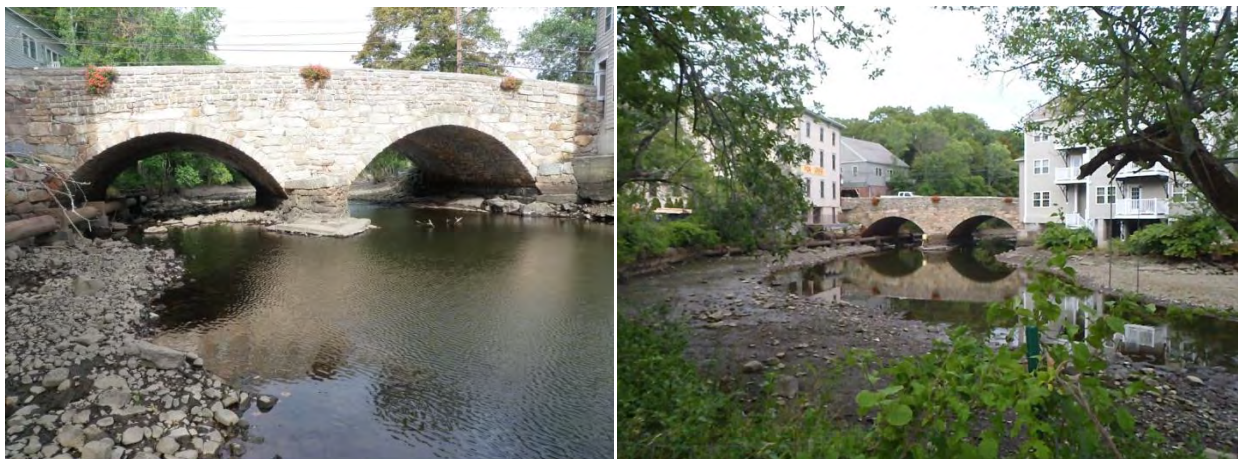
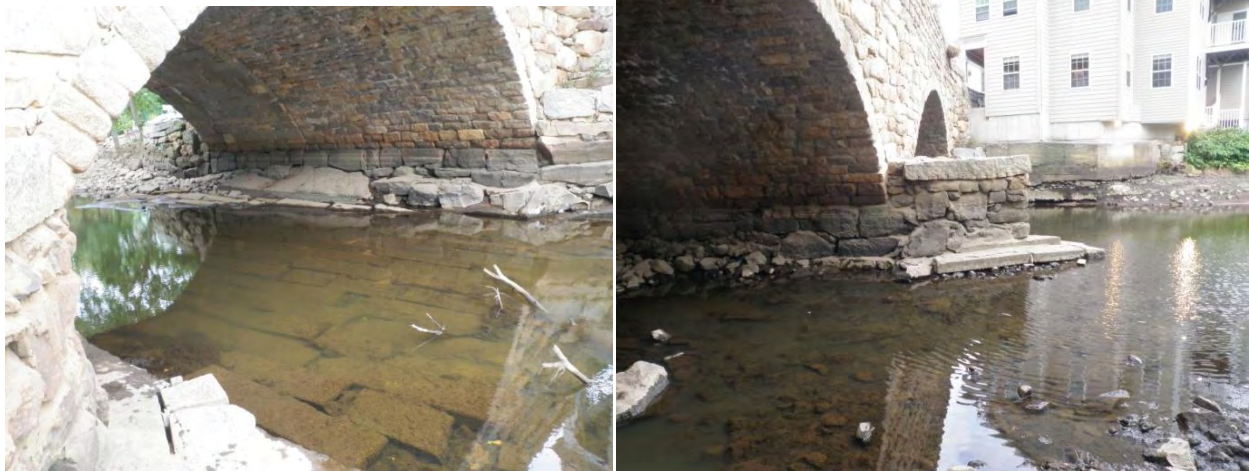
2.7 Choate Bridge (DS-7):

Choate Bridge Views from Upstream (top and lower right) and from Downstream (lower left)

According to the Town of Ipswich, the Choate Bridge was built in 1764 and is reportedly the oldest, surviving, double-arched, stone bridge in America. It is, therefore, of immense historical significance. Since it carries South Main Street into downtown Ipswich, it is also of high importance as a piece of transportation infrastructure for the region. Hydraulic modeling indicates no significant changes to river stage or flow velocity at this location under dam-out conditions and, therefore, the bridge is unlikely to be impacted by dam removal. However, since the U.S. Army Corps of Engineers (USACE) and Federal Emergency Management Agency (FEMA) may require a more detailed flood analysis during permitting, and since the bridge holds such practical and historical significance for the Town, flood elevations should be further evaluated during future design stages.

While no significant changes in river stage or velocity are modeled to occur as a result of potential dam removal, the bridge is modeled to be a flow restriction during larger flow events under current conditions. Under a potential dam-out scenario sediment currently retained behind the dam will migrate downstream. Model results indicate that bed shear stresses beneath the bridge will be sufficient to transport sediment sizes up to cobbles, so no long-term sedimentation impacts at the bridge are anticipated. However, it's possible that some sediment may be temporarily retained beneath the bridge, depending upon the flow conditions under which it is mobilized, until it is remobilized and transported past the bridge during subsequent high flow events. Monitoring of sediment transport past the bridge is recommended following potential dam removal.

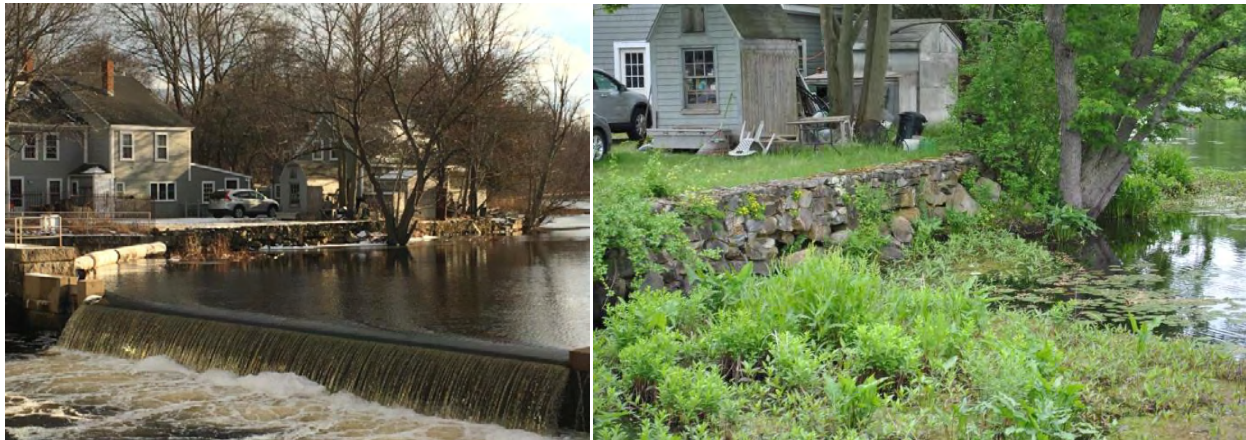
3.1 Retaining Wall River Right (US-1):

Stone Retaining Wall River Right Far-field View (left) and Close-up (right)

A stone retaining wall creates the riverbank and protects the yard of a private residence immediately upstream (approximately 0-150 feet) of the dam on river right. Hydraulic modeling suggests that, under dam-out conditions, water levels will remain the same or slightly lower for the larger storm flows and drop significantly under the lower flow scenarios (up to approximately 6 feet for the 95% exceedance/low tide scenario). River flow velocities are modeled to remain essentially the same or drop slightly for the higher flow scenarios, and to increase moderately under the moderate and low flow scenarios (up to an approximately 0.6 fps increase under the 2-year storm and 5% exceedance scenarios). However, even those increased flow velocities are simulated to remain under 3 fps with shear stresses below 0.3 pounds per square foot (psf). Table 3 below, from the Vermont Agency of Natural Resources Stream Geomorphic Assessment Handbook (VNR, April 2004) lists the critical shear stresses for various particle sizes. Table 4, from the USACE Ecosystem Management and Restoration Research Program (EMRRP, May 2001), graphically depicts the stability of channel linings for different stream velocity ranges.

Due to the unknown depth to bedrock or other hard-bottom controlling river bed elevation, because the exact alignment of the river channel in this area under a dam removal scenario for all flow conditions is uncertain, because of the importance of the retaining wall, and because of the fact that the wall will be within the heart of the construction zone if the dam is removed so that protective work can be accomplished relatively easily, the draft concept design for dam removal proposes to construct fabric encapsulated soil (FES) lifts with large rock toe protection to provide scour protection in front of the wall. The FES lifts will be planted and seeded to provide a soft, vegetative protective barrier at higher elevations, while the large stone toe provides hard protection at lower elevations. The reinforcement will serve as protection for the wall in the event more erosive river flows are experienced at this location following potential dam removal, despite current modeling indications to the contrary. Further modeling and analyses are recommended, once the elevation of bedrock or other hard-bottom controlling river bed elevation is better defined, in order to better evaluate the potential for channel incision to impact the stability of retaining walls at the river's edges.

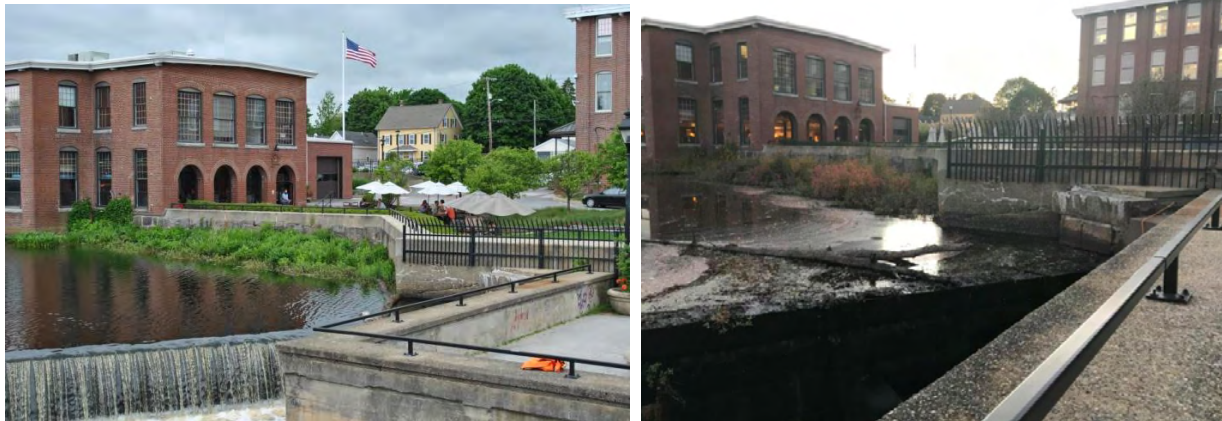
3.2 Retaining Wall River Left (US-2):

EBSCO Retaining Wall River Left Far-field View (left) and Close-up (right)

A concrete and stone retaining wall creates the riverbank and protects a patio area for the EBSCO facility immediately upstream (approximately 0-100 feet) of the dam on river left. Hydraulic modeling suggests that, under dam-out conditions, water levels will remain essentially the same or slightly lower for the larger storm flows and drop significantly under the lower flow scenarios (up to approximately 6 feet for the 95% exceedance/low tide scenario). River flow velocities are modeled to remain essentially the same or drop slightly for the higher flow

Due to the unknown depth to bedrock or other hard-bottom controlling river bed elevation, because the exact alignment of the river channel in this area under a dam removal scenario for all flow conditions is uncertain, because of the importance of the retaining wall, and because of the fact that the wall will be within the heart of the construction zone if the dam is removed so that protective work can be accomplished relatively easily, the draft concept design for dam removal proposes to construct fabric encapsulated soil (FES) lifts with large rock toe protection to provide scour protection in front of the wall. The FES lifts will be planted and seeded to provide a soft, vegetative protective barrier at higher elevations, while the large stone toe provides hard protection at lower elevations. The reinforcement will serve as protection for the wall in the event more erosive river flows are experienced at this location following potential dam removal, despite current modeling indications to the contrary. Further modeling and analyses are recommended, once the elevation of bedrock or other hard-bottom controlling river bed elevation is better defined, in order to better evaluate the potential for channel incision to impact the stability of retaining walls at the river's edges.

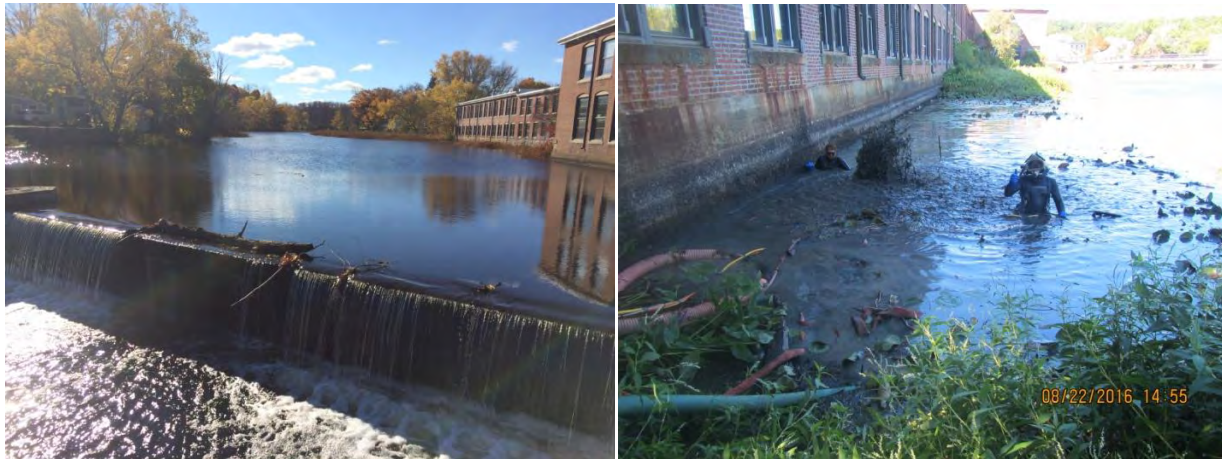
3.3 EBSCO Foundation (US-3):

EBSCO Foundation River Left Far-field View (left) and Close-up (right)

Slightly further upstream from the concrete and stone retaining wall on river left (approximately 100-440 feet from the dam), the foundation of the EBSCO facility creates the left river bank under existing conditions. Underwater test pits dug during the Task 3 Structural assessment of the EBSCO facility during this current feasibility study revealed that this foundation wall extends below the depth to which the river might potentially drop following dam removal, and appears to have rip rap stone protection placed in front of it that has become covered with river sediment over time.

Hydraulic modeling suggests that, under dam-out conditions, water levels will remain essentially the same or slightly lower for the larger storm flows and drop significantly under the lower flow scenarios (up to approximately 6 feet for the 95% exceedance/low tide scenario). River flow velocities are modeled to remain essentially the same or drop slightly for the higher flow scenarios, and to increase moderately under the moderate and low flow scenarios (up to an approximately 1.5 fps increase under the 2-year storm and 5% exceedance scenarios). However, even those increased flow velocities are simulated to remain under 3 fps with shear stresses below 0.3 psf. As can be seen in Tables 3 and 4, those modeled shear stresses and velocities are capable of mobilizing smaller sediment sizes from silts up to coarse gravel, but not larger materials or any vegetated or stabilized surfaces. The Pennsylvania DEP Erosion and Sediment Control Manual (PADEP, 2012), also indicates that these shear stresses are adequate to mobilize bare, erodible soils, but not sufficient to erode vegetated or reinforced soils. A portion of the EBSCO building foundation is located further out into the river and has existing river bed bathymetry at lower elevation than occurs at the retaining wall mentioned above. Therefore, the river's water level is more likely to remain at or near the foundation under dam-out condition for more flow scenarios than is the case for the retaining wall mentioned above.

Despite the generally low risk to the EBSCO foundation indicated by hydraulic modeling and despite the fact that test-pits suggest that at least some rip rap protection may already be in place in front of the foundation, the draft concept design for dam removal does include some reinforcement protection for the foundation wall. This protection is recommended because of the fact that foundation is located further out in the river channel than the walls mentioned

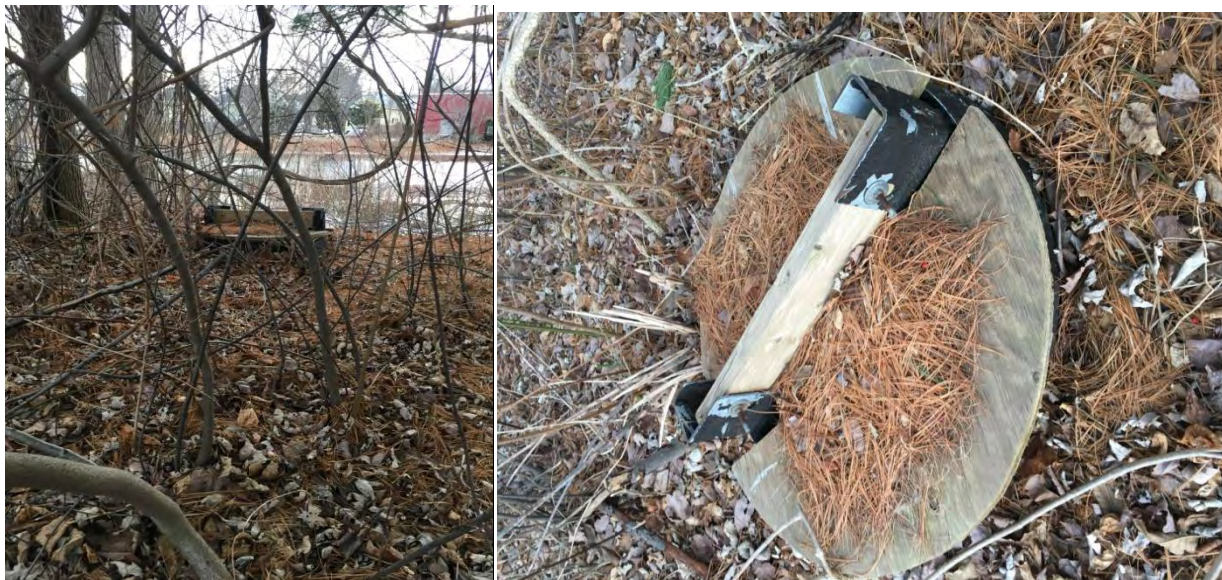
Sally Pond Outlet Control Structure Far-field View (left) and Close-up (right)

According to Town Conservation Commission records, Sally's Pond was constructed at its location shortly upstream of the dam above the right bank in the 1970s. An outfall control structure was visually observed adjacent to the pond shore, between the pond and the river. Inside the outlet structure is a removable board, weir structure that appears to have been built to allow the pond to drain to the river at varying pond elevations that could be set with the weir. The structure appeared to be disused and at least partially clogged with debris (IRWA observation). No outfall to the river was observed even during the impoundment drawdown period in September 2016, suggesting that the river end of the outfall must be below the water level observed during the drawdown, or even potentially buried in sediment. If an outfall exists to the river, visual observation of the likely connection line between the outlet structure on the

The concern here is that if the new river level were significantly below the invert of the outfall for extended periods when the outfall was actively draining significant water from the pond to the river, and the exposed sediments beneath the culvert invert were sufficiently soft and mobile, a headcutting concern could be realized between the culvert and the new river's edge. However, even if the pond's outlet pipe proves to be above the river's water level under dam-out conditions and most flow scenarios, it is unclear if the outlet is currently active. According to IRWA, and based on visual observation of the outlet structure at the pond's edge, it does not appear that the Town actively uses the outlet structure to release water from the pond to the river. Therefore, potential headcutting concerns at this location do not appear likely as a result of potential dam removal. We recommend that conditions be monitored following dam removal to see if an outlet pipe is observed that actively drains pond water.

Another potential impact from dam removal to consider is the impact to Sally's Pond itself. The water level in Sally's Pond is likely a relatively close approximation of the surrounding groundwater elevation, though the pond's outlet control structure likely serves to maintain pond levels somewhat higher than the surrounding groundwater elevations. Lowered river levels following potential dam removal would result in lowered groundwater levels for areas in close proximity to the river. Because groundwater responds much slower to prevailing hydrologic conditions than does surface water, groundwater impacts from river level changes will respond more closely to average river levels than to any time-specific river level condition. H&H modeling shows an approximately 5.5-foot decrease in river levels for the area in front of Sally's Pond for the 50% exceedance flow condition, averaged between low and high tide conditions. Due to the resistance to flow posed by the aquifer sediments, changes in groundwater levels will quickly dissipate with distance from the river.
