Ipswich Mills Dam Removal Feasibility Study

Ipswich, Massachusetts

March 2019

Prepared by:
Horsley Witten Group, Inc.

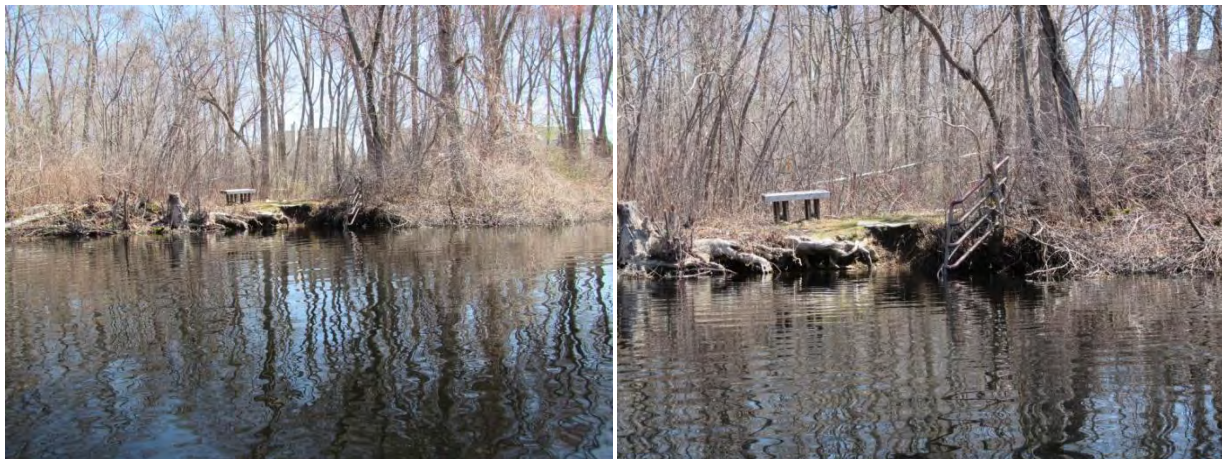
Sally's Pond Public Canoe Launch River Right Far-field View (left) and Close-up (right)

A public canoe launch is located on the river right bank below Sally's Pond. Modeled hydraulic river changes at this location following potential dam removal are as described above for the Sally's Pond outfall. Since the river stage is modeled to drop at this location under all but larger storm flow conditions, the distance between the current canoe launch site and the water's edge will increase under most conditions when the canoe launch would likely be used. The potential risk here is that canoe launch access to the river may be impacted if the newly exposed shoreline is too soft or muddy to allow for equivalent access as currently exists. According to IRWA, the river bottom at this location is relatively firm so that potential impacts to canoe access are expected to be minimal. According to IRWA, this canoe launch site is used primarily as a portage location for paddlers to get around the dam. Therefore, under a dam-out scenario usage of the portage would be significantly reduced. An adaptive management approach is recommended for this site. Conditions should be monitored following dam removal and improvements made to the canoe launch site, as necessary, to preserve public access. According to IRWA, such improvements, if needed, are anticipated to be relatively minor. They

might include providing supportive matting, or similar solid walking surface, between the current and post dam-removal river's edges to allow for continued canoe launch access.

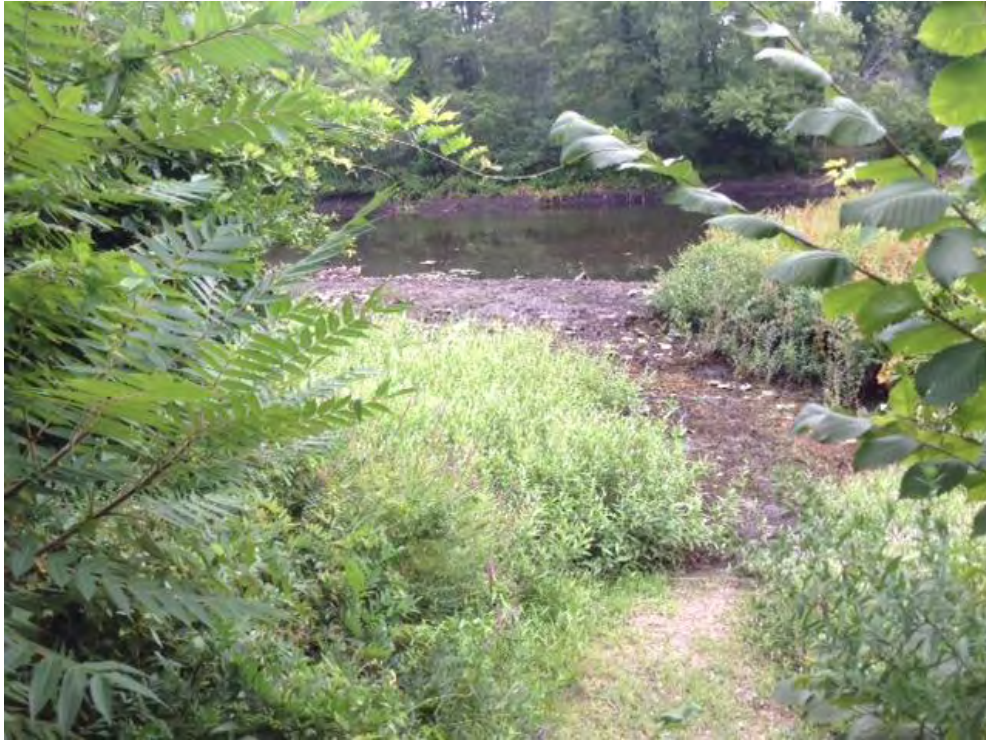
Peatfield Street Public Canoe Launch River Left (during September 2016 drawdown)

A, public river access/ canoe launch site is located at the end of Peatfield Street, approximately 920 feet upstream from the dam on river left. Hydraulic modeling indicates that water levels at this location will remain essentially the same or slightly lower for the larger storm flows and drop significantly under the lower flow scenarios (up to approximately 6 feet for the 95% exceedance/low tide scenario). River flow velocities are modeled to remain essentially the same or drop slightly for the higher flow scenarios, and to increase moderately under the moderate and low flow scenarios (up to an approximately 1.8 fps increase under the 2-year storm and 5% exceedance scenarios). However, even those increased flow velocities are simulated to remain under 4 fps with shear stresses below 0.35 psf. As can be seen in Tables 3 and 4, those modeled shear stresses and velocities are capable of mobilizing smaller sediment sizes from silts up to coarse gravel, but not larger materials or any vegetated or stabilized surfaces. The Pennsylvania DEP Erosion and Sediment Control Manual (PADEP, 2012), also indicates that these shear stresses are adequate to mobilize bare, erodible soils, but not sufficient to erode vegetated or reinforced soils. Therefore, some channel bottom erosion and sediment migration may occur as the river adjusts to new hydraulic conditions following dam removal.

Since the river stage is modeled to drop at this location under all but larger storm flow conditions, the distance between the current canoe launch site and the water's edge will increase under most conditions when the canoe launch would likely to be used. However, for average to lower flow events (those conditions under which canoe launch access might be expected to be greatest impacted), twice daily high tides will raise modeled river elevations by between 0.5 and 1.5 feet above those modeled for low tides. The potential concern here is if

canoe launch access to the river may be impacted if the newly exposed shoreline is too soft or muddy to allow for equivalent access as currently exists. According to IRWA, the river bottom at this location is relatively firm so that potential impacts to canoe access are expected to be minimal. An adaptive management approach is recommended for this site. Conditions should be monitored following dam removal and improvements made to the canoe launch site, as necessary, to preserve public access. According to IRWA, such improvements, if needed, are anticipated to be relatively minor. They might include providing supportive matting, or similar solid walking surface, between the current and post dam-removal river's edges to allow for continued canoe launch access.

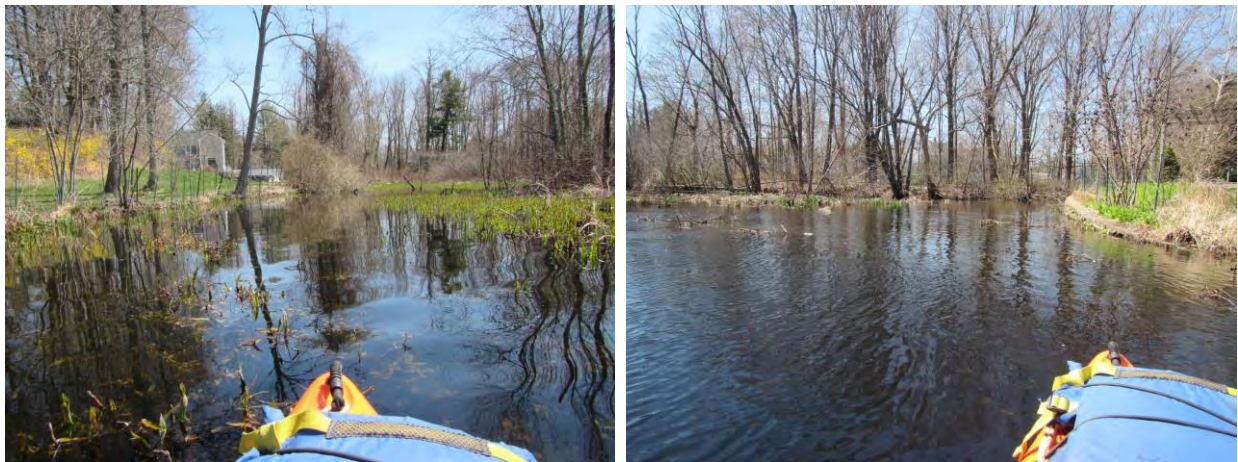
Saltonstall Brook River Left (left) and Kimball Brook River Right (right) Confluences

Approximately 1,200 and 1,400 feet upstream from the dam on river right and left, respectively, two tributaries (Saltonstall and Kimball Brooks) join the river. Both confluences are natural channels with no culverts or other hard, engineered structures. Hydraulic modeling indicates that water levels at this location will remain essentially the same or slightly lower for the larger storm flows and drop significantly under the lower flow scenarios (up to approximately 6 feet for the 95% exceedance/low tide scenario). River flow velocities are modeled to remain essentially the same or drop slightly for the higher flow scenarios, and to increase moderately under the moderate and low flow scenarios (up to an approximately 1.8 fps increase under the 2-year storm and 5% exceedance scenarios). However, even those increased flow velocities are simulated to remain under 4 fps with shear stresses below 0.35 psf. As can be seen in Tables 3 and 4, those modeled shear stresses and velocities are capable of mobilizing smaller sediment sizes from silts up to coarse gravel, but not larger materials or any vegetated or stabilized surfaces. The Pennsylvania DEP Erosion and Sediment Control Manual (PADEP, 2012), also indicates that these shear stresses are adequate to mobilize bare, erodible soils, but not sufficient to erode vegetated or reinforced soils. Therefore, some channel bottom erosion and sediment migration may occur as the river adjusts to new hydraulic conditions following dam removal.

Since the river stage is modeled to drop at these river confluences under all but larger storm flow conditions, and shear stresses and velocities are modeled to be capable of mobilizing

smaller sediment sizes, some degree of sediment migration and channel headcutting is expected to occur as the tributary channel seeks to adjust to the new river level. This type of channel reconfiguration is expected as the river and its tributaries reconfigure themselves to the natural conditions that prevailed before the influence of the dam. According to IRWA, and as observed from aerial photography, there are no culverts, bridges, or other infrastructure in the vicinity of these confluences likely to be impacted by channel reconfiguration. We recommend that conditions be monitored following dam removal to document the extent of headcutting that occurs.

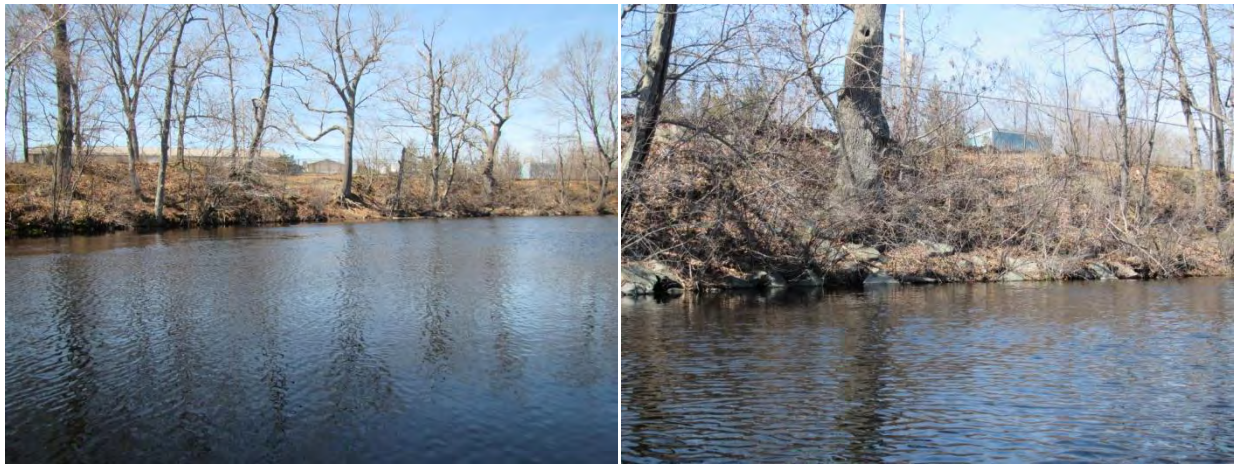
Railroad Embankment River Left Near Hayward Street Far-field View (left) and Close-up (right)

The railroad line crossing and adjacent to the river is owned by the Massachusetts Bay Transportation Authority (MBTA) and operations, including maintenance and repairs, are undertaken by Keolis, a private company contracted by the MBTA to run the commuter rail service. Currently the river touches the embankment for the MBTA railroad line at two locations upstream from the dam. The closest, approximately a half mile upstream from the dam, is near Hayward Street and shortly upstream from Sixth Street, where an approximately 265-foot long

Because modeled increases in river velocity are moderate, and because those flow scenarios where velocity is modeled to increase also are simulated to have lower river elevations, the potential for significant erosive impacts to these embankments appears relatively low. Nonetheless, due to the importance of the railroad infrastructure and because some potential increase of erosive river flows is possible, further study of this concern is recommended. Such study should include field evaluation of the topography and bathymetry of the embankments and adjacent river channel, field evaluation of the sediment characteristics relevant to their potential

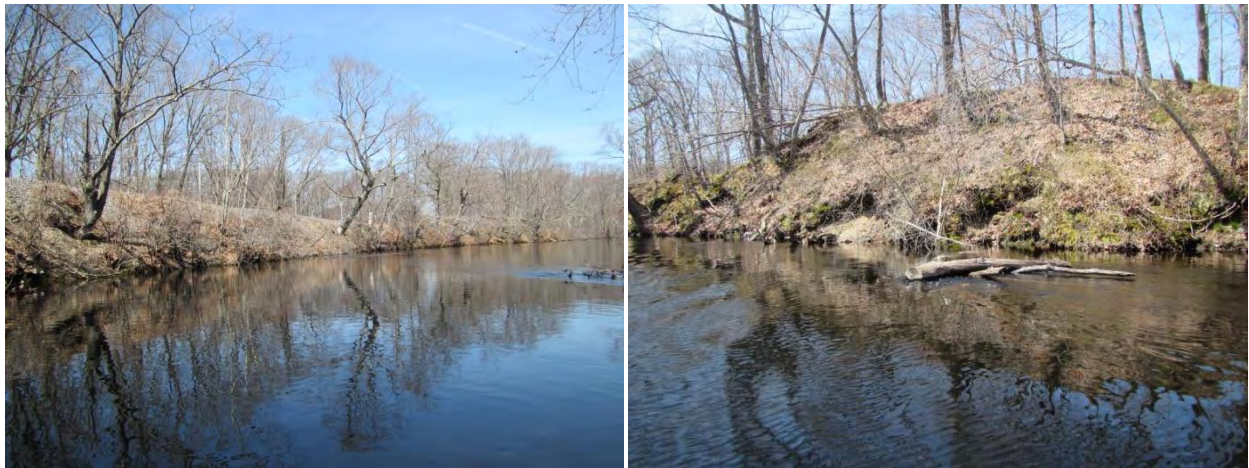
Railroad Embankment River Left Across from IRWA Office Far-field View (left) and Close-up (right)

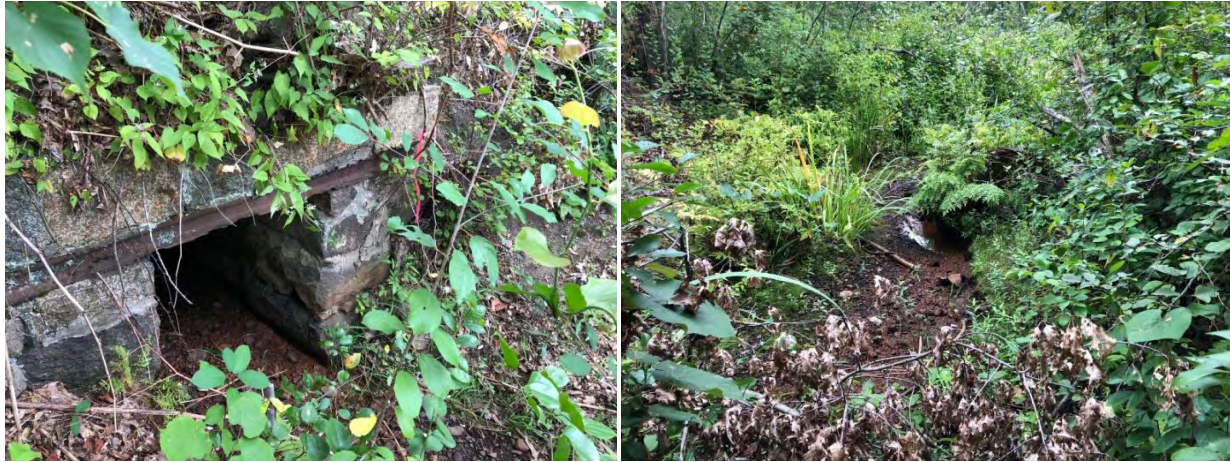
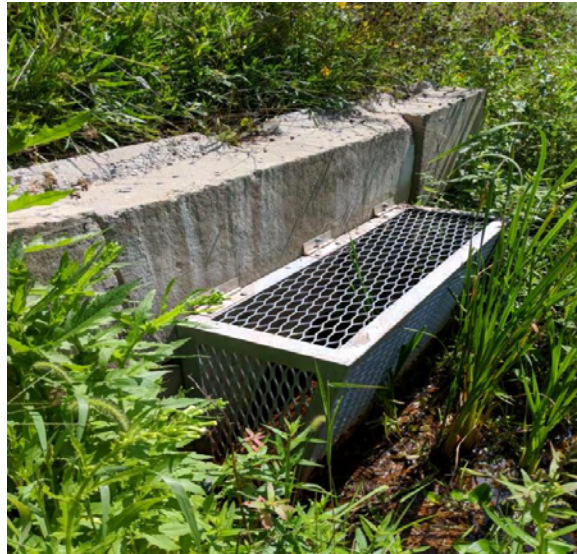
Shady Brook Culvert Downstream End (left), Shortly Downstream (right), and Upstream (bottom)

Approximately a mile upstream from the dam, and just downstream from the more upstream railroad embankment discussed above, on river left, the Shady Brook tributary joins the river. Shady Brook drains a small wetland upstream (northwest) of the railroad tracks and is conveyed beneath the railroad bed by a culvert. According to IRWA, the Ipswich River may flood into the Shady Brook area during high flow events and then drain back to the river downstream through the culvert beneath the railroad bed. According to 2015 culvert modification plans obtained from the Ipswich Conservation Commission by IRWA, the culvert is an old, 3-foot X 5-foot granite-block, box culvert. The 2015 modifications appear to have been the addition of two -1-foot diameter concrete pipes inserted into the upstream end of the granite box culvert to extend the

IRWA and HW staff visited the site in September of 2018 to observe conditions and noted that the upstream work had been completed approximately as shown on the 2015 plans, that the downstream invert was dry at the time of the visits, and that no significant erosion was currently evident downstream of the culvert. According to IRWA, a berm at the river's edge separates the river from Shady Brook during drier, lower-flow conditions.

Since the river stage is modeled to drop at these river confluences under all but larger storm flow conditions, and shear stresses and velocities are modeled to be capable of mobilizing smaller sediment sizes, the potential for some degree of sediment migration and channel headcutting exists as the tributary channel seeks to adjust to the new river level. This type of channel reconfiguration is expected as the river and its tributaries reconfigure themselves to the natural conditions that prevailed before the influence of the dam. Because the culvert is offset so far from the main river channel and is separated from the main channel by a berm, the potential that lowered water levels in the main channel as a result of dam removal would encourage significantly increased headcutting below the culvert may be less than would otherwise be the case. We recommend that conditions be monitored following dam removal to document the extent of headcutting that occurs.

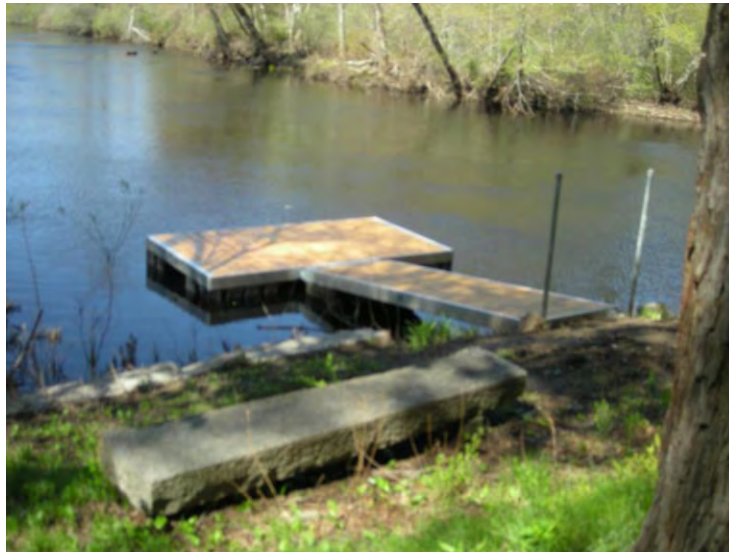
IRWA maintains a dock and canoe launch site approximately 6,300 feet upstream from the dam on river right. Hydraulic modeling indicates that water levels at this location will remain essentially the same or slightly lower for the larger storm flows and drop moderately under the lower flow scenarios (up to approximately 1.7 feet for the 95% exceedance/low tide scenario). River flow velocities are modeled to remain essentially the same or drop slightly for the higher flow scenarios, and to increase slightly under the moderate and low flow scenarios (up to an approximately 0.6 fps increase under the 2-year storm and 5% exceedance scenarios). However, even those increased flow velocities are simulated to remain under 2.5 fps with shear stresses below 0.15 psf. As can be seen in Tables 3 and 4, those modeled shear stresses and velocities are capable of mobilizing smaller sediment sizes from silts up to medium gravel, but not larger materials or any vegetated or stabilized surfaces. The Pennsylvania DEP Erosion and Sediment Control Manual (PADEP, 2012), also indicates that these shear stresses are adequate to mobilize bare, erodible soils, but not sufficient to erode vegetated or reinforced soils. Therefore, some channel bottom erosion and sediment migration may occur as the river adjusts to new hydraulic conditions following dam removal. According to IRWA, since the depth of water under the existing dock exceeds 1.7 feet during current low flow periods, dam removal is not expected to limit access significantly.

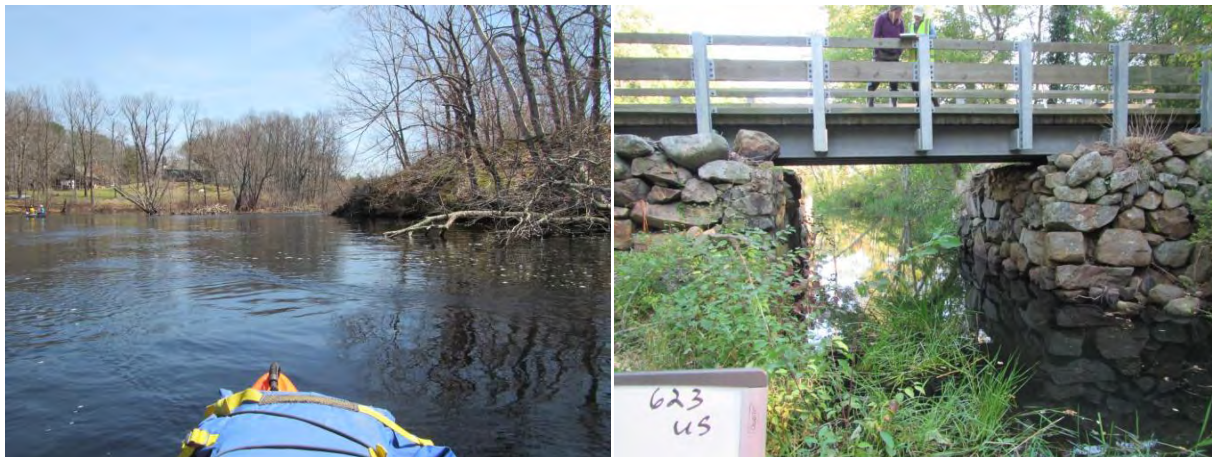
Miles River Confluence River Right (left) and Further Upstream on the Miles River (right)

The Miles River is the largest tributary entering the Ipswich River in the stretch of the lower river assessed in this memorandum. It joins the Ipswich approximately 7,200 feet upstream from the dam on river right, shortly downstream from the railroad bridge crossing. Hydraulic modeling at this location indicates that water levels in the vicinity of the Miles River confluence will remain essentially the same or slightly lower for the larger storm flows and drop moderately under the lower flow scenarios (up to approximately 1.7 feet for the 95% exceedance/low tide scenario). River flow velocities are modeled to remain essentially the same or drop slightly for the higher flow scenarios, and to increase moderately under the moderate and low flow scenarios (up to an approximately 0.4 fps increase under the 2-year storm and 5% exceedance scenarios). However, even those increased flow velocities are simulated to remain under 2 fps with shear stresses below 0.1 psf. As can be seen in Tables 3 and 4, those modeled shear stresses and velocities are capable of mobilizing smaller sediment sizes from silts up to fine gravel, but not larger materials or any vegetated or stabilized surfaces. The Pennsylvania DEP Erosion and Sediment Control Manual (PADEP, 2012), also indicates that these shear stresses are adequate to mobilize bare, erodible soils, but not sufficient to erode vegetated or reinforced soils. Therefore, some channel bottom erosion and sediment migration may occur as the river adjusts to new hydraulic conditions following dam removal.

Since the river stage is modeled to drop at these river confluences under all but larger storm flow conditions, and shear stresses and velocities are modeled to be capable of mobilizing smaller sediment sizes, some degree of sediment migration and channel headcutting is expected to occur as the tributary channel seeks to adjust to the new river level. This type of channel reconfiguration is expected as the river and its tributaries reconfigure themselves to the natural conditions that prevailed before the influence of the dam. Because the Miles River is the largest tributary in the potentially impacted stretch of the Ipswich River assessed herein, the concern for headcutting is perhaps greater here than at the smaller tributaries due to its greater flow rate. Contradicting the potentially greater risk for headcutting here due to higher flows is the fact that the modeled declines in water level here are less than at locations further downstream.

According to IRWA, and as observed from aerial photography, there are no culverts, bridges, or other infrastructure in the vicinity of this confluence likely to be impacted by channel reconfiguration. There is a large wetland complex in the area of the confluence that would be expected to transition its vegetation community type towards less land under water and more BVW under the influence of lower average water levels under potential dam-out conditions. Emergent marsh would also be expected to shift to lower elevations. We recommend that conditions be monitored following dam removal to document the extent of headcutting that occurs. Therefore, an adaptive management approach is recommended here, the same as at the other confluences. We recommend that conditions be monitored following dam removal to document the extent of headcutting that occurs, as well as the changes in wetlands community types.

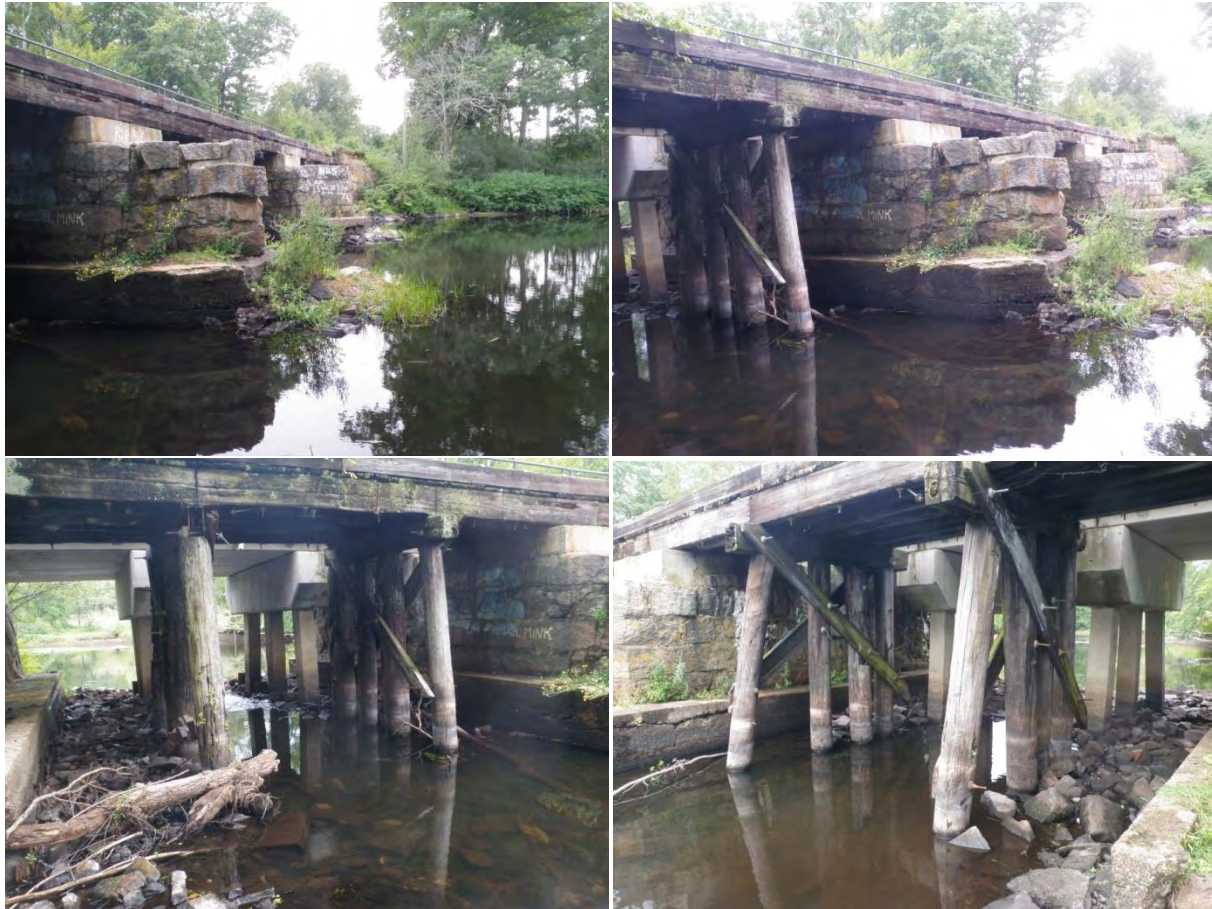
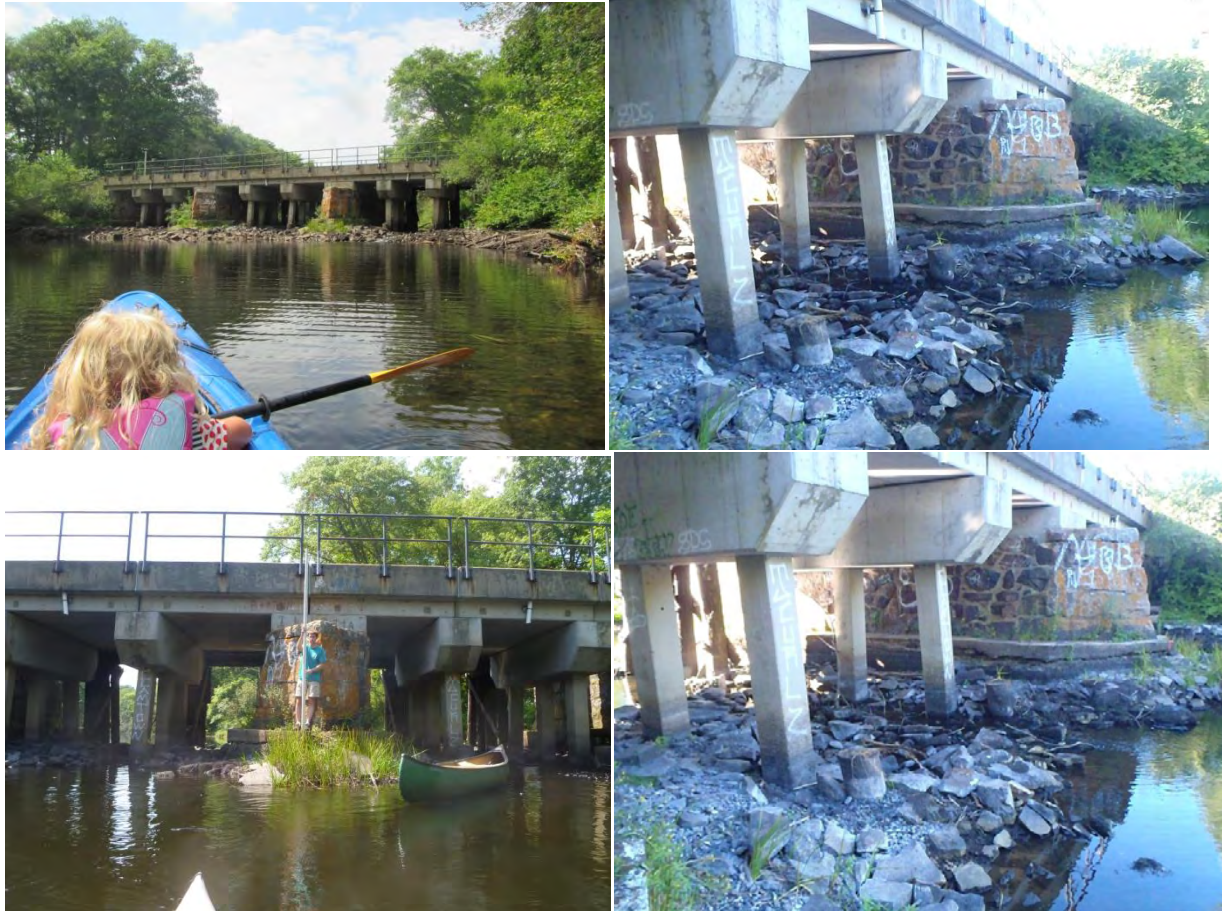
Railroad Bridge Views (Photos Taken During September 2016 Drawdown)
 from Upstream (top two rows) and Downstream (bottom two rows)

Located approximately a mile and a half upstream from the dam, the railroad bridge crossing is the most upstream structure with the potential to be impacted by dam removal. According to IRWA, the bridge is owned by the MBTA and operations are undertaken by Keolis. The crossing is actually two separate bridges adjacent to each other. The railroad bridge is the more downstream of the two, newer, and supported by newer concrete piers. The older, more upstream bridge, supported by timber piers, is for the railroad's service road.

Due to the elevated, stone-reinforced river bed beneath the bridges, a hydraulic drop is created at the bridge during lower river water levels under current conditions (as evident from the above photos taken during the September 2016 drawdown and with drought conditions). Visual observations during the drawdown also indicated that there is a tendency for logs and other large debris flowing down river to become trapped against the upstream bridge support piers, exacerbating the potential for a hydraulic drop at this location. Under a potential dam-out scenario with lowered water levels, both the magnitude of that hydraulic drop and the frequency with which it occurs are expected to be increased. According to IRWA, MBTA conducts routine clearing of debris beneath the bridge. That maintenance program would likely become more important to sustain fish and recreational passage beneath the bridges with lowered water levels under potential dam-out conditions.

Despite these significant increases in erosive river flow for certain flow scenarios, the simulated velocity and shear stress numbers for those scenarios with the greatest modeled increases resulting from potential dam removal are still lower than are modeled to currently occur under larger storm events. For example, the dam-out modeled velocity and shear stress for the 2-year storm of 12 fps and 5.5 psf, respectively, are less than the modeled existing conditions values for the 10-year storm event of 15.3 fps and 8.1 psf. No significant changes to river level, velocity, or shear stress are simulated to occur as a result of dam removal for flow scenarios of the 10-year storm and greater.

These modeling results suggest that the existing stone scour protection beneath the bridge will become the new elevation control holding back upstream river flows and increasing river velocity beneath the bridge for the lower flow and non-storm scenarios. Higher modeled river flow scenarios and all storm flow scenarios are not modeled to be significantly impacted by dam removal at this location. Because the existing scour protection apparently adequately serves the existing conditions, and the existing conditions for higher flow scenarios are simulated to represent more erosive velocities and shear stresses than the increased velocity, lower flow scenarios simulated to occur under dam-out conditions, the existing scour protection may be adequate for potential dam-out conditions.

Nevertheless, because of the importance of the railroad bridge and because more erosive conditions under lower flow scenarios may occur more frequently than those erosive conditions that currently occur under higher flow scenarios, further study of this concern is recommended. Such study should include field evaluation of the sediment characteristics relevant to their potential for erosion, scour analysis of the potential for erosion at these locations (U.S.DOT, April 2012), and more detailed design to specifically address any identified erosion concerns. The MBTA and Keolis should also be consulted to solicit their input on the types of additional analyses and design factors it would require to satisfy any of its potential concerns. Access to the railroad line for work would be via the existing gates and maintenance roads. One is located at Hayward Street from the North, and the other at Waldingfield Road from the south (Figure 2B).

H&H modeling indicates that the area beneath the railroad crossing may become more problematic for fish passage under potential dam-out conditions due to the hydraulic jump created by the existing rock-bed scour protection under low flow conditions. As was observed during the 2016 drawdown, irregularities in the rock bed may provide diverse flow conditions and opportunities for fish passage over this short distance that would allow functional fish passage to continue under potential dam-out conditions, but this situation should be further evaluated in subsequent project design phases to ensure that appropriate fish passage is maintained (Turek et al, 2016, and USFW, 2017). Fish passage design should be conducted in concert with scour protection design to ensure that both goals can be achieved.

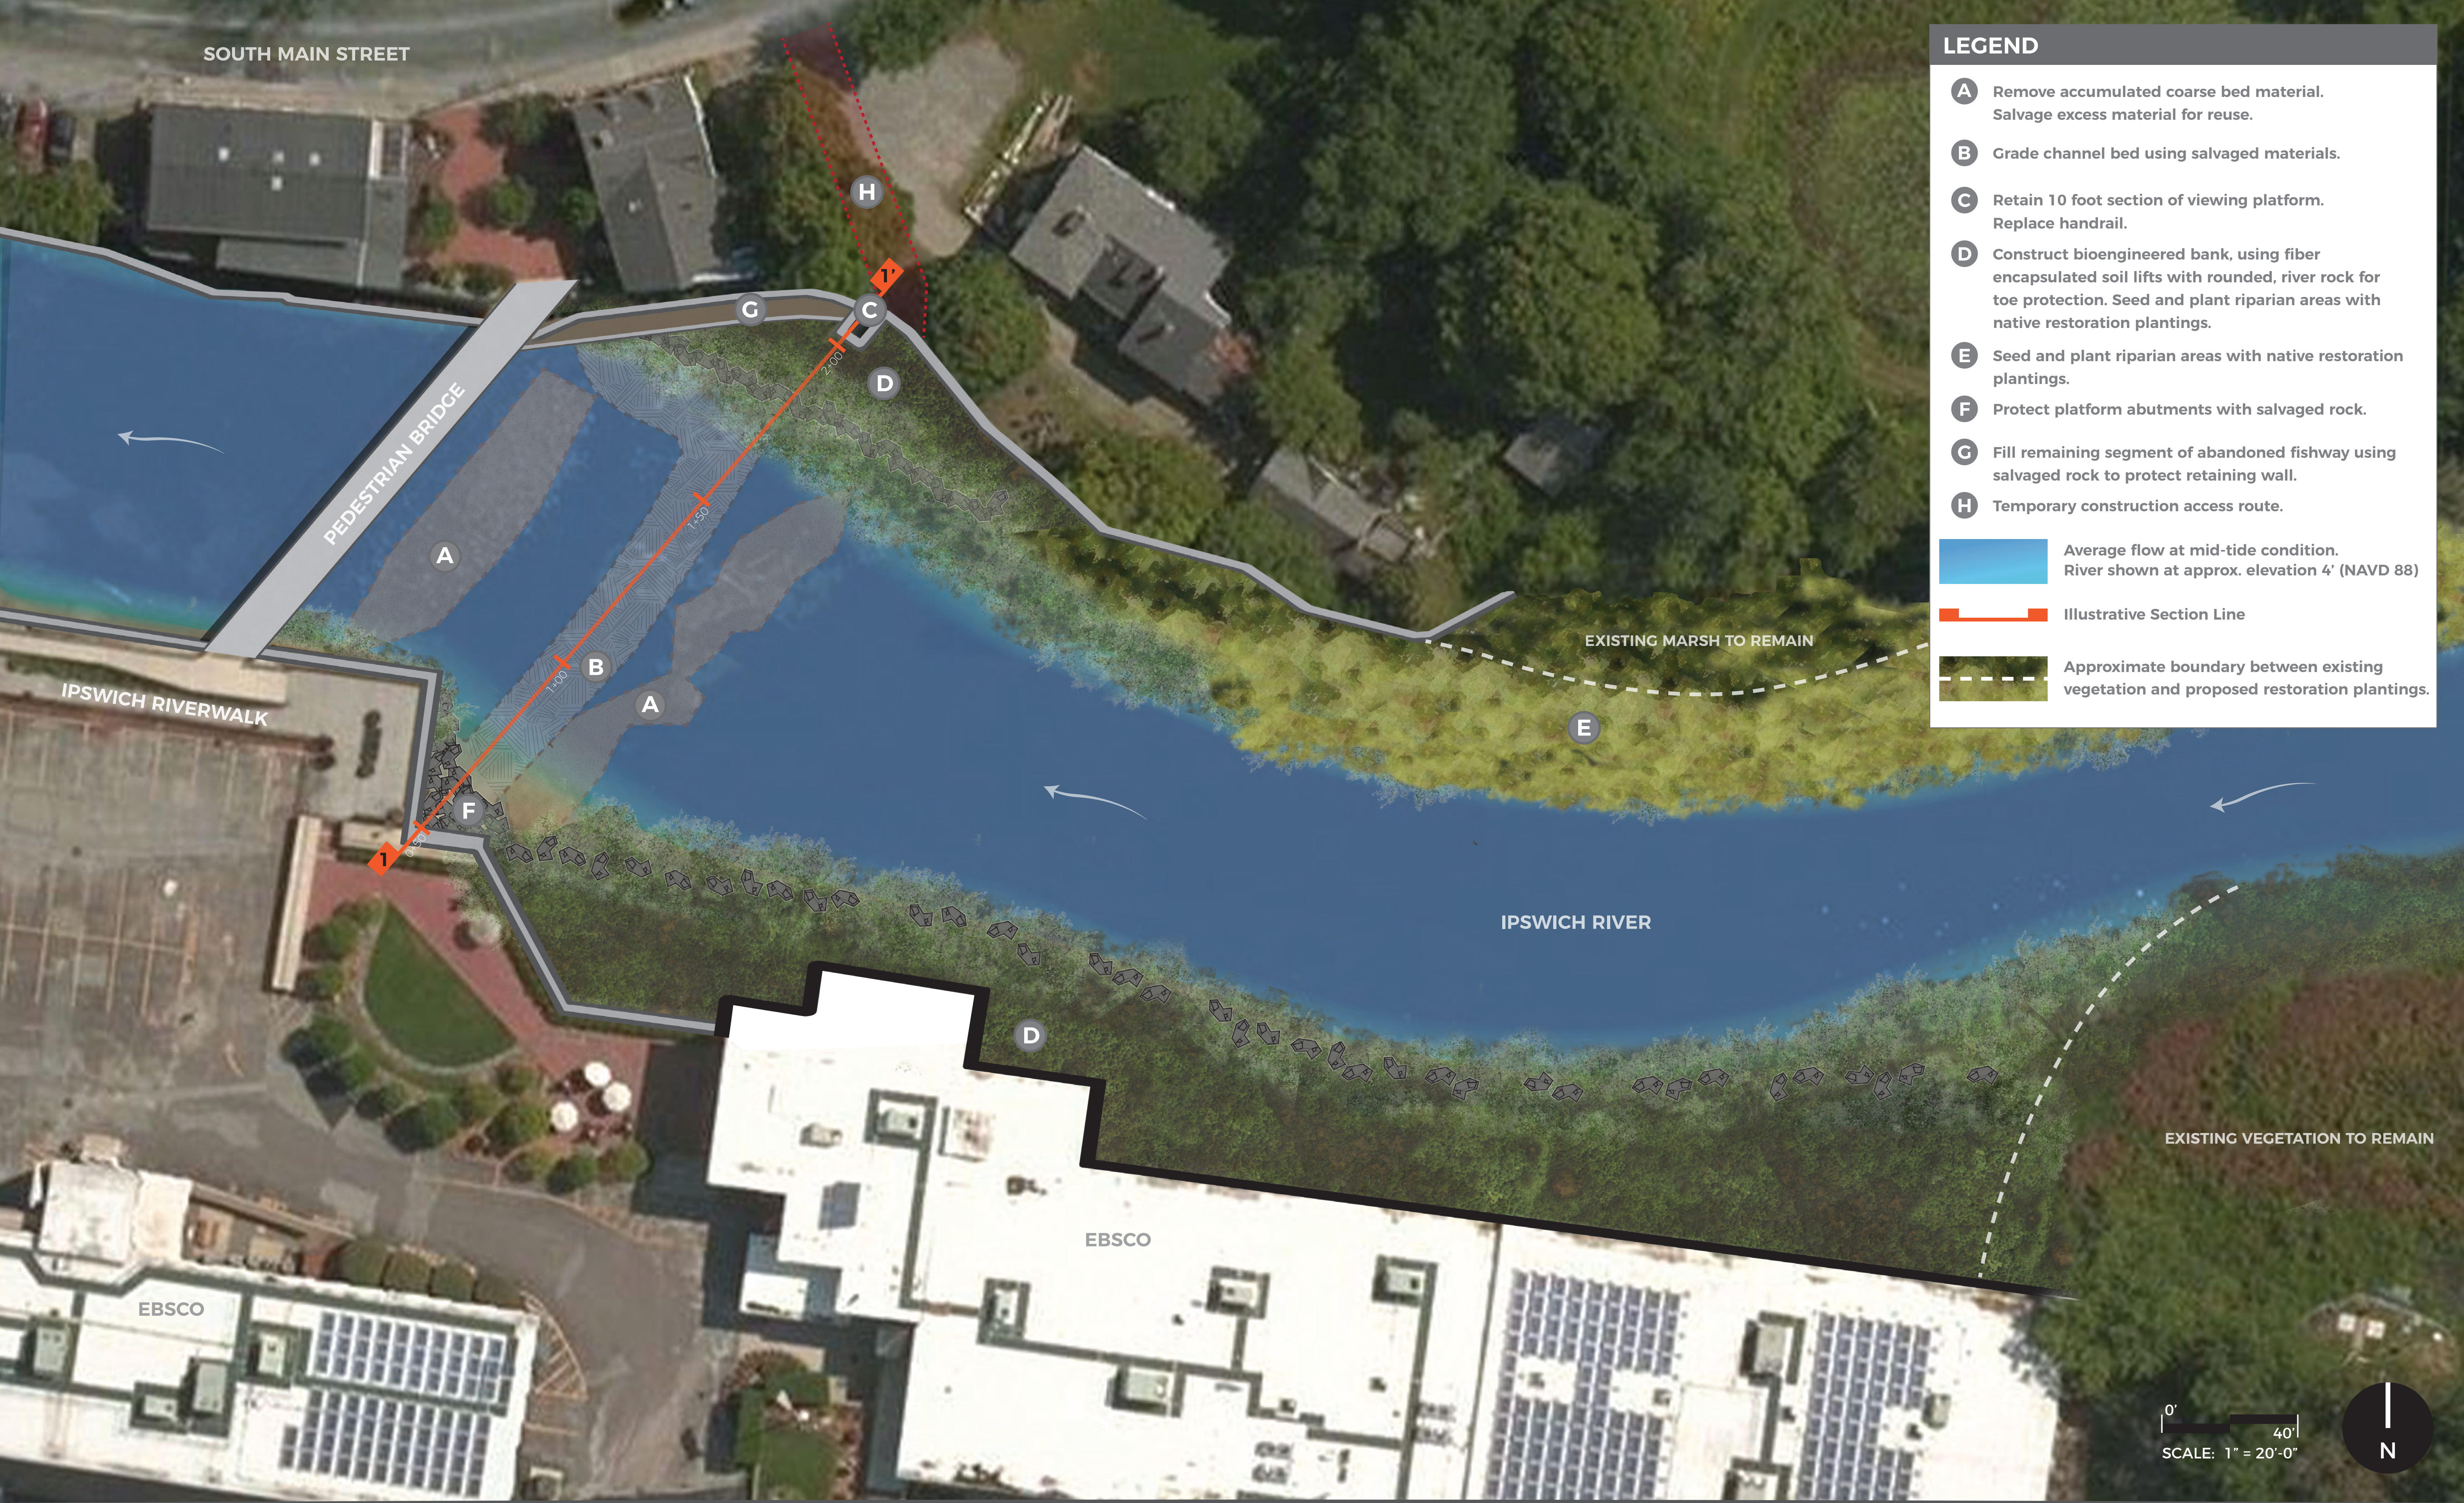
- A** Remove accumulated coarse bed material. Salvage excess material for reuse.
- B** Grade channel bed using salvaged materials.
- C** Retain 10 foot section of viewing platform. Replace handrail.
- D** Construct bioengineered bank, using fiber encapsulated soil lifts with rounded, river rock for toe protection. Seed and plant riparian areas with native restoration plantings.
- E** Seed and plant riparian areas with native restoration plantings.
- F** Protect platform abutments with salvaged rock.
- G** Fill remaining segment of abandoned fishway using salvaged rock to protect retaining wall.
- H** Temporary construction access route.

- Average flow at mid-tide condition. River shown at approx. elevation 4' (NAVD 88)
- Illustrative Section Line
- Approximate boundary between existing vegetation and proposed restoration plantings.

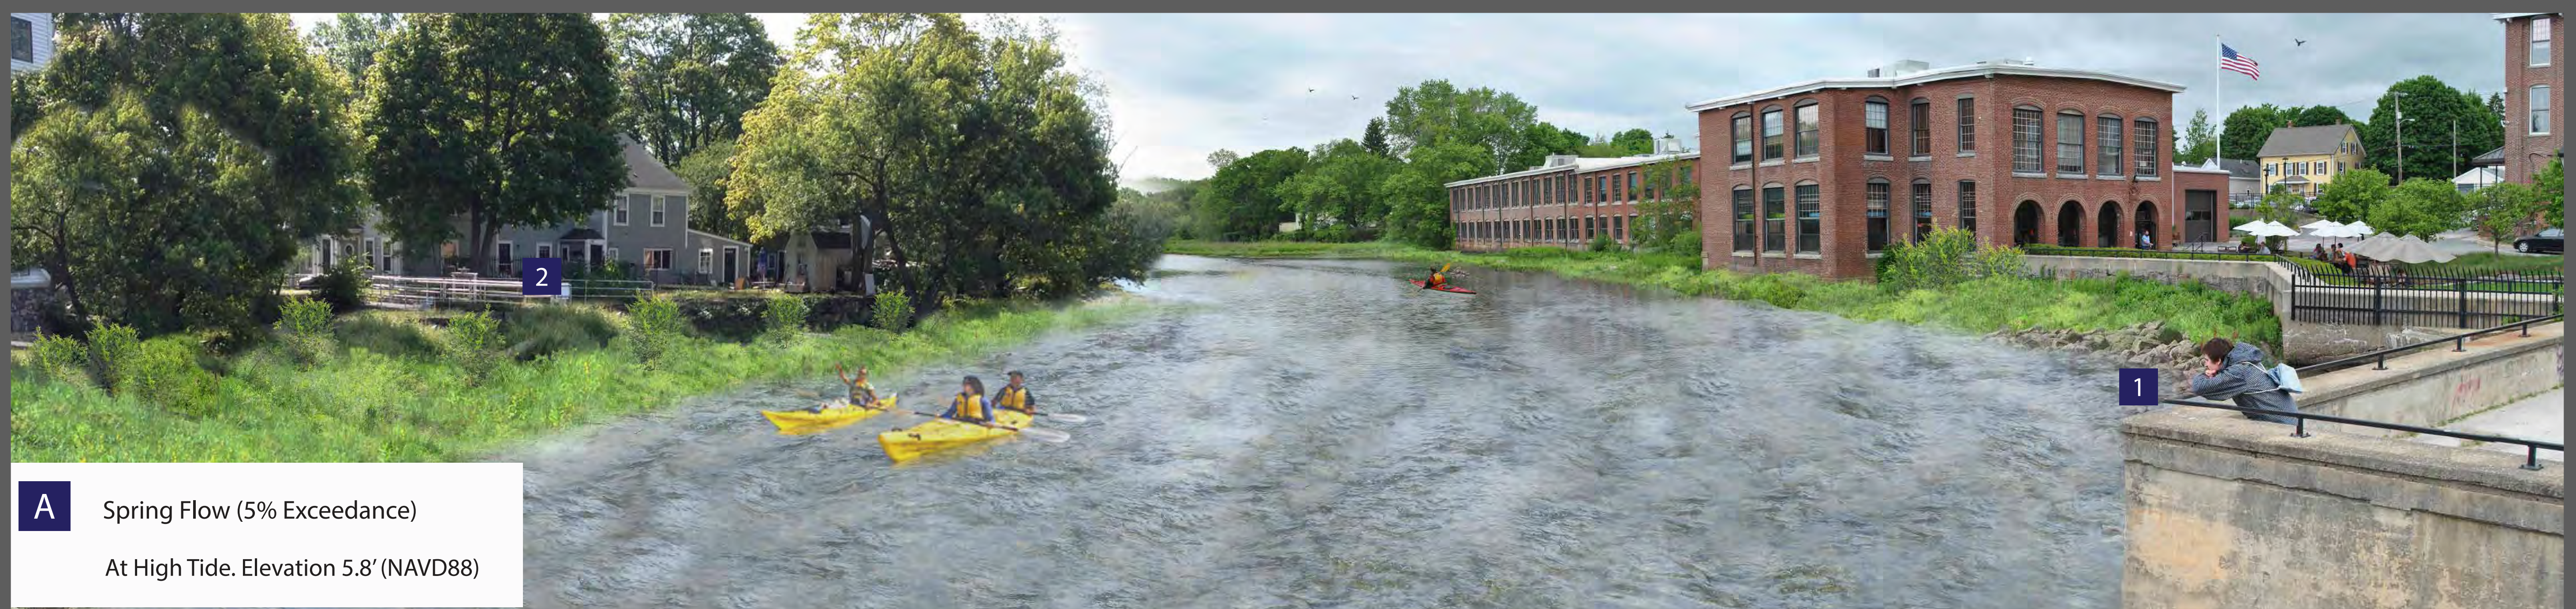
A Spring Flow (5% Exceedance)
At High Tide. Elevation 5.8' (NAVD88)

1 The elevation of top of wall is 12.73 feet (NAVD88)
2 The elevation of viewing platform is 13.46 feet (NAVD88)

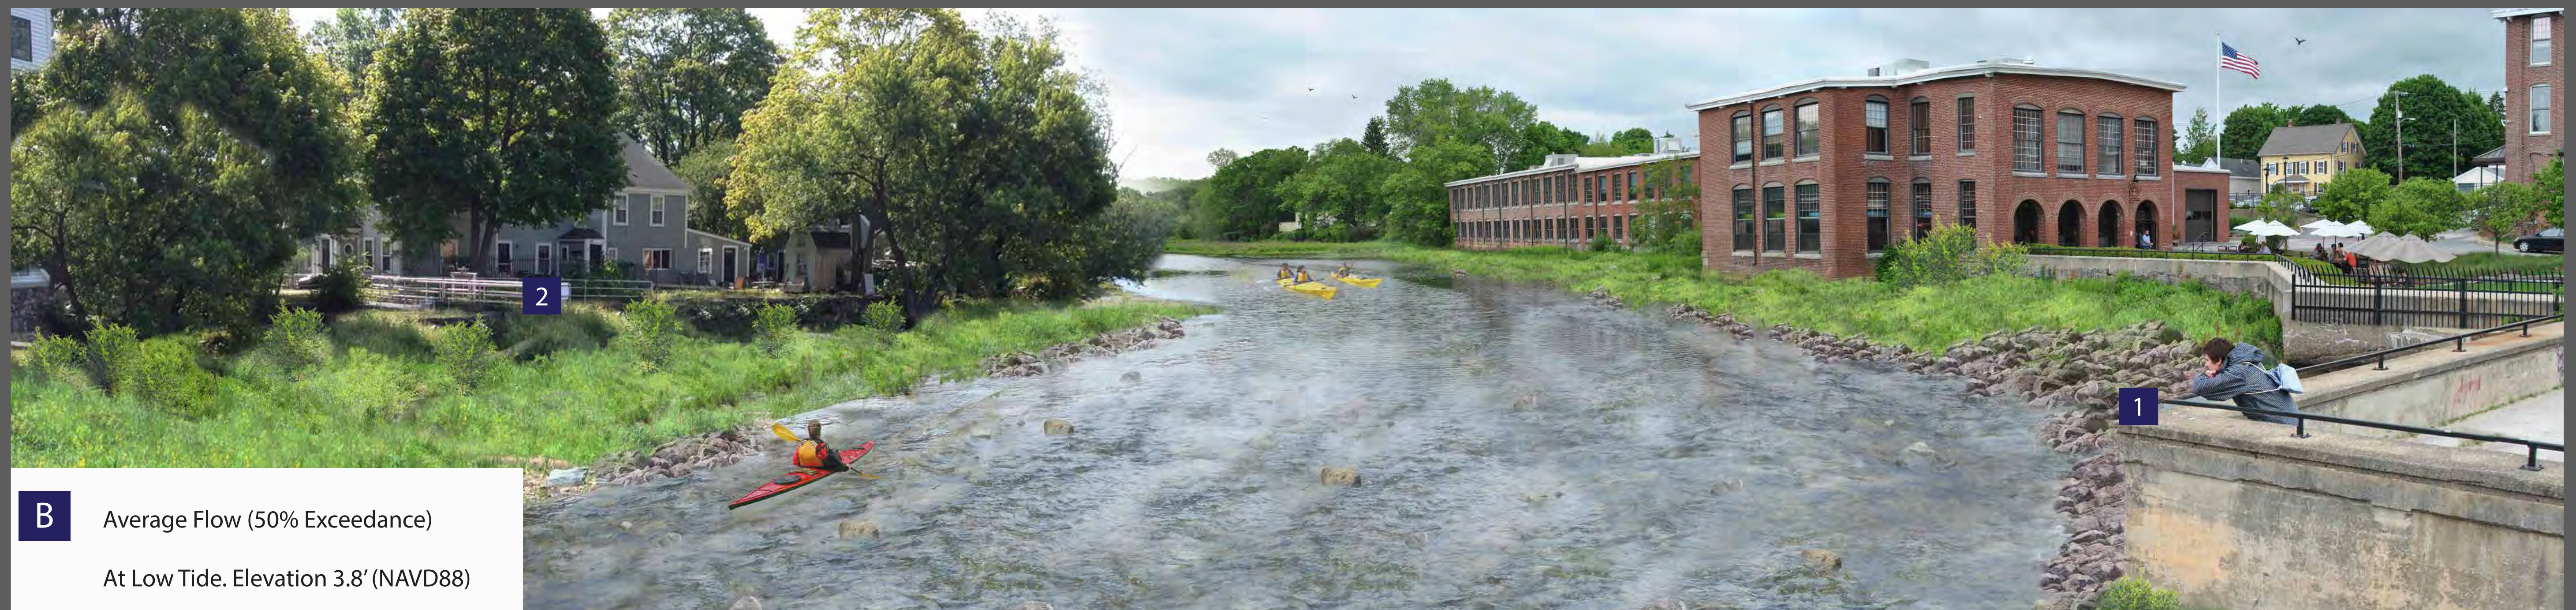
B Average Flow (50% Exceedance)
At Low Tide. Elevation 3.8' (NAVD88)

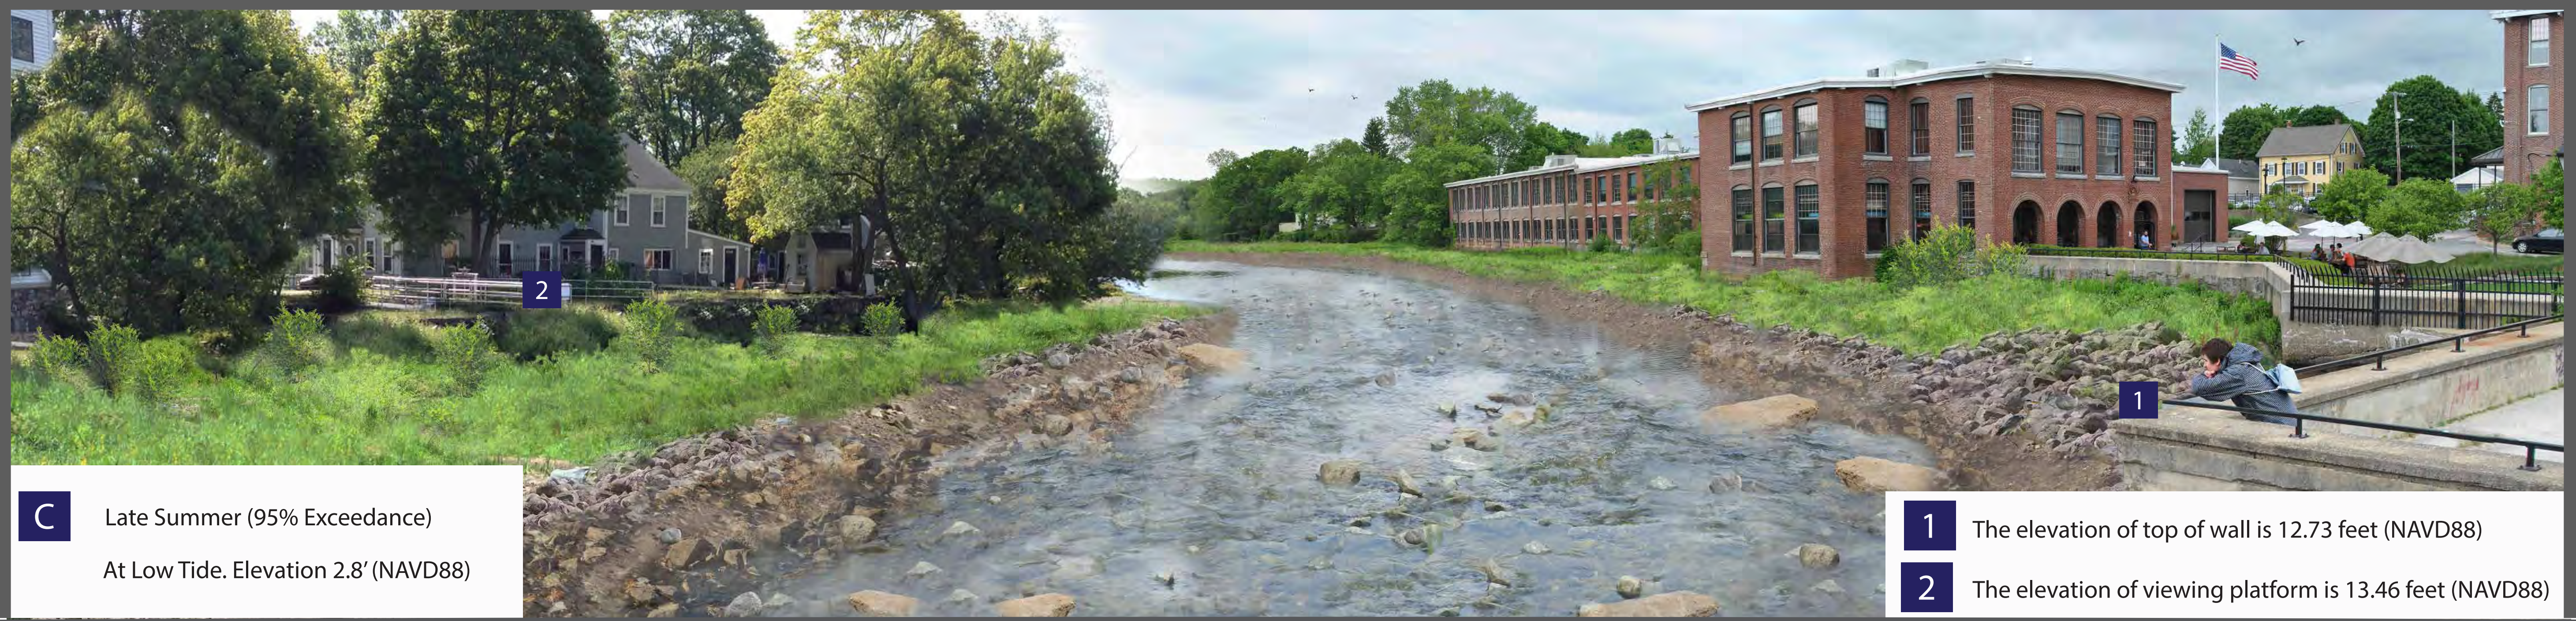
C Late Summer (95% Exceedance)
At Low Tide. Elevation 2.8' (NAVD88)
